Project acronym: **LASH FIRE**
Project full title: **Legislative Assessment for Safety Hazard of Fire and Innovations in Ro-ro ship Environment**
Grant Agreement No: **814975**
Coordinator: **RISE Research Institutes of Sweden**

Deliverable D04.1

Review of accident causes and hazard identification report

May 2020

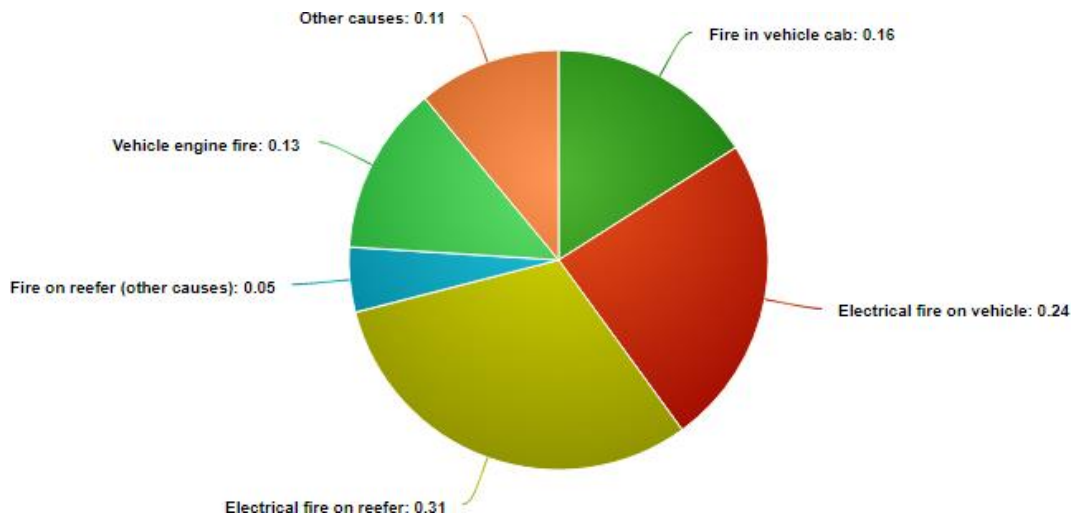
Figure 1: Ignition sources, as identified by MAIB in their investigation of fire in ro-ro space (Marine Accident Investigation Branch, 2011).

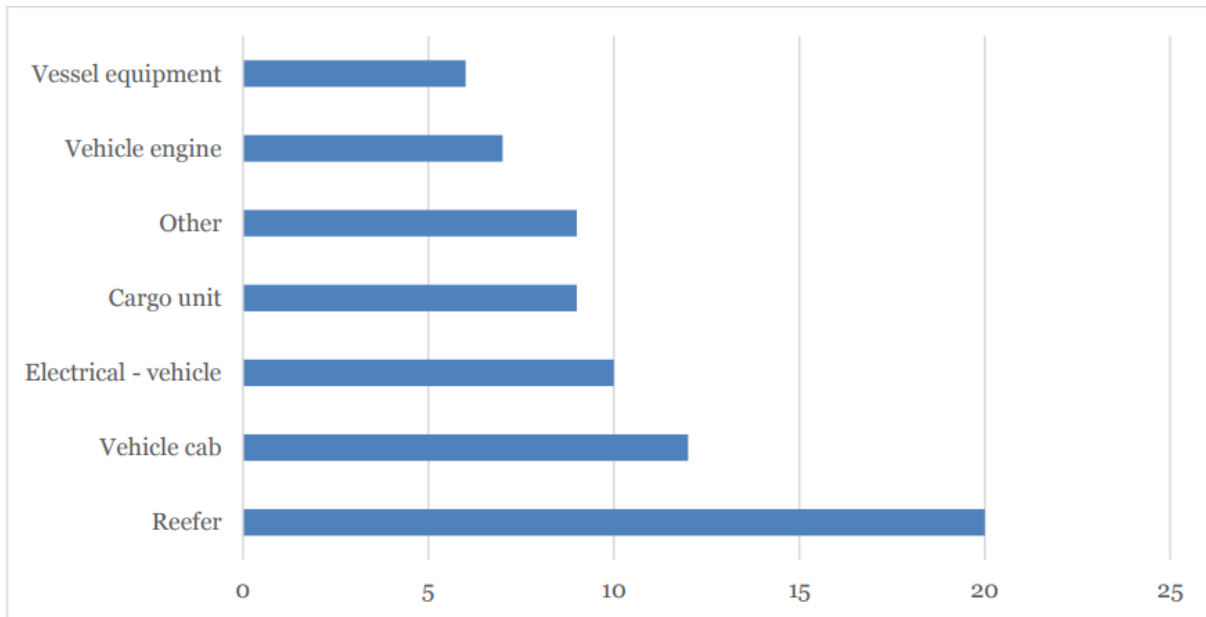
The aforementioned paper from IUMI presents a summary of ignition sources, see Figure 2, and builds upon the investigation conducted by the IMO-FSI Correspondence Group on Casualty Analysis (2012). The resulting report by the correspondence group was further analysed in 2015 by a Group of Experts (GoE), consisting of European Flag State representatives and maritime accident investigation bodies, on the initiative of the European Maritime Safety Agency (EMSA). The GoE concluded that *Electrical Fire as Ignition Risk* and *Fire Extinguishing Failure* were the most significant fire risk contributors, triggering European Maritime Safety Agency (EMSA) to commission the FIRESAFE studies — the most comprehensive public studies on ro-ro space fire safety to date.

Figure 2: Ignition sources on ro-ro vehicle decks 1994–2011 based on FSI 21/5. (Source: IUMI)

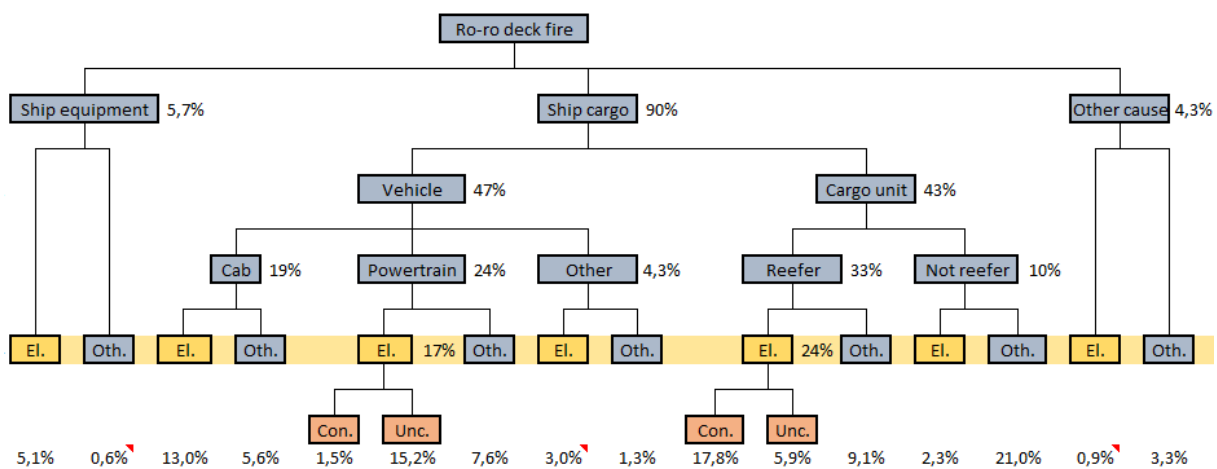
Figure 3: Fault tree risk model developed in the first FIRESAFE study, detailing ignition sources leading to ro-ro space fire.

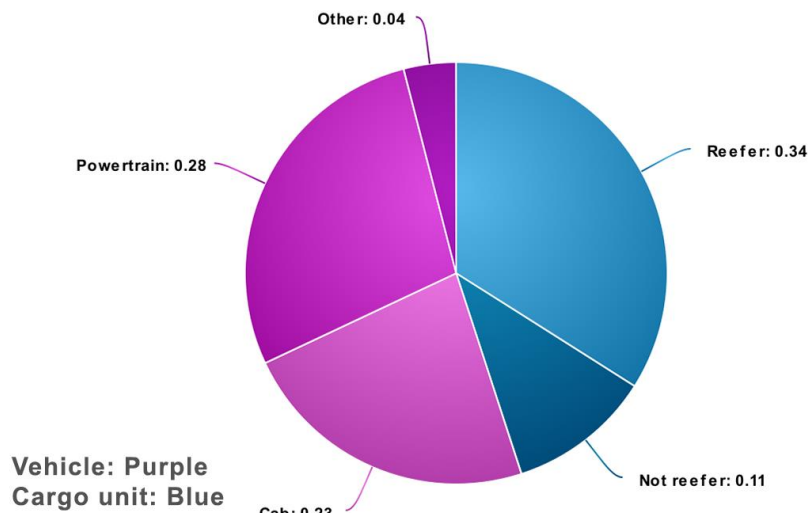
In 2016, based on the findings from the GoE, EMSA commissioned the first FIRESAFE study, which comprised two parts—*Electrical Fire as Ignition Risk* and *Fire Extinguishing Failure*. The former aimed to outline a range of cost-efficient safety measures that would help to reduce the number of fires arising from electrical failures in cargo stowed in ro-ro spaces. To that end, a fault tree describing ignition sources leading to fire in ro-ro spaces was developed. Input to the fault tree was extracted from three filtered datasets involving 140 cases of fire in ro-ro spaces in total, all of which occurred during the period 1994–2016. The developed fault tree is presented in Figure 3 and illustrates that, inter alia, approximately 60 % of all reviewed ro-ro ship fires were caused by electrical faults. Furthermore, roughly 90 % of the fires which occurred in ro-ro space originated in the ship’s cargo, over one third of which were caused by refrigeration units, as illustrated in Figure 4.

Figure 4: The specific origins of fires related to the ship's cargo (90 %), which includes the cargo unit and the vehicle – excluding fires caused by “ship equipment” and “other causes” (in total 10 %).

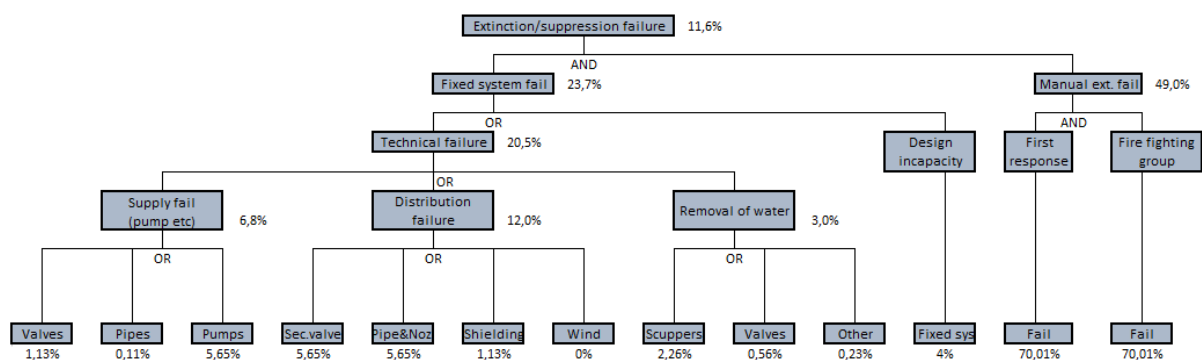
Figure 5 illustrates the fault tree for the *extinguishment/suppression failure in case of “early decision” in a closed ro-ro space*. The values assigned to the bottom nodes were based on expert judgement and literature values, if available (Wikman, et al., 2016).

Figure 5: Extinguishment/suppression fault tree developed in FIRESAFE.

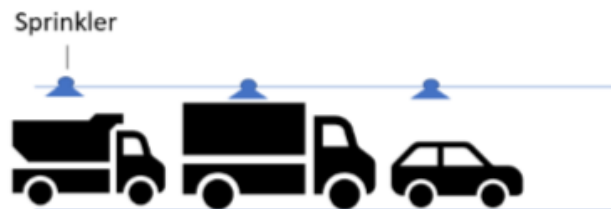
The efficiency of a drencher system may be limited if the distribution of water is obstructed by a closed-top, high-sided vehicle (Bram, Millgård, & Degerman, 2019; Murdoch, Jenkins, & Anderson, 2018), as illustrated in Figure 6.

Figure 6: Drencher spray obstructed by cargo (Bram, Millgård, & Degerman, 2019).

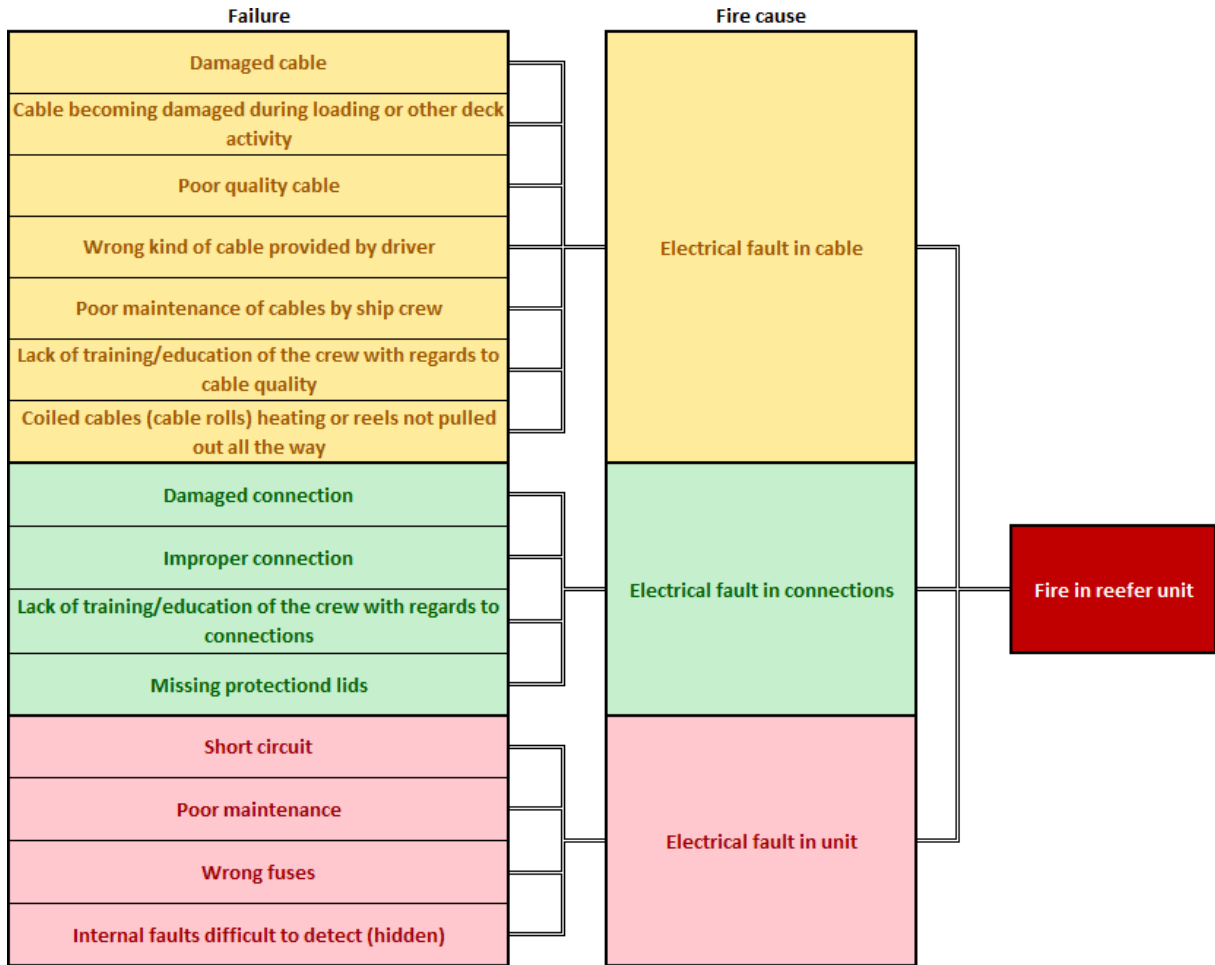
Refrigeration units, commonly referred to as reefer units or reefers, are commonly subject to electrical faults and constitute a significant fire hazard in ro-ro spaces (Wikman, et al., 2016; DNV GL, 2016). Electrical malfunction may occur due to a faulty/damaged cable, connection, or unit and can develop to cause ignition (see Figure 7). Not only are refrigeration units that are connected to a power supply more likely to catch fire than other sources of ignition, four out of the five major ro-ro passenger ship fires in recent years have been caused by electrical failure in refrigeration units² (DNV

Figure 7: Refrigeration unit failure modes and their relation to fire cause. Based on data from the report Stena Line HAZID Study - Transport of Alternatively Fuelled Vehicles (2015).

- **Only ship cables**
 - Aims to reduce the likelihood of short circuit in cables and adapters, overheating due to wrong size and arc faults due to damaged cables by prohibiting unknown cables from being connected to the ship. Cables should be treated as consumables and routines for maintenance and exchange of cables should be developed.

- **Training for awareness**
 - Expand ongoing training processes and training programs to include fire hazards related to substandard installations and other sources of electrical faults, e.g. damaged connections/cables. The training program should also include routines for reviewing units and how to handle risk.

- **Only crew connections**
 - Cables should only be connected and disconnected by trained crew, who through training and routines, can reduce the likelihood of fire through proper control of, care for and maintenance of cables, as well as the ability to identify faulty and risky connections. Routines include e.g. avoiding long cables and cable routing.

- **Cable reeling drums**
 - By placing cable reeling drums in appropriate locations in the ceiling of the RoRo space, it is possible to protect cables from damage during loading or other deck activity.

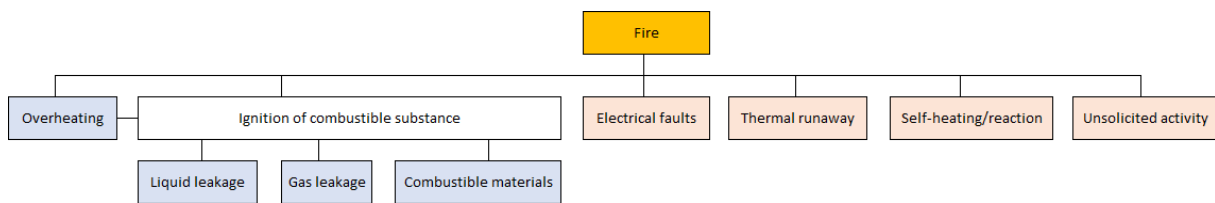
As can be seen from the documented results presented in ANNEX B, fire causes were grouped into 7 categories, represented by the bottom nodes in Figure 8. The bottom nodes have been coloured to distinguish between causes that depend on another failure to develop into a fire (blue nodes), and those which do not (orange nodes). As illustrated by the diagram, leakage of gas or liquid will not cause a fire to develop unless there is an ignition source present. The ignition source can be in the form of an overheated car part, sparks, friction due to cargo shift, etc. Similarly, overheating will not lead to fire development unless the overheated part is impinged upon flammable substances, such as gas or liquid leakage. Another possible scenario is one where the overheated part itself is made of combustible material, e.g. a tyre, in which case overheating unaidedly may develop into a fire. This is similar to fires caused by electrical faults, thermal runaway, self-heating and unsolicited activity, which likewise do not depend on other failures for a fire to develop.

Figure 8: Simple tree describing different fire causes in ro-ro spaces.
