Project acronym: **LASH FIRE**  
Project full title: **Legislative Assessment for Safety Hazard of Fire and Innovations in Ro-ro ship Environment**  
Grant Agreement No: **814975**  
Coordinator: **RISE Research Institutes of Sweden**

## **Deliverable D10.4**

# **Large-scale validation of the new fire test standard for alternative fixed fire-fighting systems**

**February 2023**

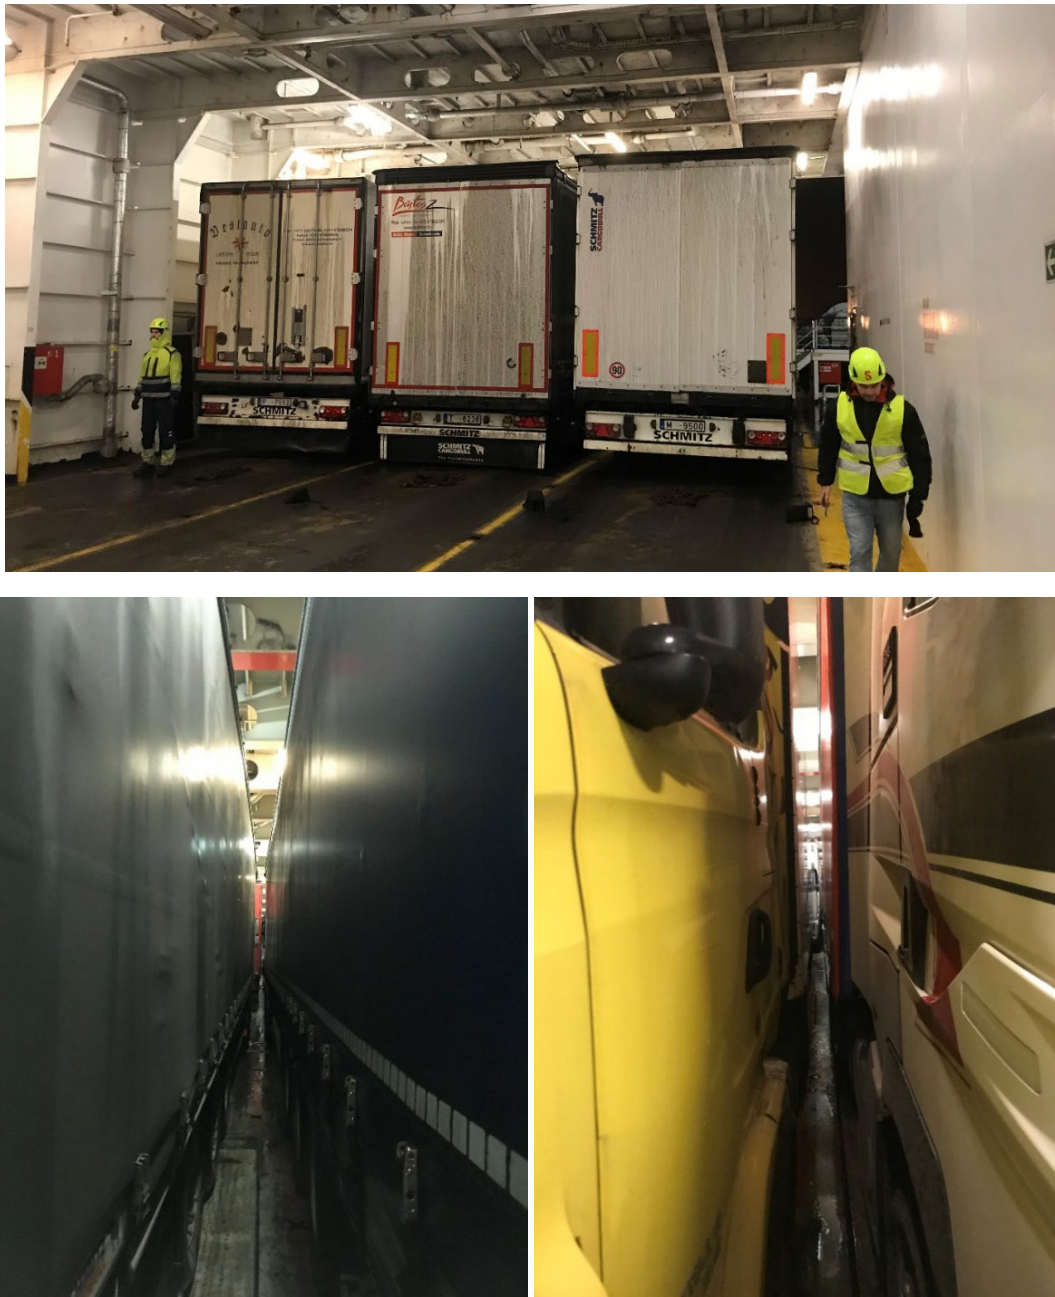
Figure 1. Typical cargo stowage on ro-ro passenger and ro-ro ships. Photo: FLOW.

On ro-ro passenger and ro-ro cargo ships, cargo is (mainly) stowed in lanes, including passenger cars, trucks, trailers and other. Typical cargo stowage is illustrated in Figure 1.

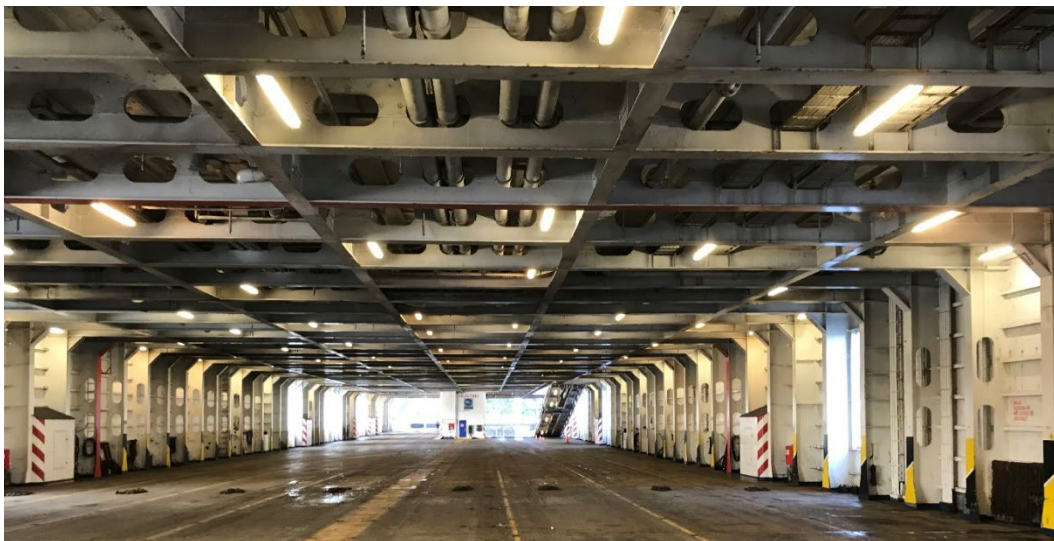
Figure 2. Typical vehicle space on a ro-ro passenger ship (photo from Stena Flavia). Photo: FLOW.

Figure 2 through 5 illustrate a typical vehicle space on a ro-ro passenger and ro-ro cargo ships.

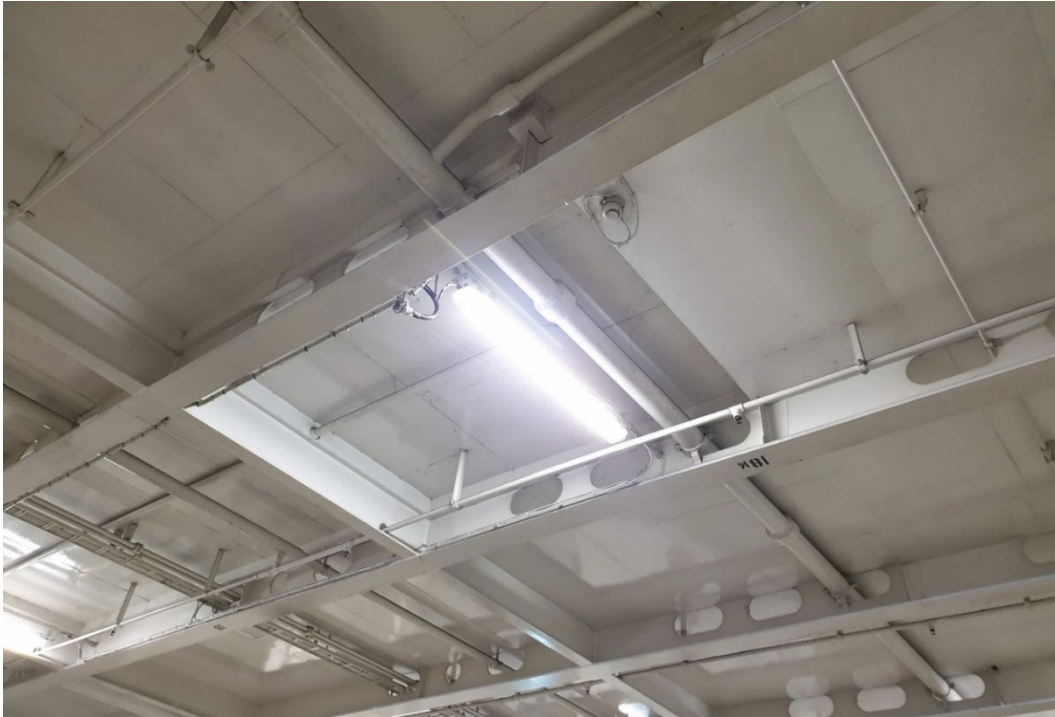
Figure 3. Typical vehicle space deck structure arrangement with insulation of the steel deck. Photo: FLOW.

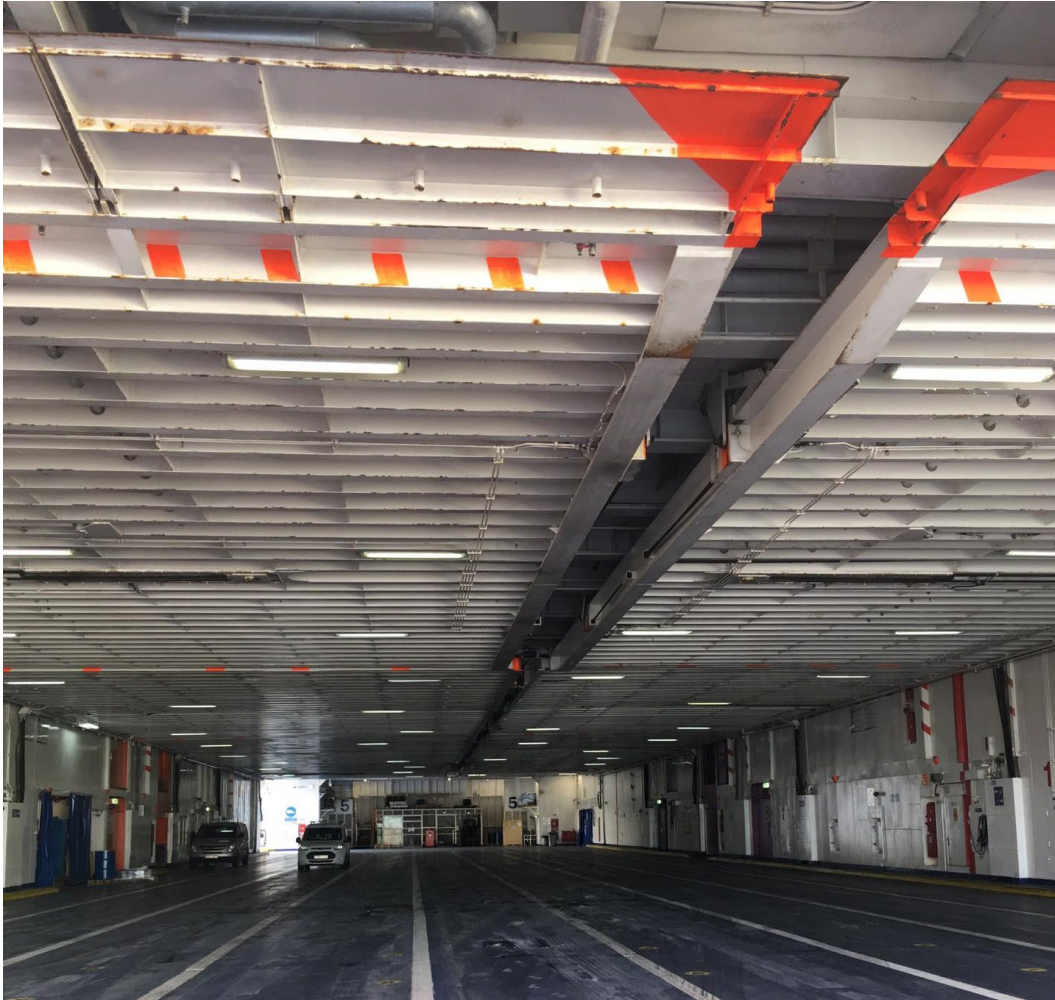
Figure 5. Typical vehicle space on a ro-ro passenger and ro-ro cargo ship with movable deck arrangement.  
Photo: FLOW.

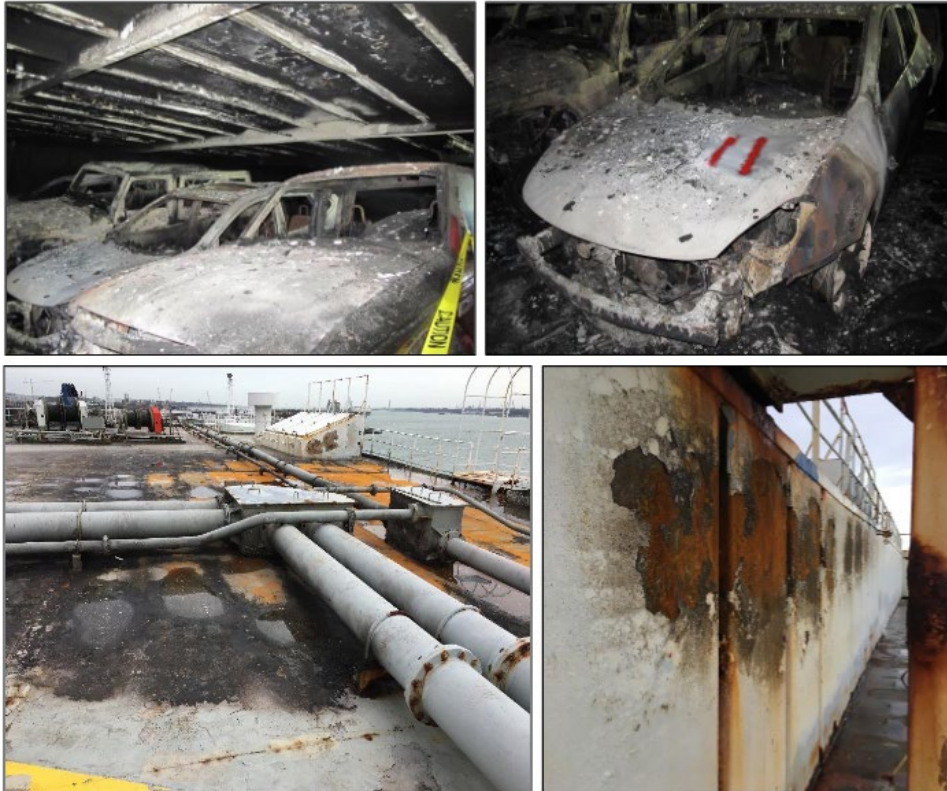
At top, damaged cars on the garage deck. At bottom from left to right, damage to the top deck above the garage and the exterior bulkhead on the port side of the garage while looking aft.

Figure 7. The fire damage to the vehicle carrier Honor [2].

**Comments:** Another example of an electrical cause of fire and extensive fire damage on a vehicle carrier. Note that these types of ships have not a fixed-installed water-based fire-fighting system.

However, it was concluded that the crew's appropriate and effective use of the Carbon Dioxide system, along with boundary cooling, likely prevented the spread of the fire and reduced the damage. The likely cause of the fire was a fault in the starter motor solenoid in one of the personally owned vehicles in shipment. Preliminary testing of this scenario confirmed that a fault within the solenoid could cause ignition of the insulation and covering on the adjacent wiring.

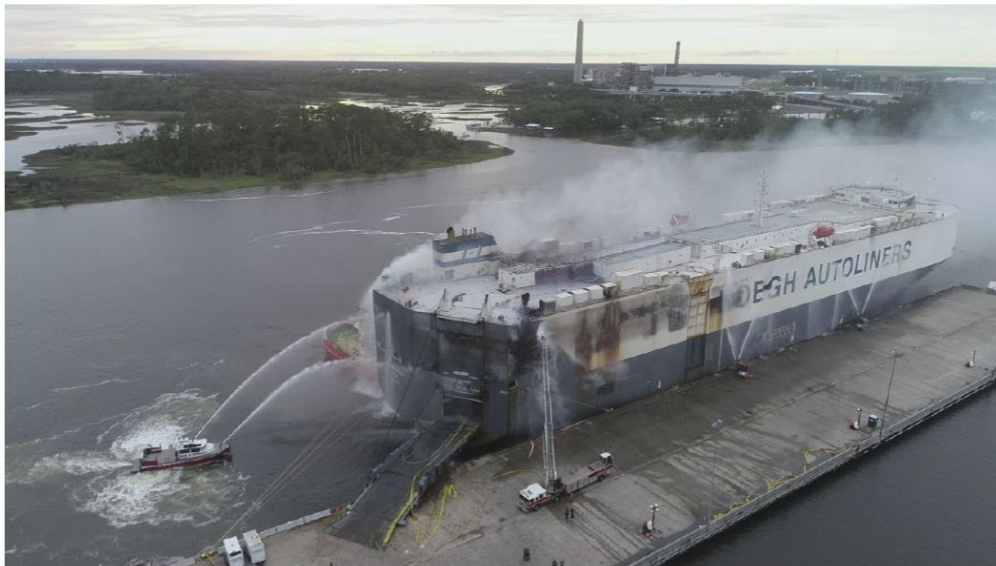
**Figure 6.** Firefighters conducting exterior boundary-cooling on June 5, 2021, the day after the fire was discovered. (Source: JFRD)

Consequently, a defensive strategy was adopted, cooling external exposed surfaces of the ship with fire monitors and fire hoses, refer to Figure 8.

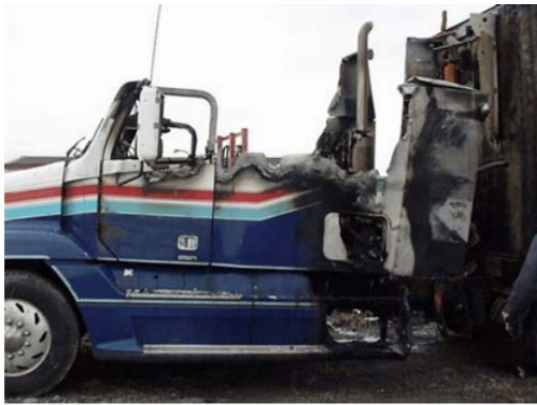
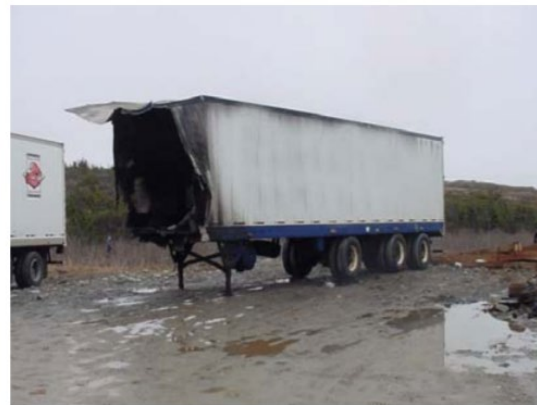
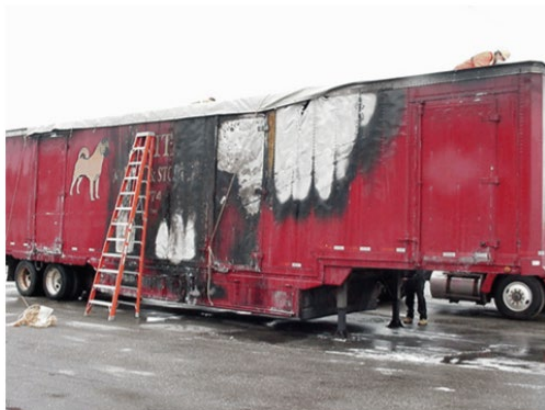
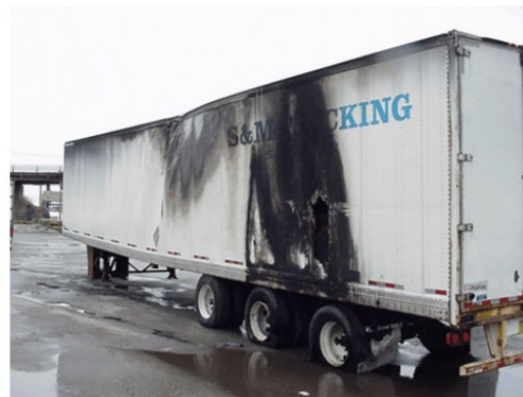
Tractor fire damage

Trailer fire damage

Figure 9. The fire damage to the freight ('tractor') truck and the attached trailer on board Joseph and Clara Smallwood. It was concluded that fire likely started in the freight truck. Note: From these photos it appears that fire have spread from the cabin of the freight truck and towards the back, thereby involving the attached trailer. The exterior of the trailer exhibit (at least the side shown in the photo) very little fire damage [4].

Moving and storage trailer fire damage

Drop trailer fire damage

One freight ('tractor') truck was severely damaged, and the attached trailer was heavily damaged. The cargo of orange juice was destroyed. The contents of a moving and storage company trailer had heavy damage and a drop trailer with building supplies sustained heavy damage. Several other tractor-trailer rigs suffered varying degrees of smoke and water damage and a private motor vehicle sustained heat damage to the rear bumper, left tail-light and rear tires. It was concluded that fire likely started in the freight truck. This vehicle was too badly damaged to be easily removed from the deck and was finally towed off the vessel later in the morning. Figures 9 and 10, respectively, shows the fire damage to the freight truck and trailers.

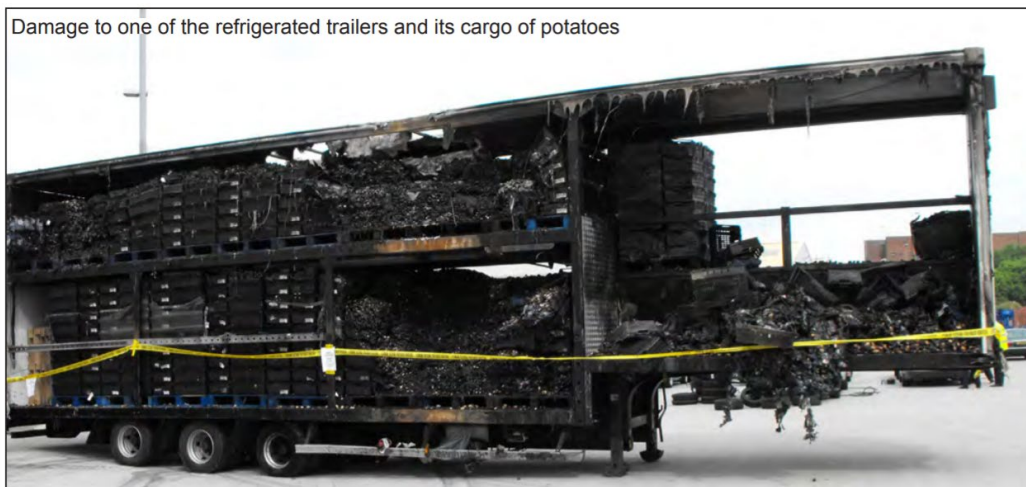
Figure 11. The damage to one of the refrigerated trailers in the fire on board Commodore Clipper [5].

The distance between trailers on the main vehicle deck of Commodore Clipper was generally in the order of 150 mm to 450 mm and in some cases, adjacent trailers were nearly touching. The report concludes that this density of trailers encourages higher rates of fire growth and reduces the effectiveness of fixed water spray systems and portable firefighting equipment. It is reported that crew and fire-fighters saw water from the water spray system bouncing off the roofs of the trailers and running down their sides. The cargo continued to burn inside, shielded but still ventilated through the damaged curtain-sides. It is reported that the potatoes were contained in plastic crates. Figure 11 illustrates the damage to one of the refrigerated trailers.

Another observation is that only part of the roof of the trailer have burnt through. It may well be that the application of water from the overhead water spray nozzles have prevent burn through.

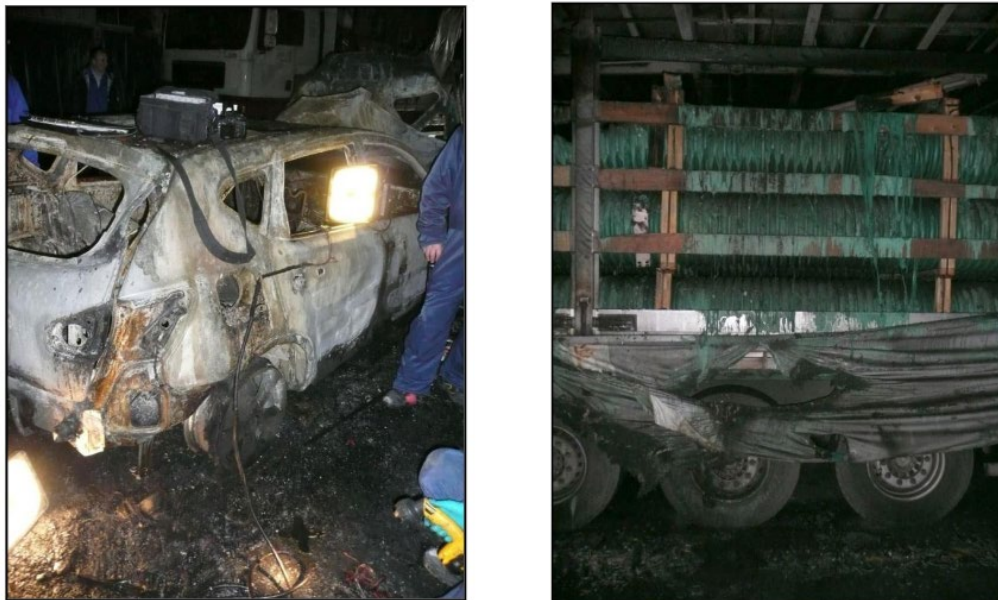
*The electric car and a trailer carrying plastic pipes*

An attempt to fight the fire by fire hoses was considered to be hazardous and was terminated. The sprinkler system in section 5 was manually operated at 06:15. At 07:00 Swedish fire-fighters arrived at the ship by a helicopter and at 07:12 the water flow from the sprinkler system on deck 3 was shut off. The Swedish fire-fighters (using breathing apparatus) then entered the space and could ascertain that there were still some small fires. One of these under the bonnet of one of the cars. These small fires were extinguished by portable fire extinguishers. At 07:51 the fire was reported extinguished, and guards were posted for monitoring deck 3. It was concluded that an explosion in the battery pack in the rear end of the electric car spread fragments of red-hot metal through the gap between the flooding control door that resulted in a fire in two trailers. One of these trailers were carrying plastic pipes. The fire damage is shown in Figure 12.

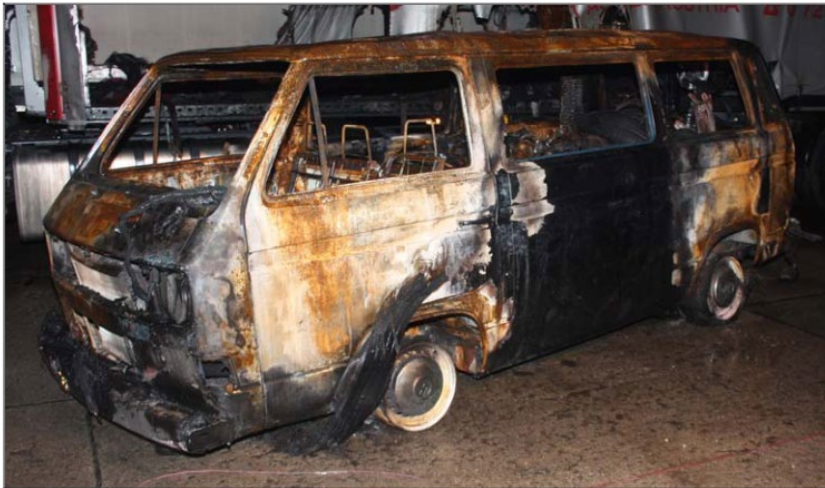
Figure 9: Driver's side of the VW Transporter

The fire started in VW Transporter, which was almost completely burnt out, refer to Figure 13, including all four tires that were completely or severely burnt. Of the two other vehicles, only the rear of the middle vehicle located in the immediate vicinity of the VW Transporter showed signs of fire damage. A battery located under the passenger seat of the VW Transporter is the probable cause of ignition.

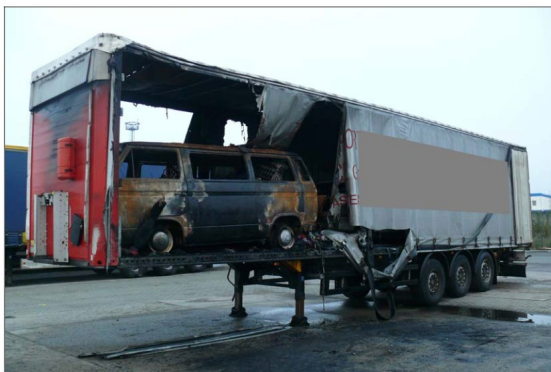
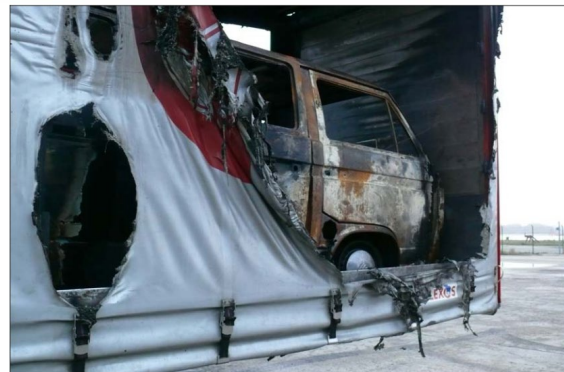
Figure 11: Fire-damaged semi-trailer with VW Transporter

The investigation concluded that water from the drencher system and the manual fire-fighting operation did not or did only indirectly reach the seat of the fire due to shielding by the tarpaulin on the semi-trailer. Fire damage to the side tarpaulins and roof of the semi-trailer was most severe in the area where the VW Transporter was positioned, refer to Figure 14. The floor of the trailer was burnt, and its front wall sustained moderate fire damage. There was no fire damage on the freight truck unit.

Figure 14. The fire damage to the semi-trailer and the VW Transporter in the fire on board Mecklenburg-Vorpommern.

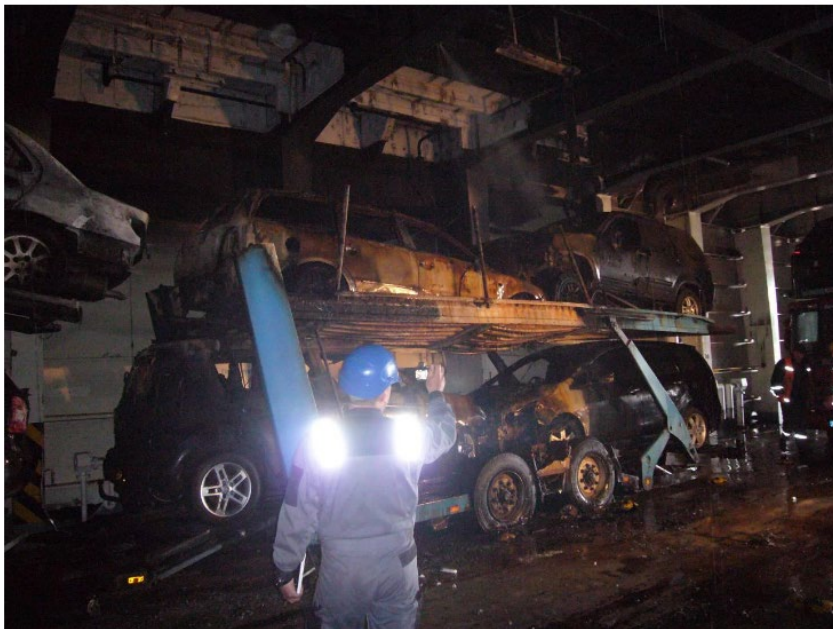
Figure 4: Burned down cars

Figure 15. The fire damage to the cars on the trailer after the fire on Victoria Seaways [8].

At 02:25, two additional fire pumps were started and connected to the drencher system, and sections 9 and 10 were activated on deck 3. At 03:00, sections 7 and 10 were deactivated while sections 8 and 9 remained on. At 03:25, deck 4 had completely cooled above the seat of fire and it was visually confirmed there were no open flames but a considerable amount of smoke. The drencher system was deactivated and cooling and inspections of deck 4 were performed on a regular basis. At 03:45, sections 8 and 9 were reactivated on deck 3 to ensure the fire was completely extinguished. No temperature changes were observed on deck 4 and at 04:00 the seat of fire had been extinguished.

The fire destroyed six cars and the car trailer, refer to Figure 15, but there were no casualties or personal injuries.

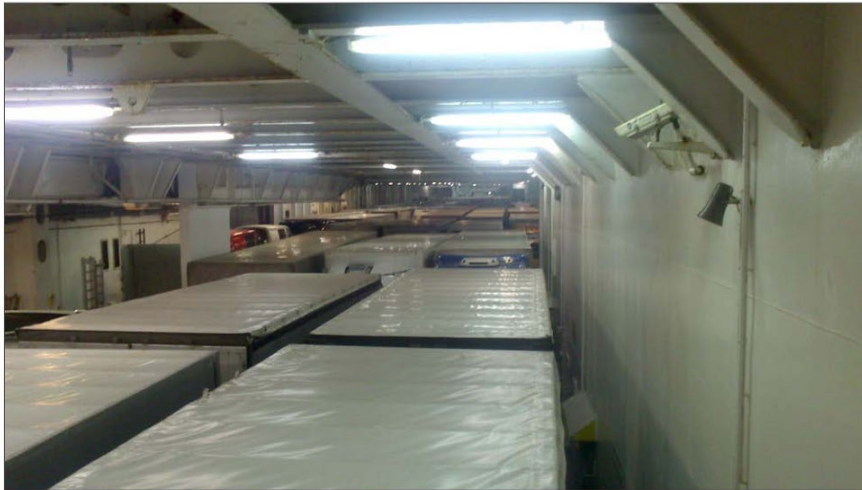
Figure 4: Main car deck on board URD, fully stowed on the day of the fire. Looking aft  
Source: Stena Line

Figure 16. The main car deck on board URD, that was fully stowed on the day of fire [9].

It was concluded that the early discovery of the fire contributed to the successful outcome of the accident. The crew noticed the fire approximately 6 minutes prior the automatic smoke detection system. The cause of the fire was a malfunction in a fluorescent light fixture at the ceiling that made the diffuser catch fire. At some point, the diffuser got detached from the light fixture and landed on the tarpaulin of the lorry situated underneath. The tarpaulin caught fire and flames and smoke developed. The investigation concluded that the close proximity of the burnt fixture to a sprinkler head that was regularly tested may have contributed to the existence of the excessive humid and saline atmosphere inside the light fixture. Figures 16 and 17, respectively, shows the main car deck at the day of the fire and the fire damage.

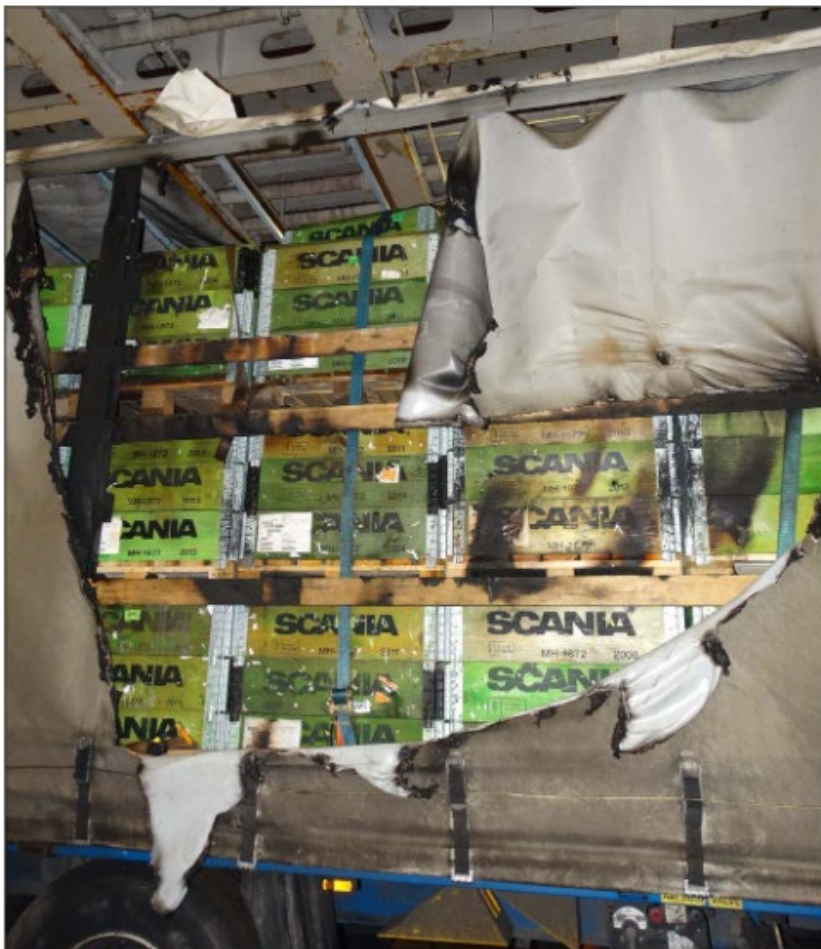
Figure 5: Burnt lorry. Picture taken after arrival in port  
Source: Stena Line

Figure 17. The fire damage to the lorry on board URD [9].

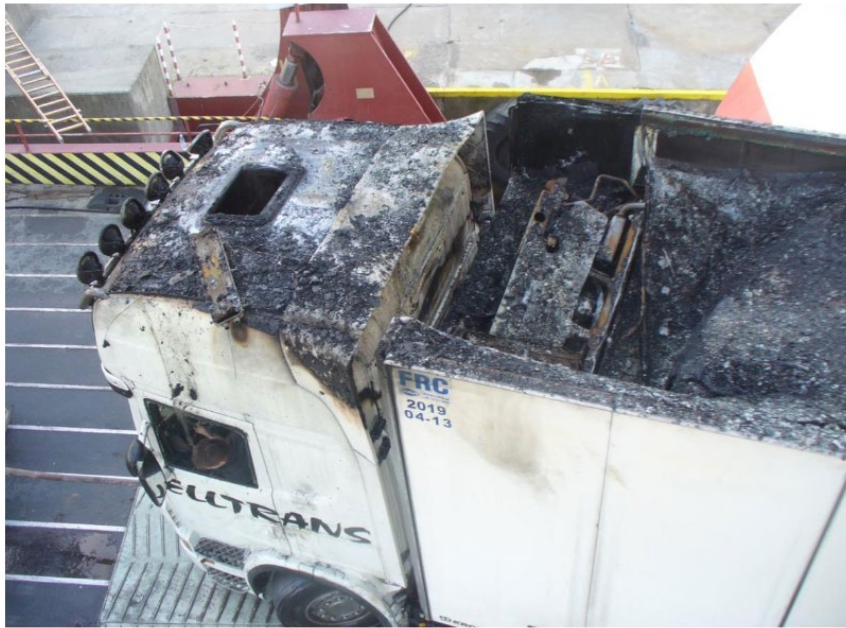
*Photograph No. 13. Burnt vehicle roof with damaged refrigeration unit*

Figure 18. The fire damage to roof of the refrigerator truck on board Stena Spirit [10].

In its first phase, the fire was relatively small and was developing slowly for more than a dozen minutes. At this stage, it could have been easily extinguished (which failed due to the difficulties of accessing the elevated source of the fire). In its second phase the fire developed rapidly, which resulted in breakage of a hydraulic oil pipeline above the fire location. Leaking oil therefore fed the fire that spanned the entire width of the vehicle's roof. The fire temperature was high enough to cause the paint to burn and the deck steel plate to deform directly above the fire source. Probably, additional hydraulic oil pipelines cracked and leaked oil that, in turn, maintained the fire in another spot on the vehicle roof which is confirmed by the second spot of burnt paint on deck 5 (the deck above the fire).

Figures 18 and 19, respectively, shows the fire damage to the refrigerator truck and the freight truck positioned adjacent.

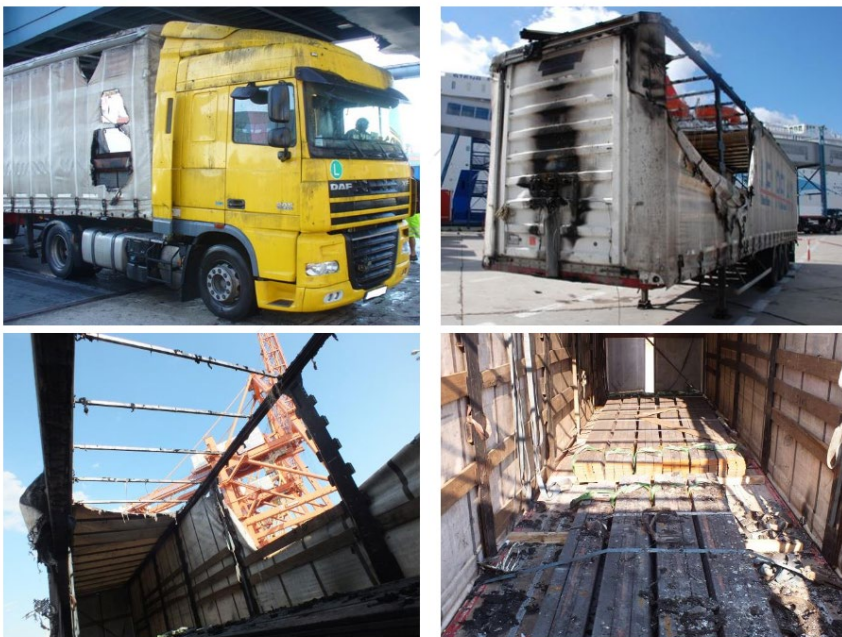
*Photograph No. 16. Burnt tarpaulin of the truck parked next to the refrigerator truck and its cargo*

Figure 19. The fire damage to the freight parked next to the refrigerator truck on board Stena Spirit [10].

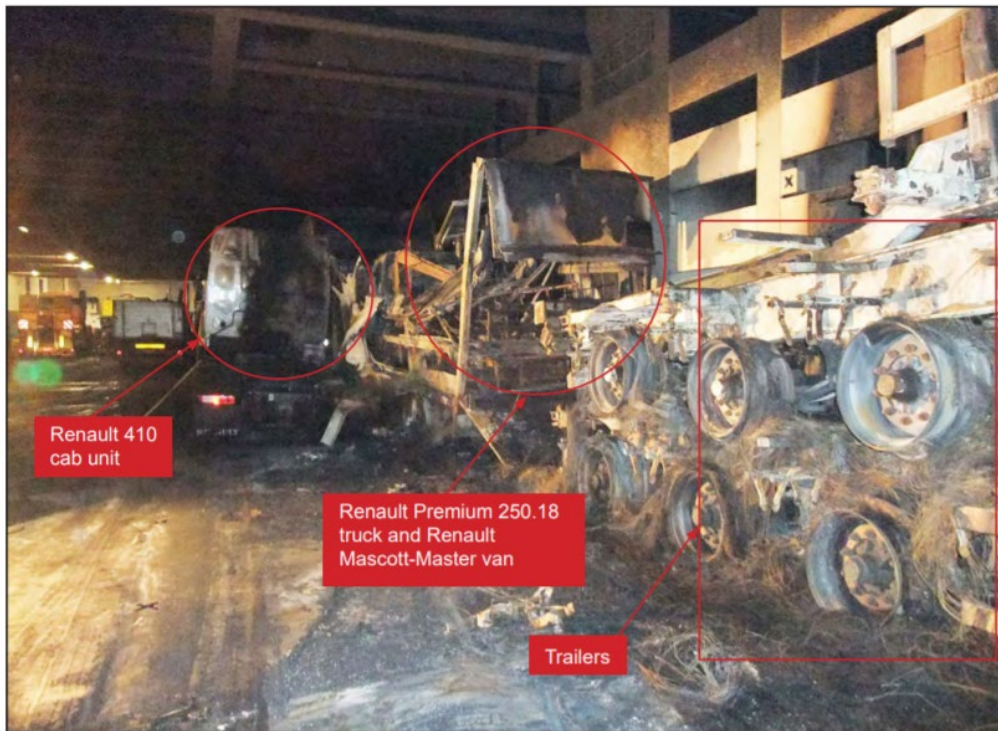
**Figure 4:** Damaged vehicles and trailers on the main deck

Figure 20. The fire damaged vehicles and trailers on the main deck on board Corona Seaways [12].

The ship suffered light structural damage and the loss of some minor electrical supplies. The majority of the structural damage was located above the fire on the underside of the upper deck. Approximately 15 m<sup>2</sup> of the steel deck was required to be replaced, including seven slightly distorted longitudinal deck head stiffeners. The pipe-work and nozzles of the Carbon Dioxide system was not damaged.

Three vehicles and six trailers were severely damaged and other vehicles suffered minor radiant heat damage, refer to Figure 20.

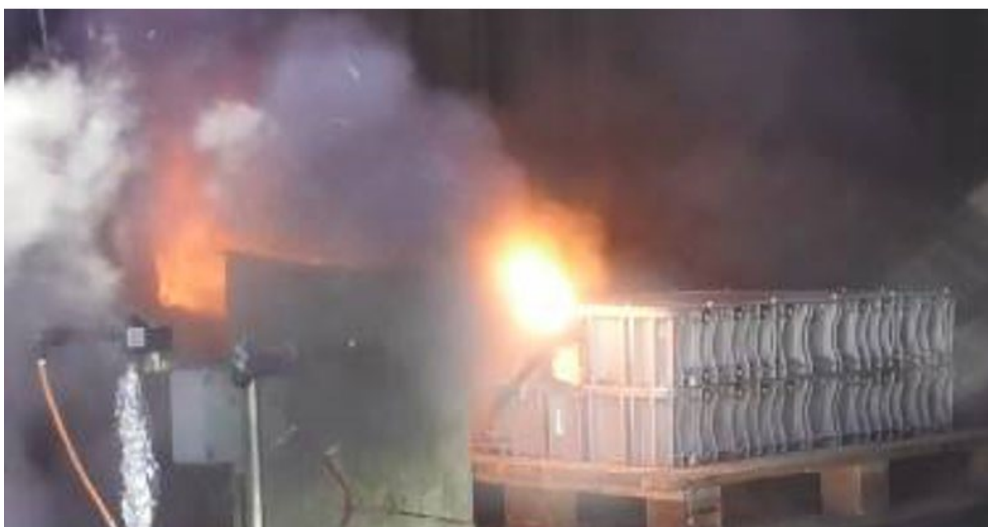
Figure 21. The jet flame from a cable feedthrough in a battery back [35]. Photo: RISE.

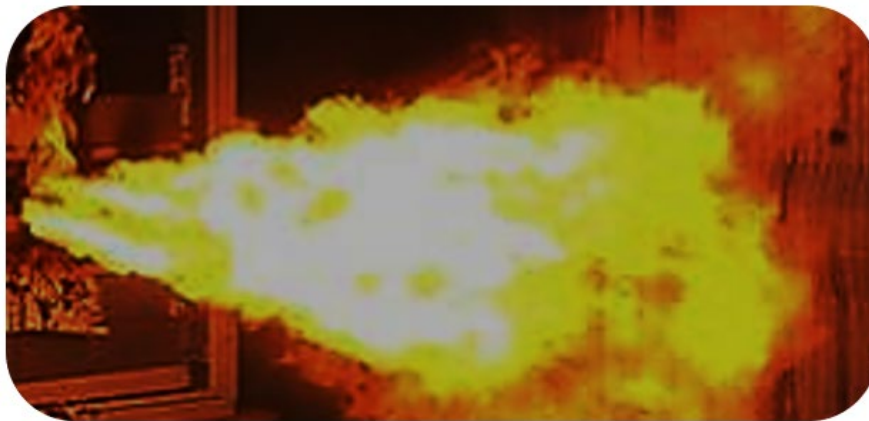
Figure 22. Jet flames from 21700 cylindrical cells. Photo: RISE. Note that the image is distorted as it is proprietary. The flame length is approximately 1.5 m. The system shown had several hundreds of 21700 cells.

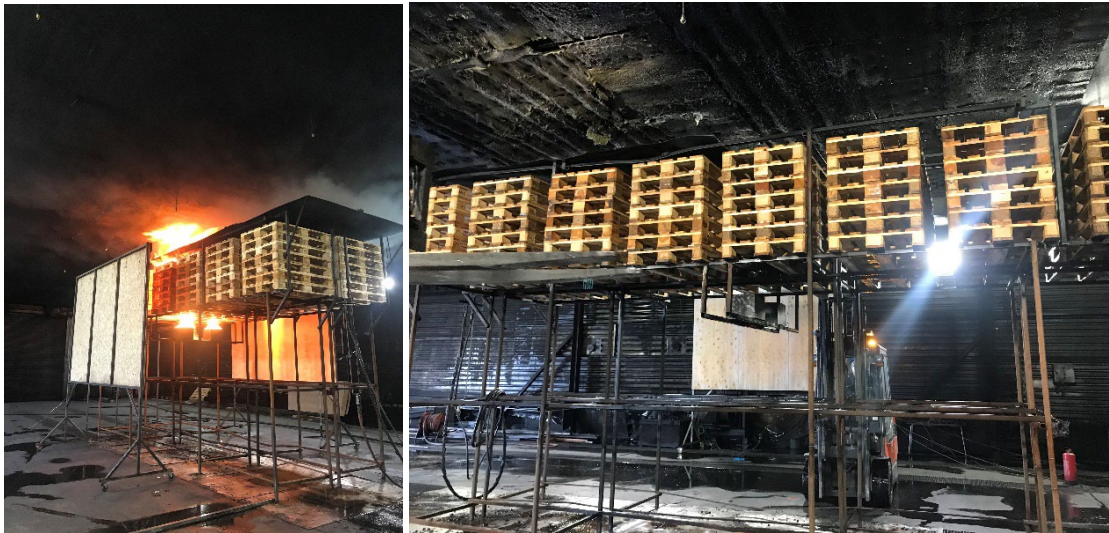
*Figure 27. The freight truck trailer mock-up. A total of 112 wood pallets are arranged in two parallel stacks, each containing seven wood pallets. The overall length is eight stacks. Half of the array is shielded from direct application of water from overhead nozzles by a horizontal steel sheet plate. The other half is fully exposed to the water spray. Fire trays with commercial heptane are positioned underneath the stacks for fire ignition. Photos: RISE Fire Research AS.*

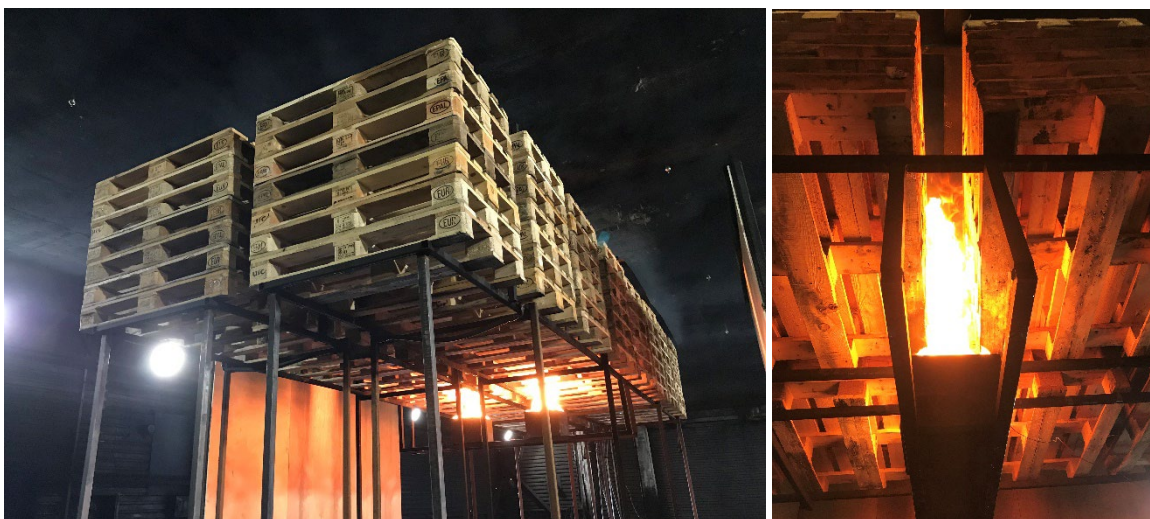
*Figure 28. The two fire trays centrally located under the wood pallets that is used to initiate the fire. Photos: RISE Fire Research AS.*

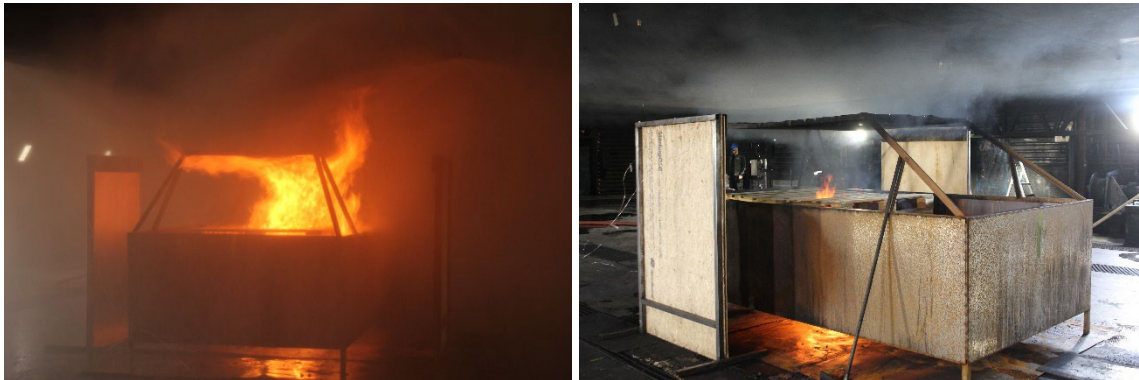
Figure 29. The passenger car mock-up. It includes a total of 12 EUR wood pallets arranged in two stacks, each containing six pallets. Photos: RISE Fire Research AS.

The passenger car mock-up consists of a total of 12 EUR wood pallets arranged in an array of 1 pallet (wide) × 6 pallets (high) × 2 pallets (long) that is stacked inside a shield made from steel sheets, simulating the body of a car. The roof of the simulated car body, that is sized 2 m (long) by 1,2 m (wide) shields the stacks of wood pallets from direct application of water from overhead nozzles.

Plywood panel targets, acting also as obstructions, of dimensions 1,2 m (wide) × 1,75 m (high) should be arranged symmetrically on both long sides of the mock-up at a horizontal distance of 0,6 m. The top edge of the target panels should be at the same level as the top level of the mock-up car. Refer to Figure 29.

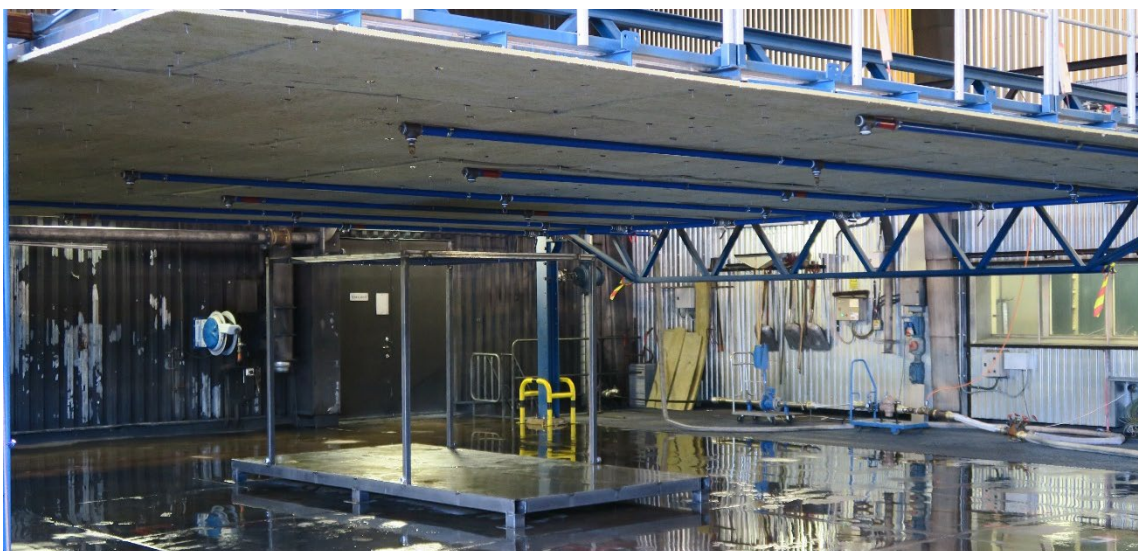
Figure 31. The suspended ceiling during the preparation work for the tests using the passenger car mock-up. The ceiling height was 2,5 m. The pipe-work has been prepared for the deluge system tests (pendent nozzles). Photo: RISE.

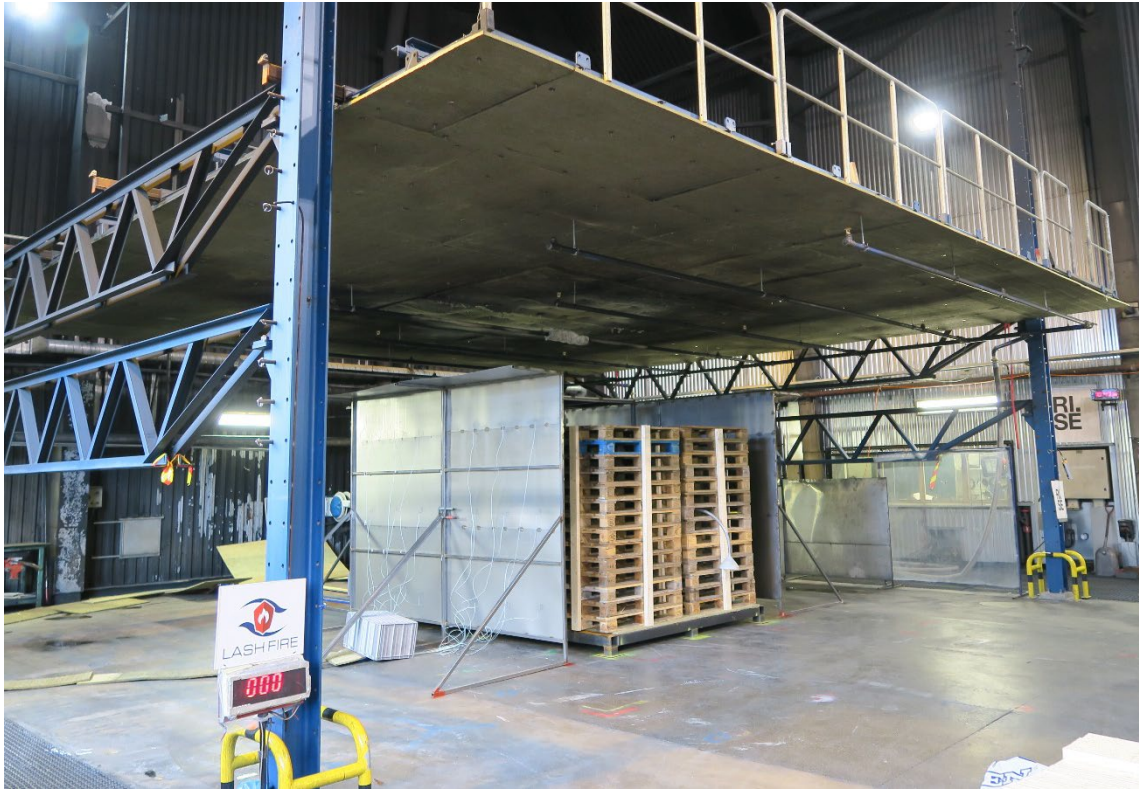
Figure 32. The suspended ceiling when installed for the tests using the freight truck trailer mock-up. The ceiling height was 3,7 m. With the reduced height of the mock-up, this resulted in a realistic clearance corresponding to a full-height freight truck trailer and a ceiling height of 5 m. The pipe-work has been prepared for the automatic sprinkler system tests (upright sprinklers). Photo: RISE.

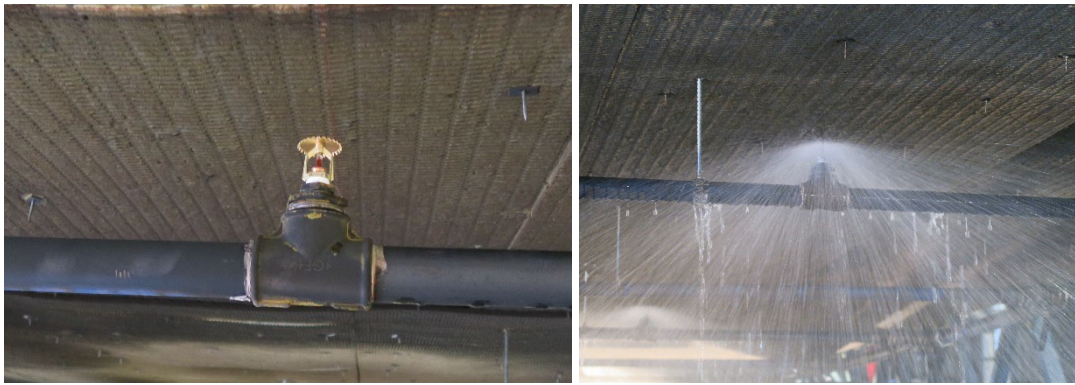
Figure 34. An automatic sprinklers as depicted prior Test 5 (left) and a close-up of its discharge pattern (right).  
Photos: RISE.

When installed, the plane of the sprinkler frame arms was parallel to the branch lines of the pipe-work. The vertical distance from the deflector of the individual sprinklers and the ceiling was 150 mm, as measured at the ceiling area directly above the fire (with a total of 40 mm fire insulation). Figure 34 shows the installation of an automatic sprinkler relative to the ceiling and the discharge pattern.

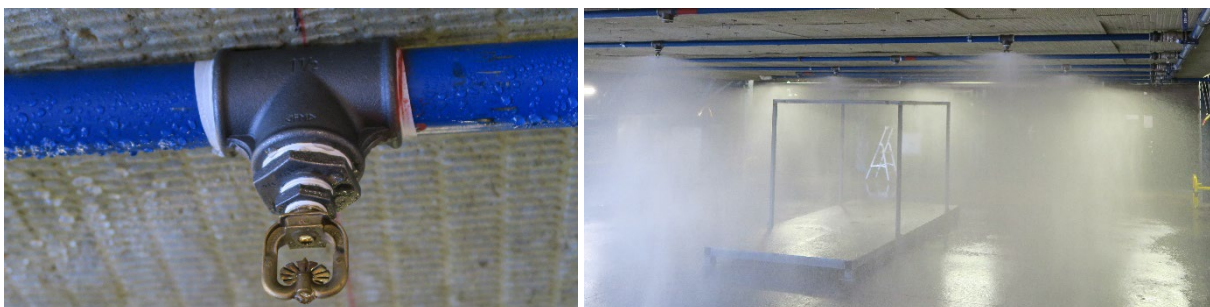
Figure 35. A water spray nozzle as depicted prior Test 1 (left) and the discharge pattern of several nozzles (right).  
Photos: RISE.

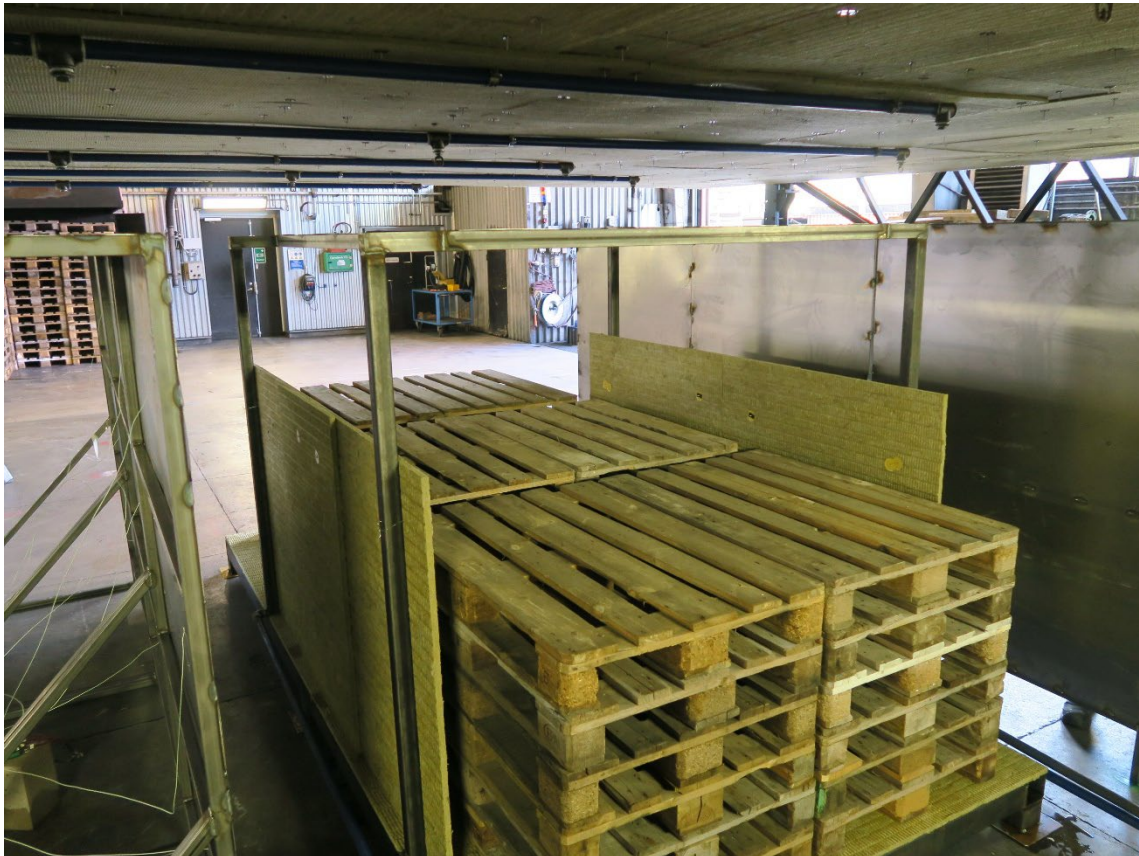
Figure 36. The passenger car mock-up depicted from the front. Photo: RISE.

Figures 36 through 38 shows the mock-up.

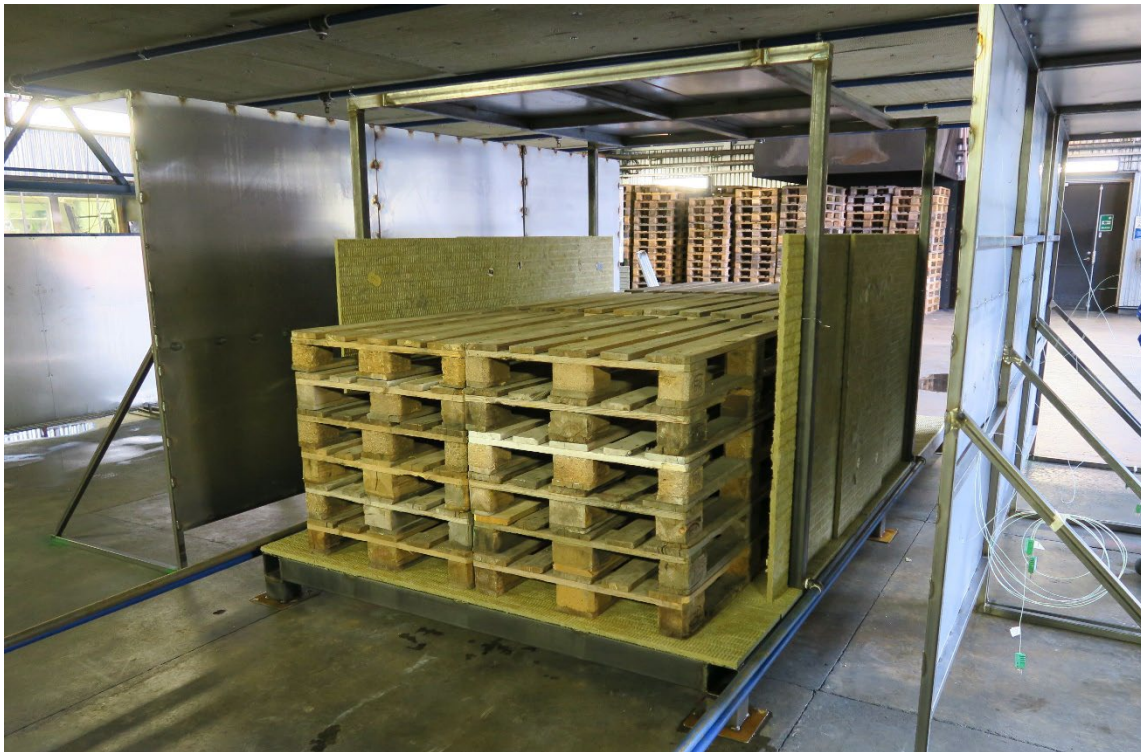
Figure 37. The passenger car mock-up depicted from the back. Photo: RISE.

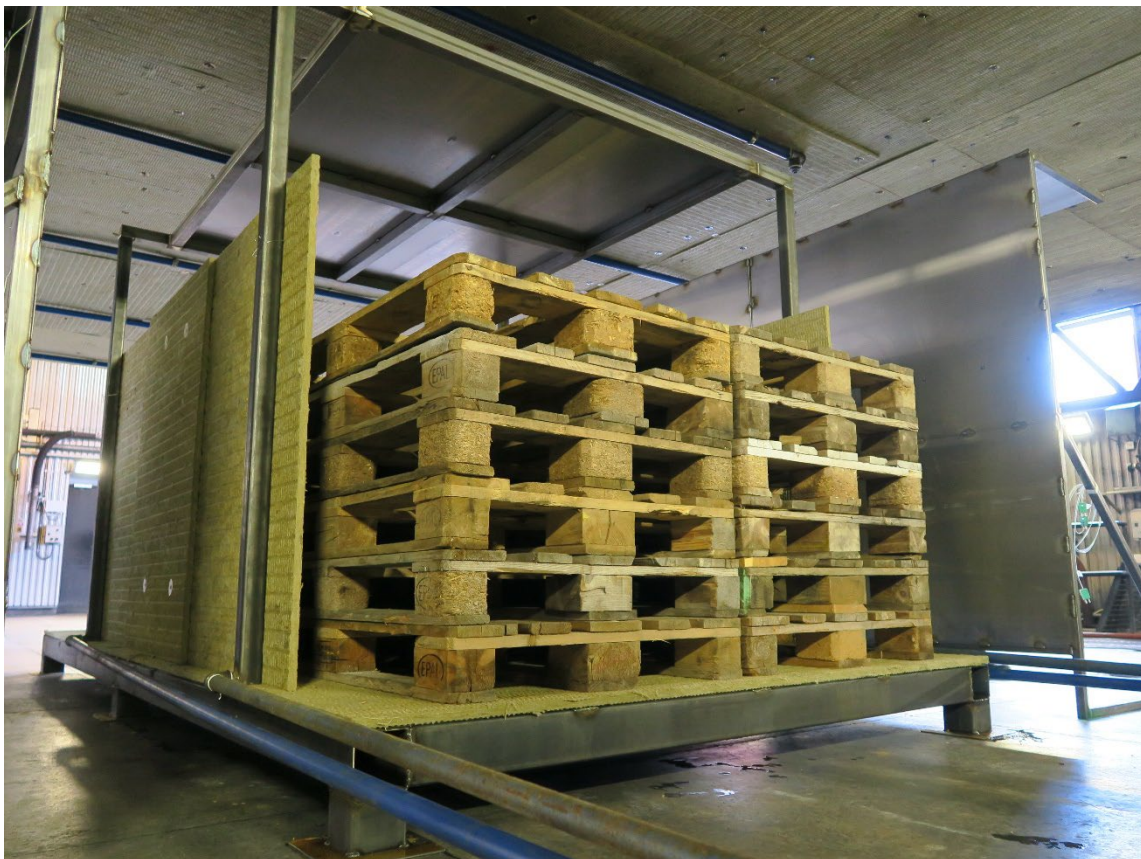
Figure 38. The roof over the passenger car mock-up depicted from the back. Photo: RISE.
