Project acronym: **LASH FIRE**  
Project full title: **Legislative Assessment for Safety Hazard of Fire and Innovations in Ro-ro ship Environment**  
Grant Agreement No: **814975**  
Coordinator: **RISE Research Institutes of Sweden**

## **Deliverable D10.4**

# **Large-scale validation of the new fire test standard for alternative fixed fire-fighting systems**

**February 2023**

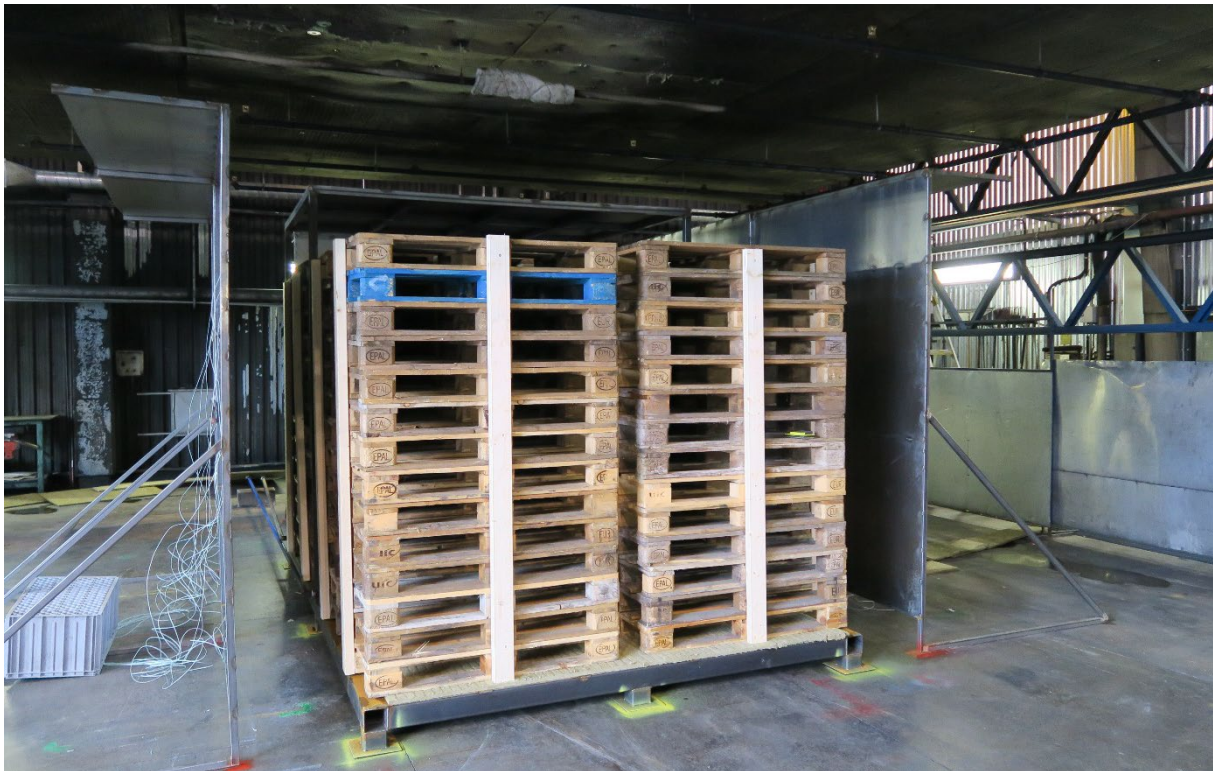
Figure 39. The freight truck trailer mock-up depicted from the front. Photo: RISE.

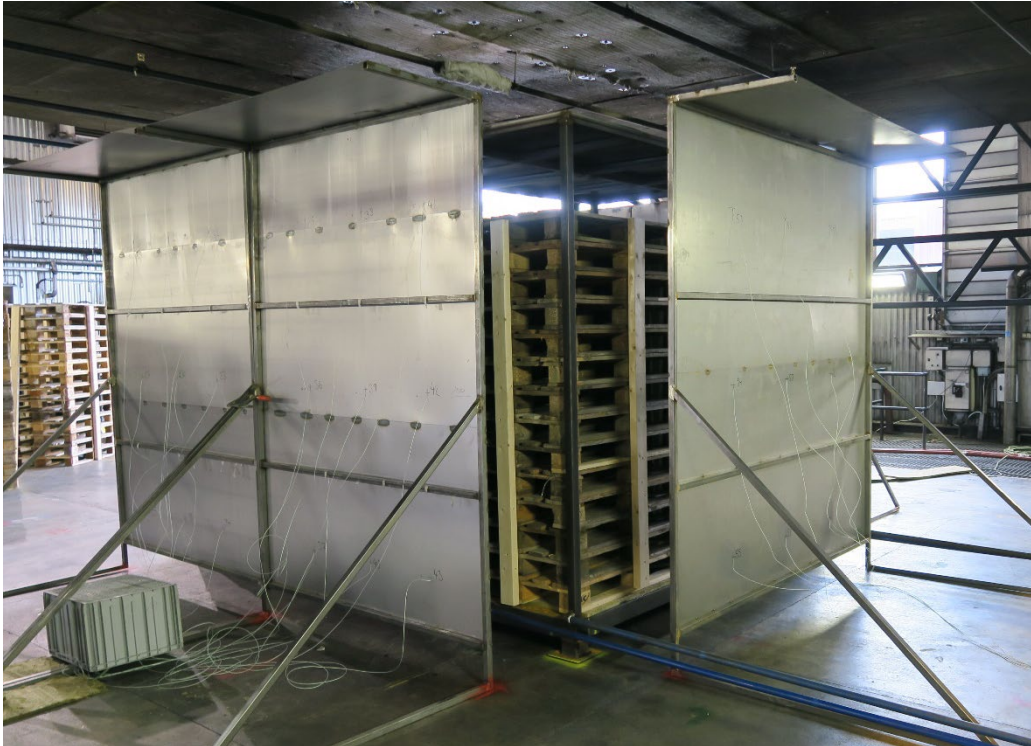
Figure 40. The freight truck trailer mock-up depicted from the back. Photo: RISE.

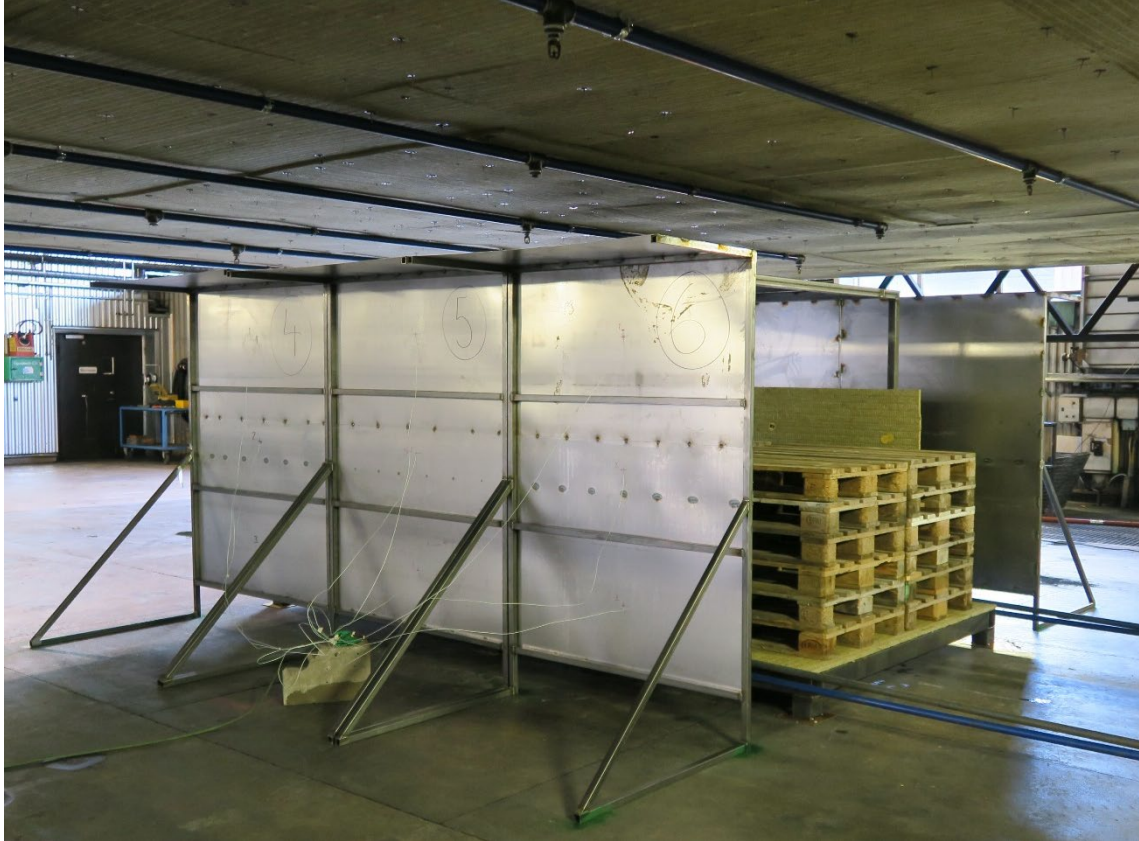
Figure 41. The steel sheet screens along the long sides of the passenger car mock-up. Photo: RISE.

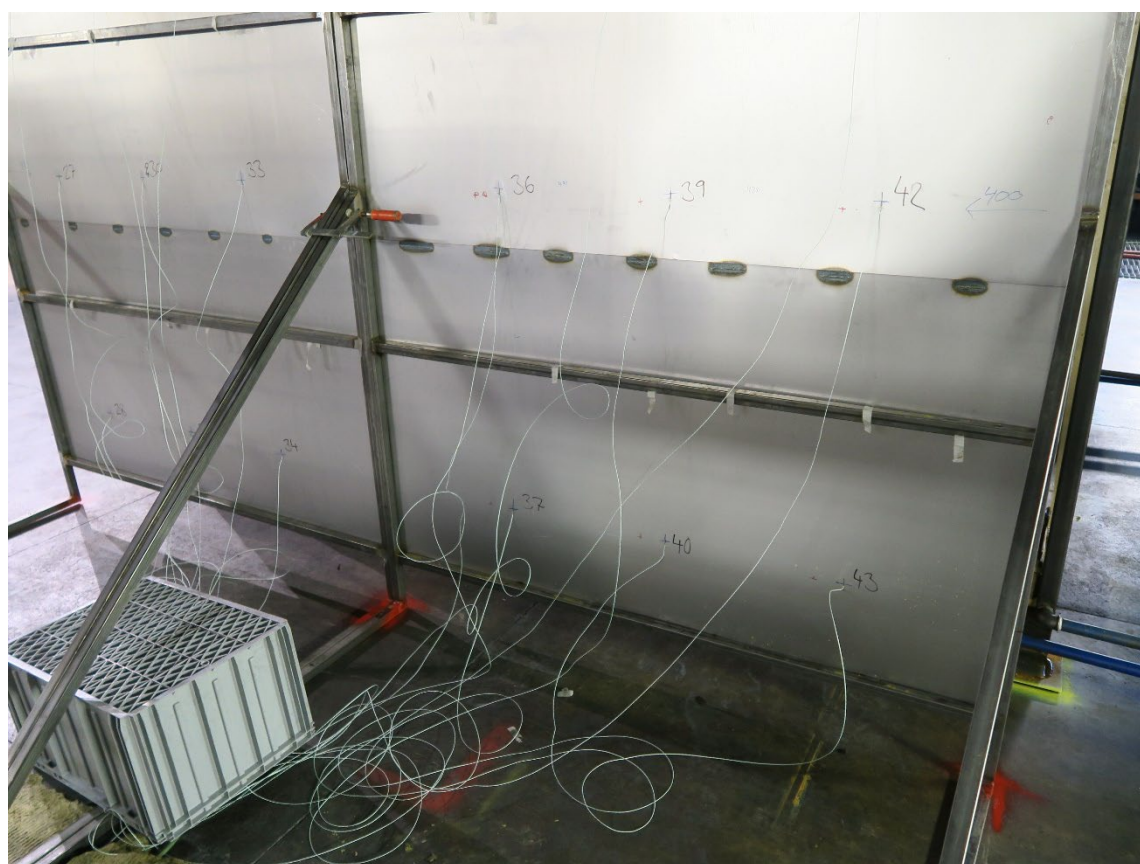
Figure 42. The steel sheet screens facing left hand side of the freight truck trailer mock-up. Similar screens faced the right hand side. Photo: RISE.

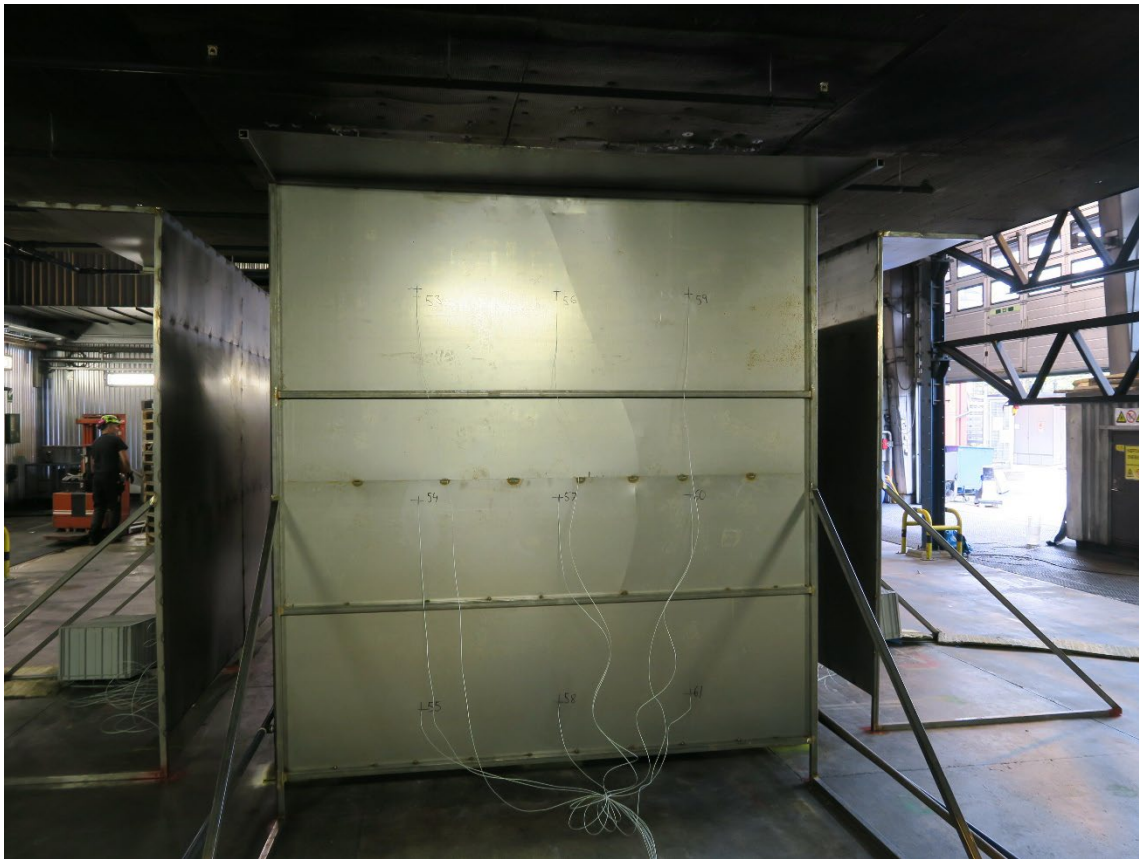
Figure 43. The steel sheet screen facing the rear end of the freight truck trailer mock-up. Photo: RISE.

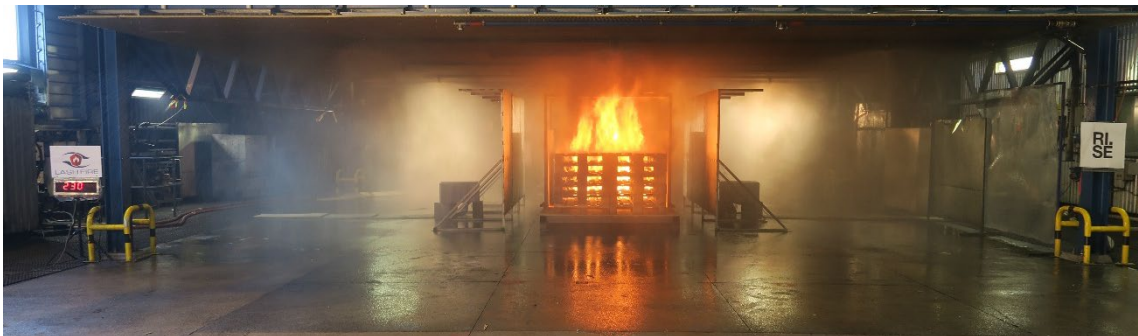
Figure 45. **Test 1:** The fire size at 02:30 [min:s], shortly after the start of the application of water. Photo: RISE.

Visually, the fire continued to grow after the start of the application of water, as the stacks of idle wood pallets were partly shielded by the roof. However, the fire did not grow very large as the application of water prevented fire spread to the parts outside of the roof. The fact that a line of water spray (on three different branch lines) passed over the longitudinal centerline of the passenger car mock-up improved the application of water over the exposed part of the stacks of idle wood pallets. Water was applied for 30 min. Figures 44 through 47 shows the test.

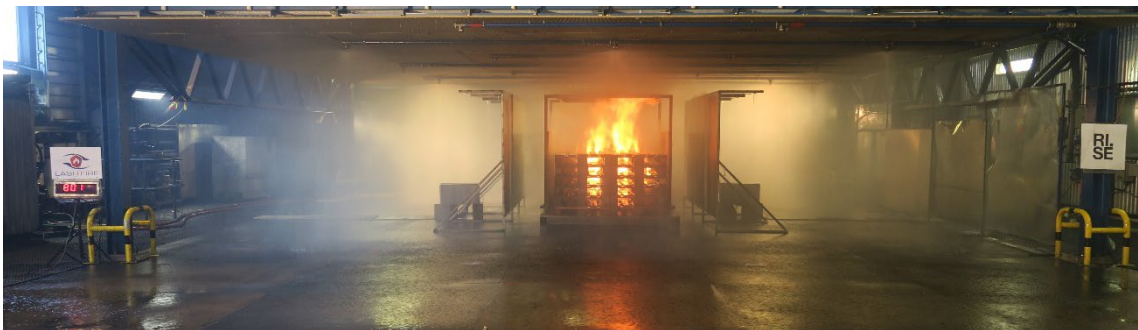
Figure 46. **Test 1:** The fire size at 08:01 [min:s], at the time the ceiling gas temperatures were the lowest. Photo: RISE.

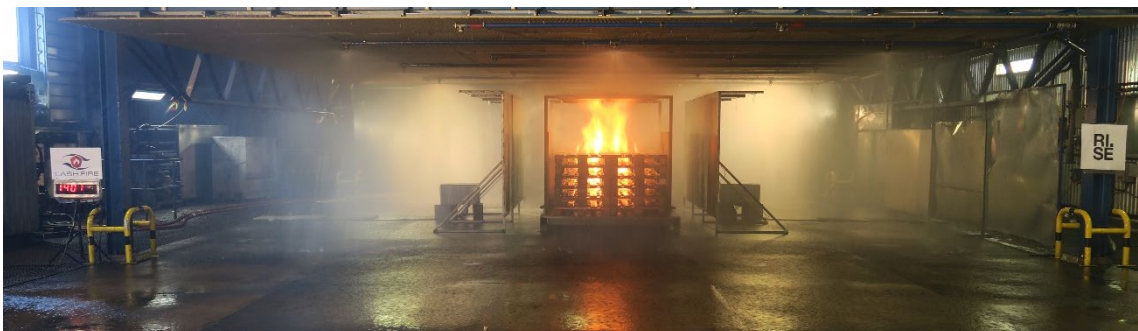
Figure 47. **Test 1:** The fire size at 14:01 [min:s], after which it started to decline. Photo: RISE.

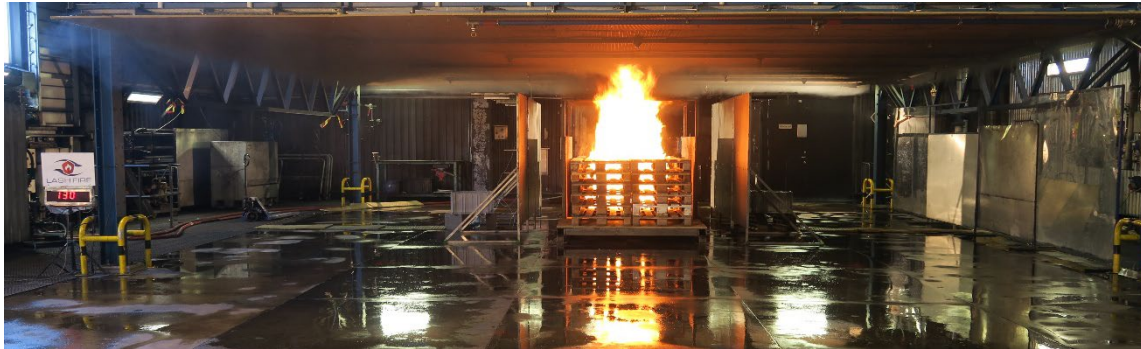
Figure 48. **Test 2:** The fire size at 01:30 [min:s], soon after both thermocouples at a 4,5 m radius from the fire had exceeded the 78 °C temperature threshold. Photo: RISE.

The second test was conducted with a deluge system, with the point of fire ignition between four open water spray nozzles. The ceiling height was 2,5 m. The 78 °C temperature threshold was exceeded at channel C6 at 01:26 [min:s] and at channel C7 at 01:27 [min:s]. Water was initiated at

02:22 [min:s], and full system pressure was achieved shortly thereafter, which resulted in a water delivery time of about 60 s. Water was applied for 30 min. Figures 48 through 51 shows the test.

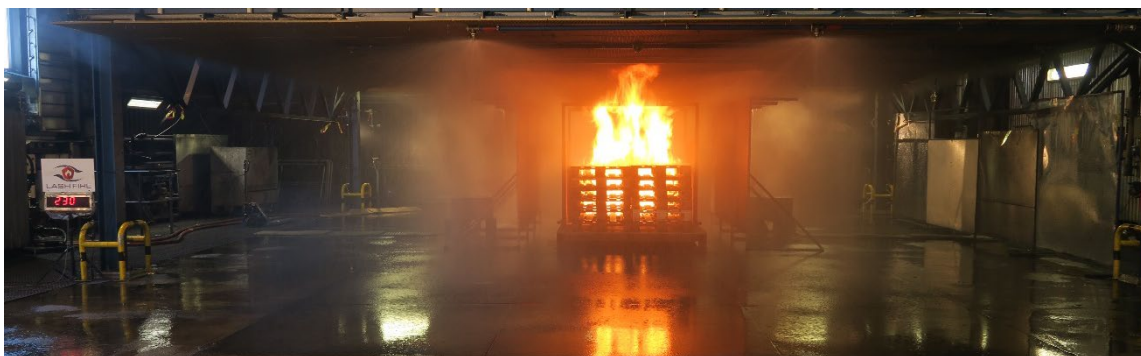
Figure 49. **Test 2:** The fire size at 02:30 [min:s], shortly after the start of the application of water. Photo: RISE.

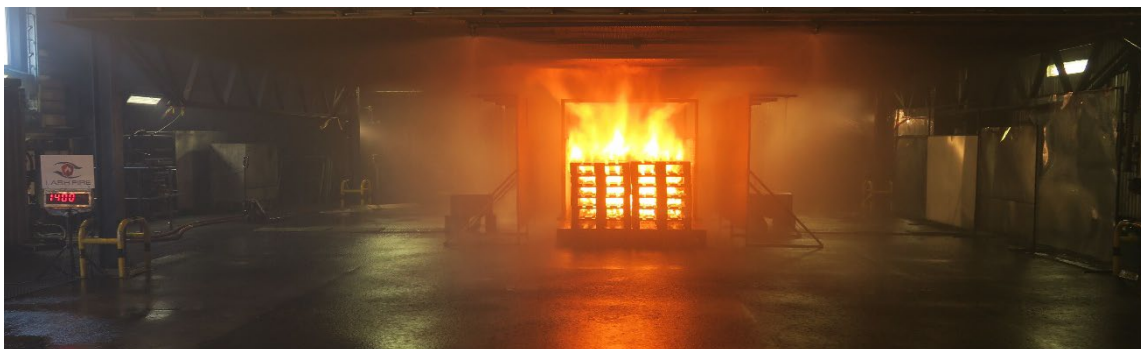
Figure 50. **Test 2:** The fire size at 14:00 [min:s], when it reached its peak according to the ceiling gas temperature measurements. Photo: RISE.

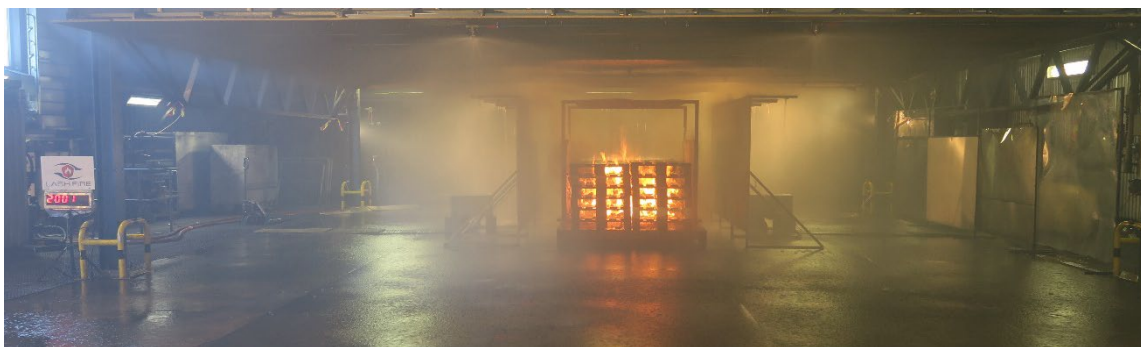
Figure 51. **Test 2:** The fire size at 20:01 [min:s], during the stage of decline. Photo: RISE.

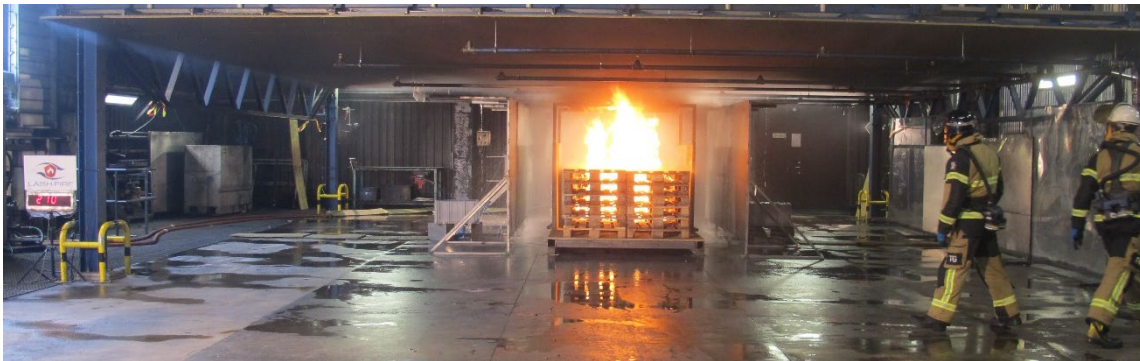
Figure 52. **Test 3:** The fire at 02:10 [min:s], shortly after water was discharging from the single automatic sprinkler that had activated prior water was allowed to entering the pipe-work. Photo: RISE.

The first sprinkler activated, as determined by the air pressure loss, at 01:08 [min:s]. Water was initiated at 02:05 [min:s], and full system pressure was achieved shortly thereafter, which resulted in a water delivery time of about 60 s. A second sprinkler activated at 02:45 [min:s] and the last (third) sprinkler at 03:55 [min:s]. In total, three sprinklers activated which provided for a constant water flow rate of 205 l/min, as compared to the nominal water flow rate of 200 l/min. Water was applied for 30 min. Figures 52 through 55 shows the test.

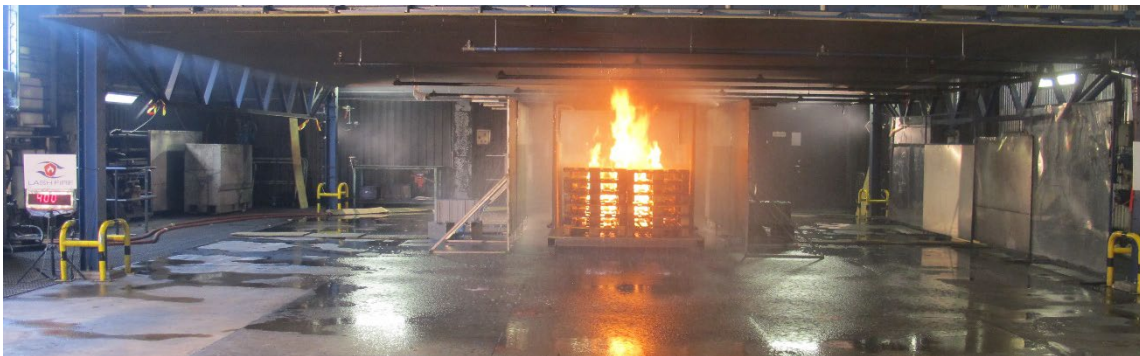
Figure 53. **Test 3:** The fire at 04:00 [min:s], when all three activated sprinklers were flowing. Photo: RISE.

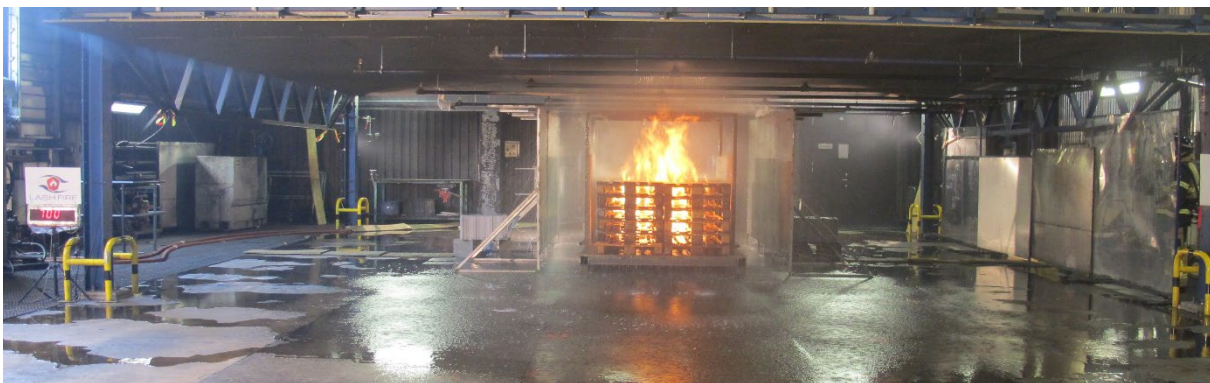
Figure 54. **Test 3:** The fire at 07:00 [min:s], when it started to decline. Photo: RISE.

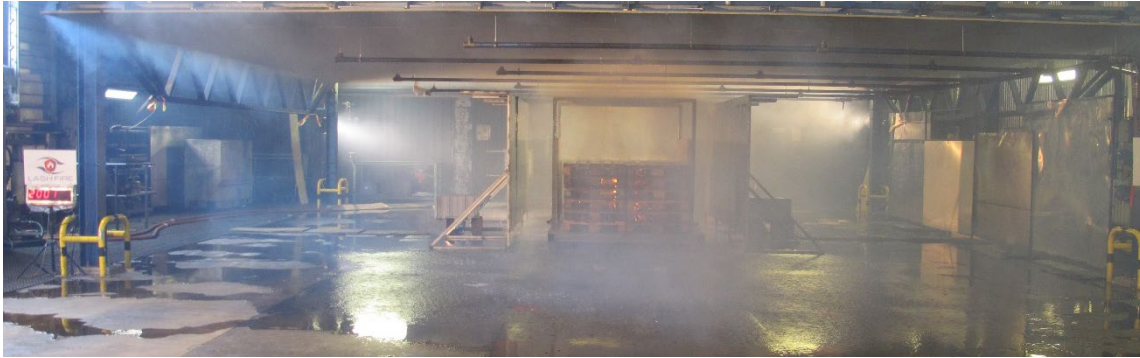
Figure 55. **Test 3:** The fire size at 20:01 [min:s], during the final stage of decline. Photo: RISE.

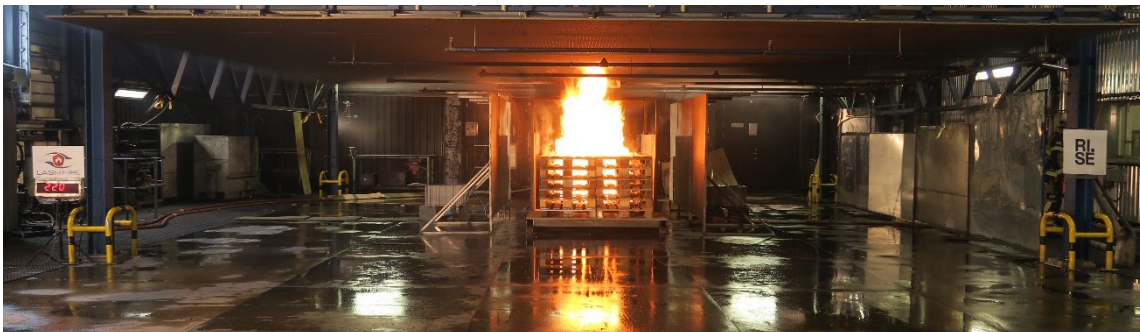
Figure 56. **Test 4:** The fire at 02:20 [min:s], shortly after the air pressure drop of the sprinkler piping indicated that the first sprinkler(s) had activated. Photo: RISE.

The first sprinkler activated, as determined by the air pressure loss, at 02:18 [min:s]. Water was initiated at 03:20 [min:s], and full system pressure was achieved shortly thereafter, which resulted in a water delivery time of about 60 s. In total, six sprinklers activated, which provided for a constant water flow rate of 398 l/min, as compared to the nominal water flow rate of 400 l/min. Water was applied until about 12:00 [min:s], as the fire was fully extinguished. Figures 56 through 59 shows the test.

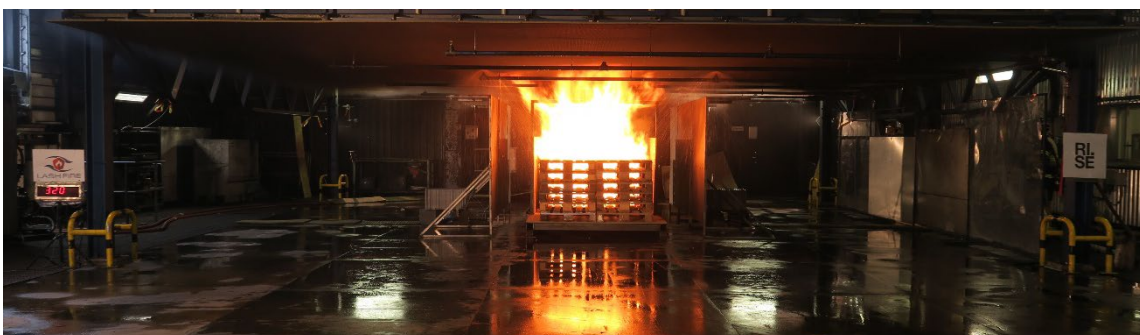
Figure 57. **Test 4:** The fire at 03:20 [min:s], when water started to flow from the sprinklers that had activated. Photo: RISE.

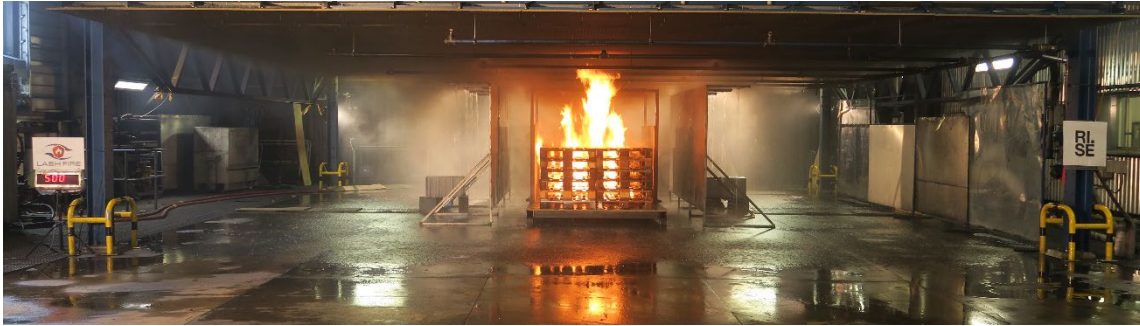
Figure 58. **Test 4:** The fire at 05:00 [min:s]. Photo: RISE.

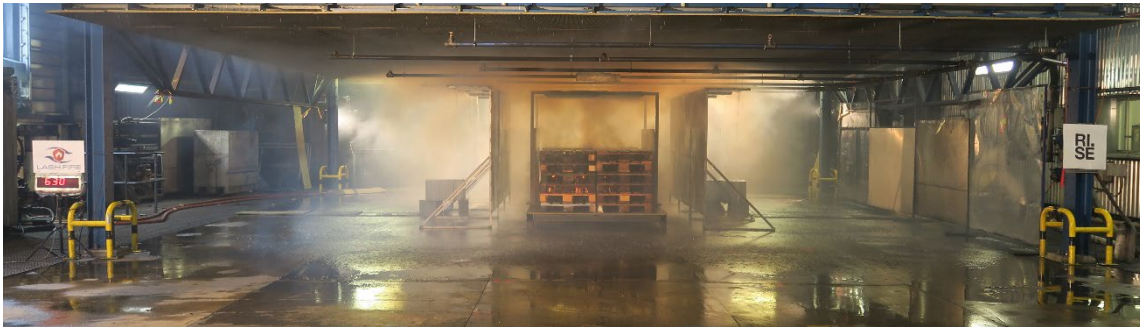
Figure 59. **Test 4:** The fire at 06:30 [min:s]. Only small flames appear at the centre core of the wood pallet array. Photo: RISE.

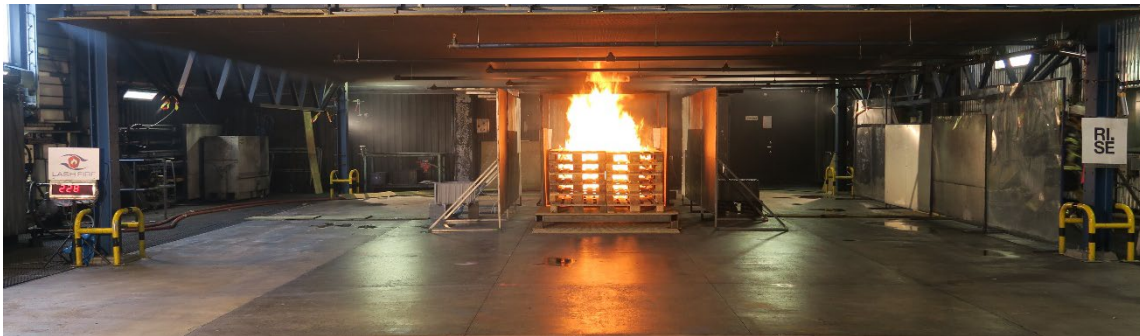
Figure 60. **Test 4b:** The fire at 02:28 [min:s], shortly before the air pressure drop of the sprinkler piping indicated that the first sprinkler(s) had activated. Photo: RISE.

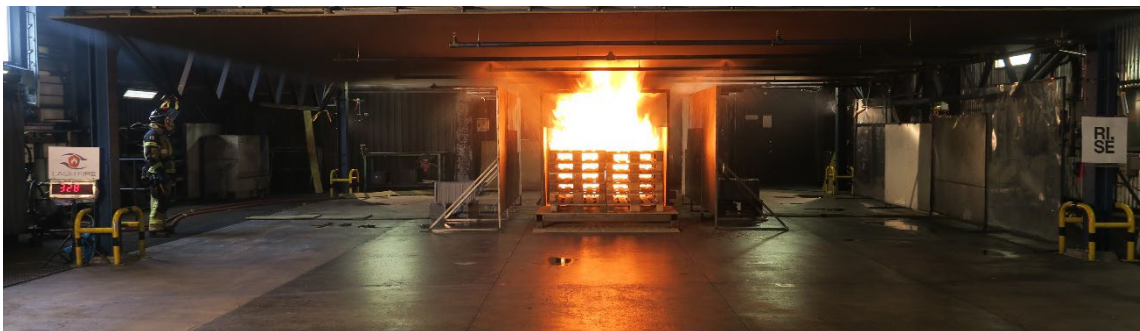
Figure 61. **Test 4b:** The fire at 03:28 [min:s], when water started to flow from the sprinklers that had activated. Photo: RISE.

The fire in the idle wood pallets was extinguished, but the fire in the trays below the mock-up continued to burn. It was observed that the pool fire was not very severe as it was limited by the small free height under the mock-up. In order to modify the fire scenario to include a spill fire underneath the passenger car mock-up, it is concluded that the free height need to be higher. In any case, Test 4b provides a possibility to compare the repeatability of the fire test scenario, comparing Test 4 and Test 4b. Water was applied for 30 min. Figures 60 through 63 shows the test.

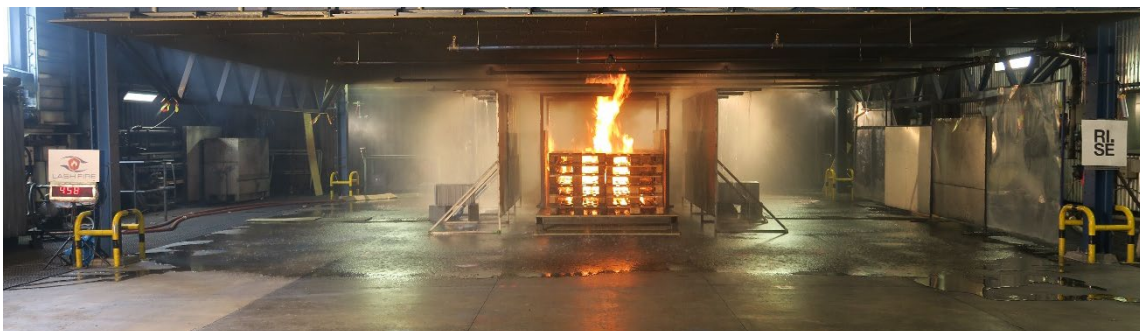
Figure 62. **Test 4b:** The fire at 04:58 [min:s]. The fire is clearly suppressed. Photo: RISE.

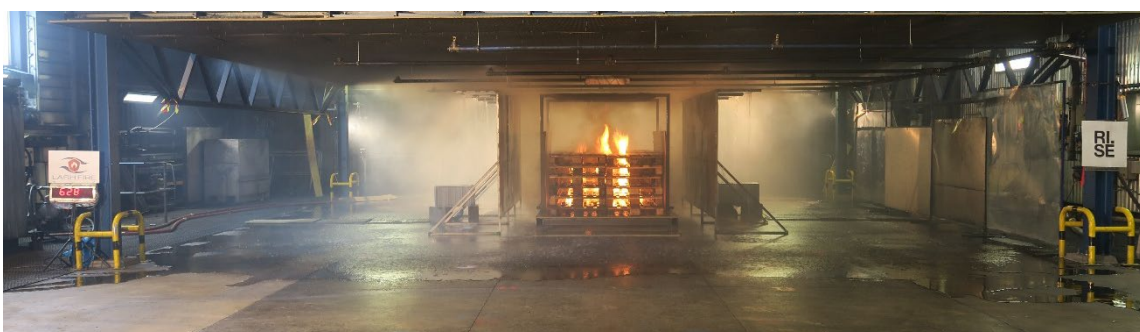
Figure 63. **Test 4b:** The fire at 06:28 [min:s]. Only small flames appear at the centre core of the wood pallet array. Photo: RISE.

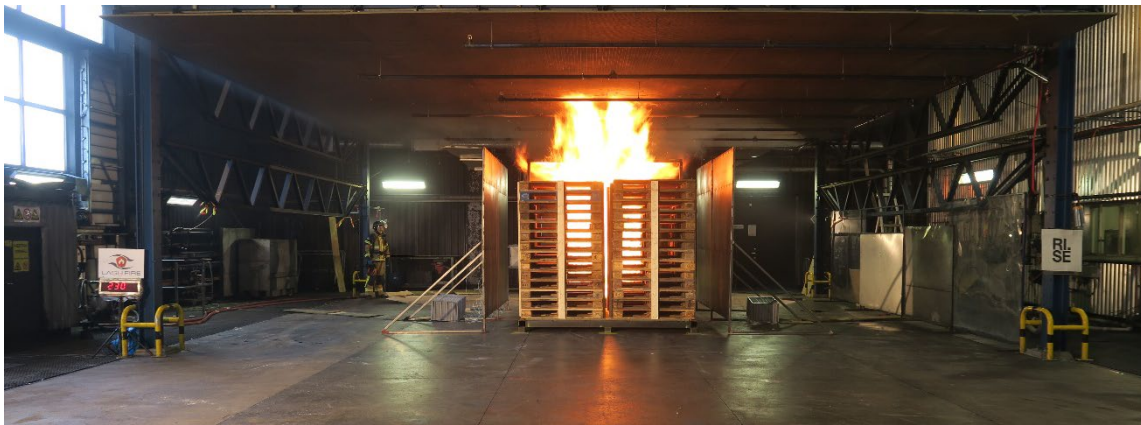
Figure 64. **Test 7:** The fire at 02:30 [min:s], shortly before the air pressure drop of the sprinkler piping indicated that the first sprinkler(s) had activated. Photo: RISE.

The test was terminated 25:10 [min:s] using fire hoses and the application of water from the sprinkler system was stopped at 26:25 [min:s]. The reason was the smoke filled the control room and parts of the building. Afterwards, it was determined that the reason was a malfunctioning of an air supply fan. In total, all seven sprinklers activated. Figures 64 through 70 shows the test.

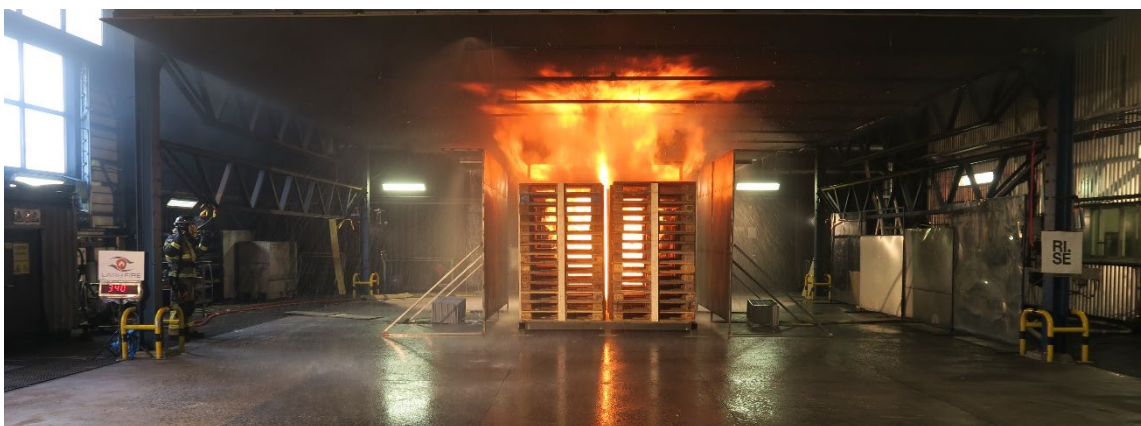
Figure 65. **Test 7:** The fire at 03:40 [min:s], shortly after water started to flow from the sprinklers that had activated. Photo: RISE.

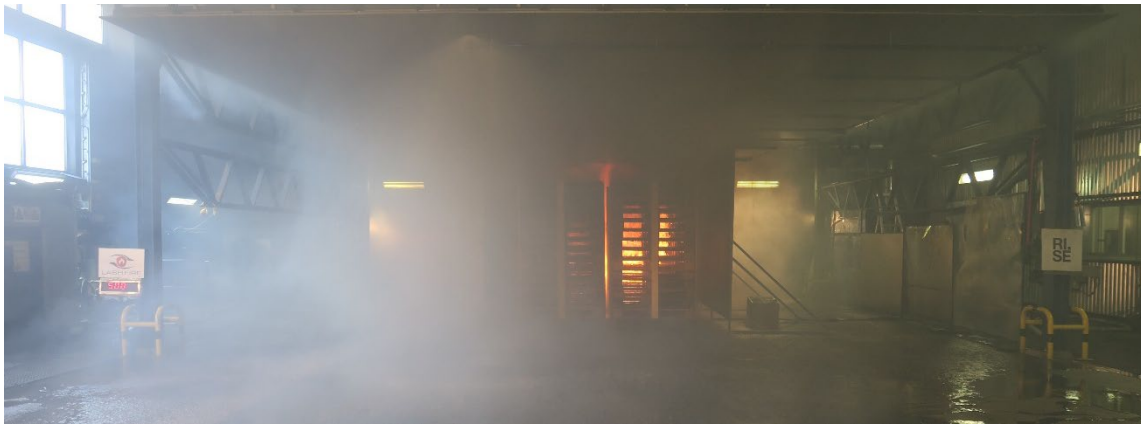
Figure 66. **Test 7:** The fire at 05:00 [min:s]. The fire was initially suppressed. Photo: RISE.

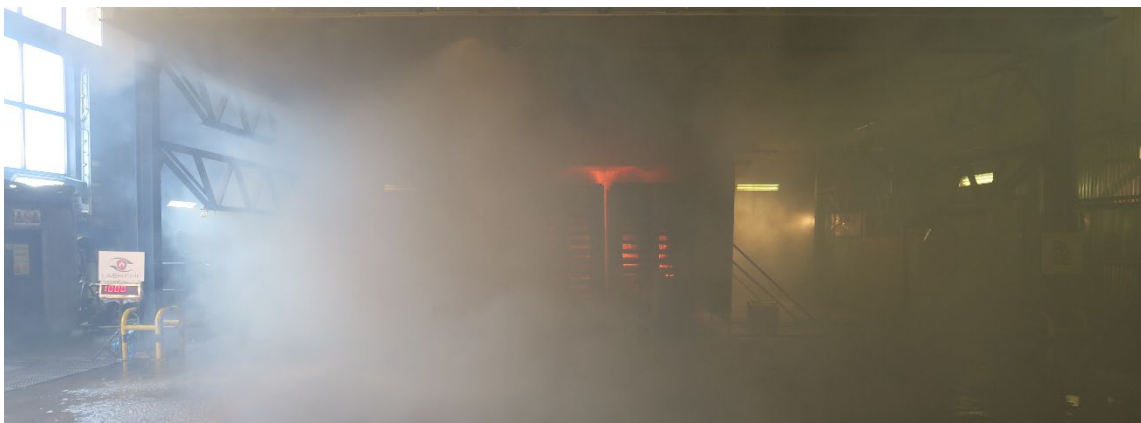
Figure 67. **Test 7:** The fire at 10:00 [min:s]. The fire is gradually growing in size when parts of the array that is shielded from the application of water becomes involved in the fire. Photo: RISE.

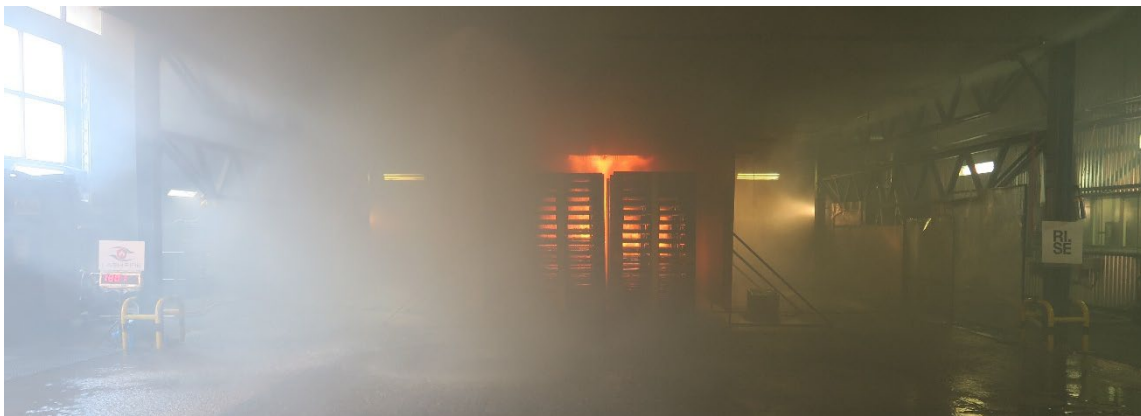
Figure 68. **Test 7:** The fire at 18:01 [min:s]. The fire is gradually growing in size when parts of the array that is shielded from the application of water becomes involved in the fire. Photo: RISE.

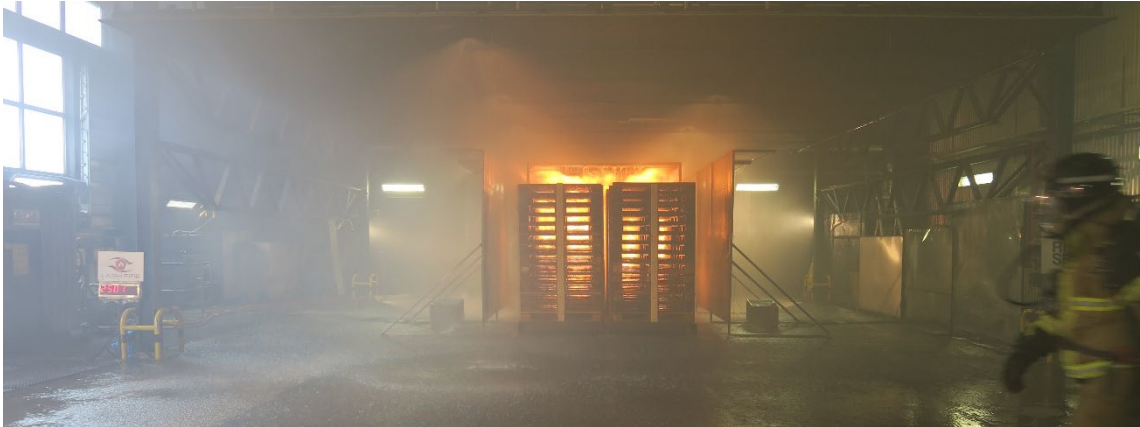
Figure 69. **Test 7:** The fire at 25:01 [min:s], just prior to the termination of the test. Photo: RISE.

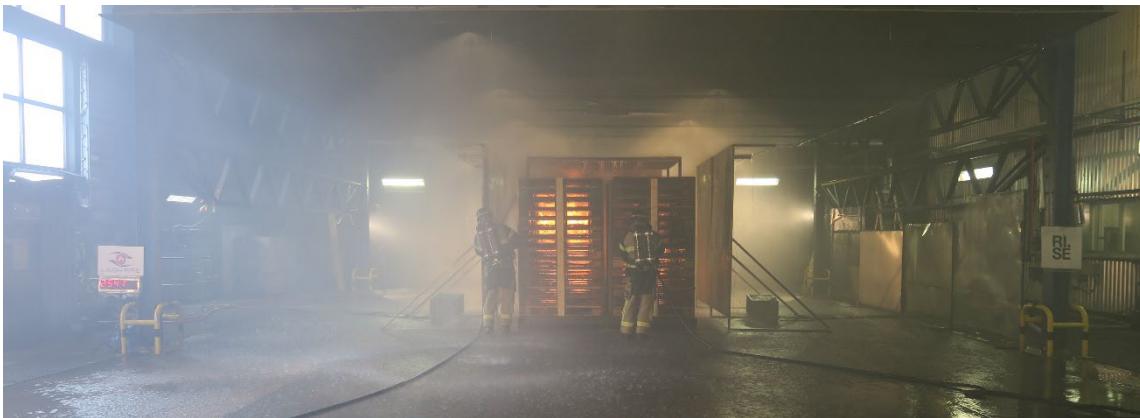
Figure 70. **Test 7:** The fire at 25:41 [min:s], during the termination using fire hoses. Photo: RISE.

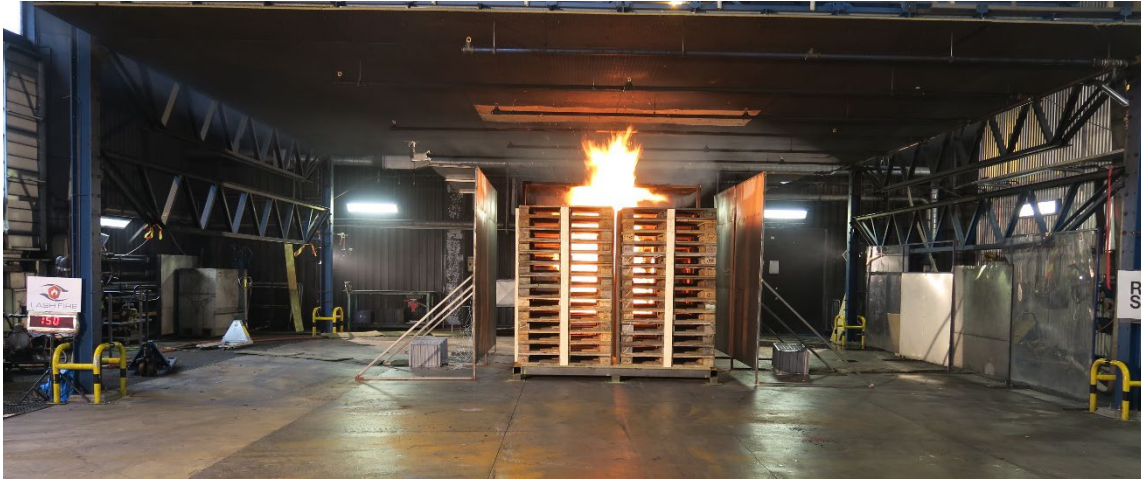
Figure 71. **Test 8:** The fire at 01:50 [min:s], shortly after the air pressure drop of the sprinkler piping indicated that the first sprinkler(s) had activated. Photo: RISE.

The first sprinkler activated, as determined by the air pressure loss, at 01:44 [min:s]. Water was initiated at 02:51 [min:s], and full system pressure was achieved shortly thereafter, which resulted in a water delivery time of about 65 s. During the delay time, three sprinklers had activated. The fourth sprinkler activated at 05:52 [min:s], the fifth sprinkler at 06:21 [min:s] and the final sixth sprinkler at 08:23 [min:s]. The six flowing sprinklers resulted in a flow rate of about 920 l/min which corresponded well to the desired discharge density of 15 mm/min. Figures 71 through 76 shows the test.

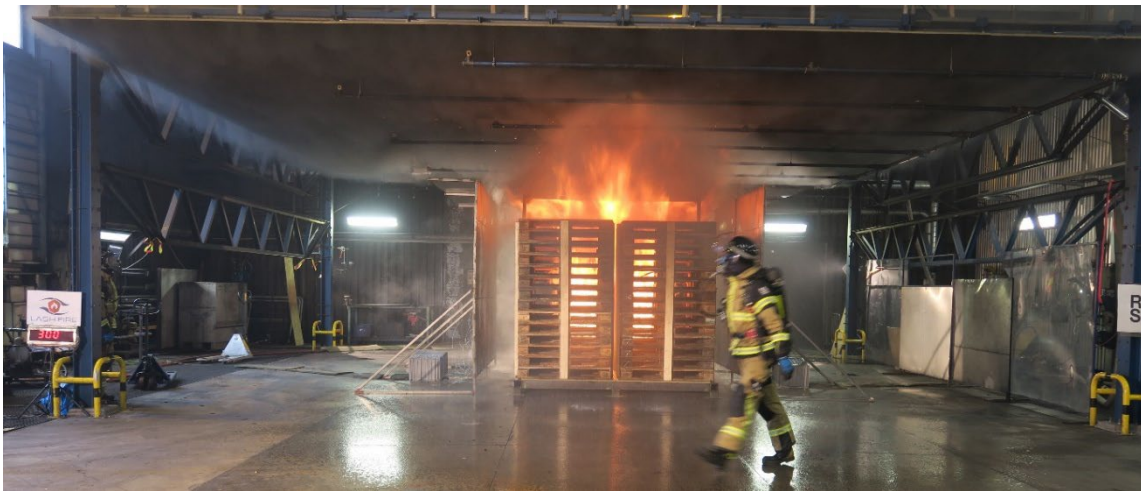
Figure 72. **Test 8:** The fire at 03:00 [min:s], shortly after water was discharging from the initial three automatic sprinklers that had activated. Photo: RISE.

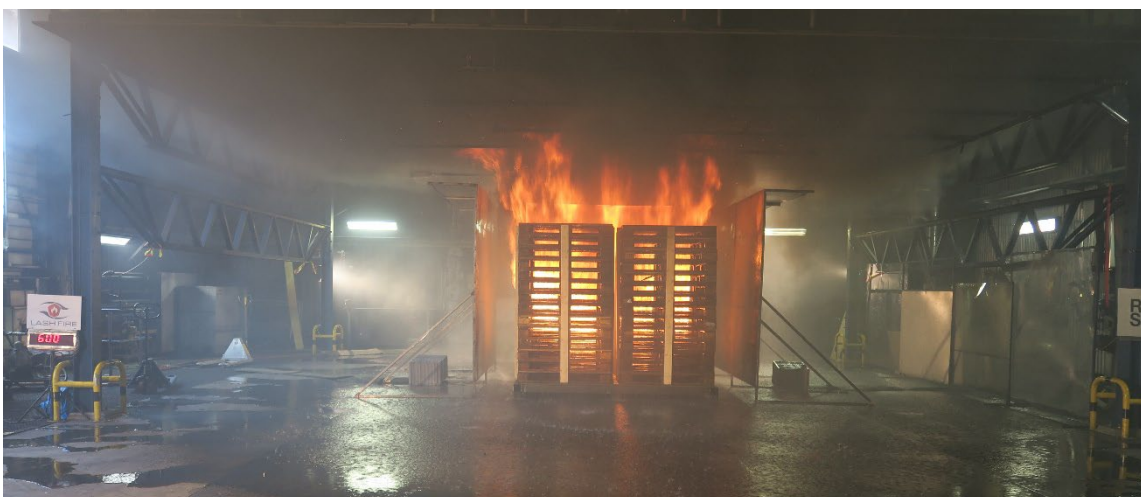
Figure 73. **Test 8:** The fire at 06:00 [min:s], shortly after the activation of the fourth automatic sprinkler. Photo: RISE.

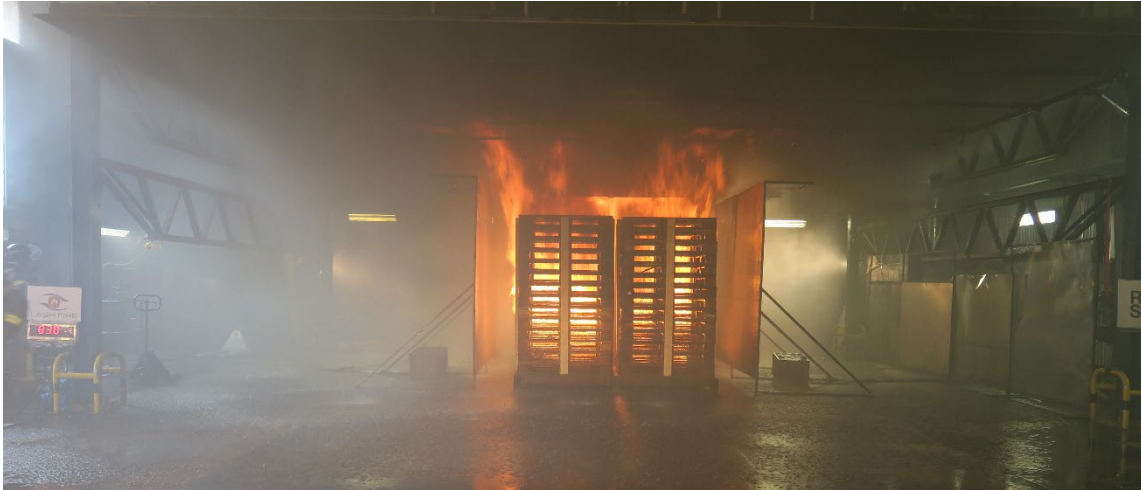
Figure 74. **Test 8:** The fire at 08:30 [min:s], shortly after the activation of the sixth (final) automatic sprinkler. Photo: RISE.

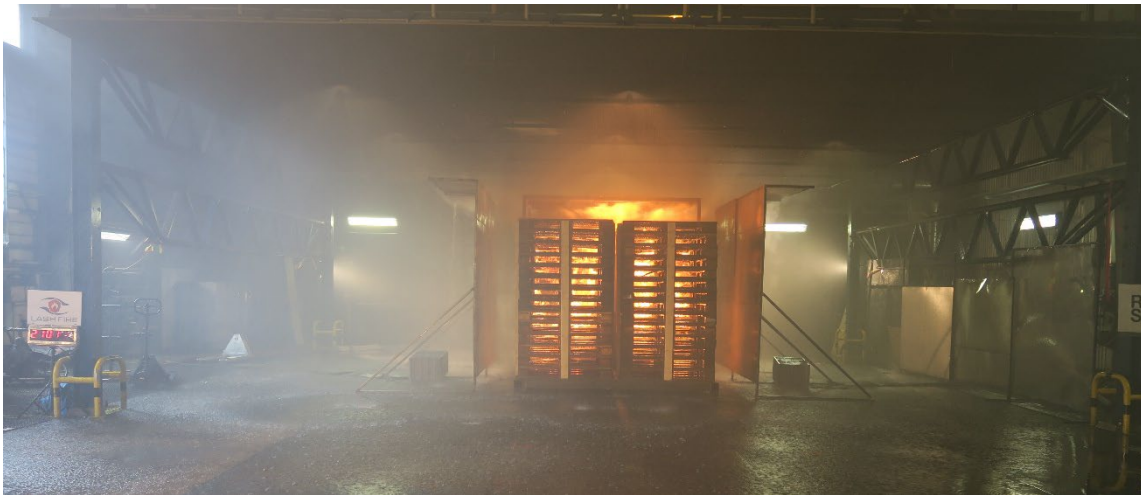
Figure 75. **Test 8:** The fire at 21:01 [min:s], as the fire intensity started to decline. Photo: RISE.

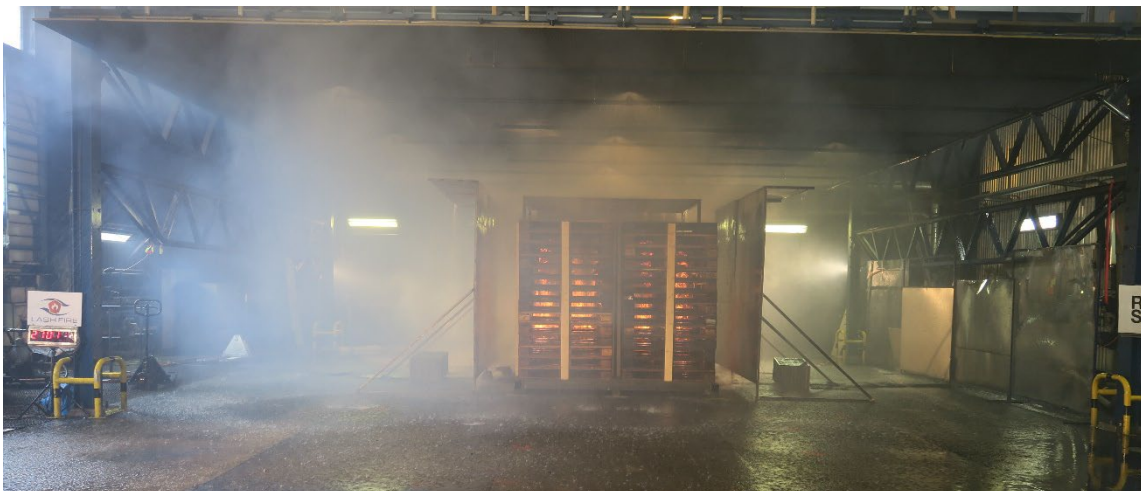
Figure 76. **Test 8:** The fire at 27:01 [min:s]. Photo: RISE.

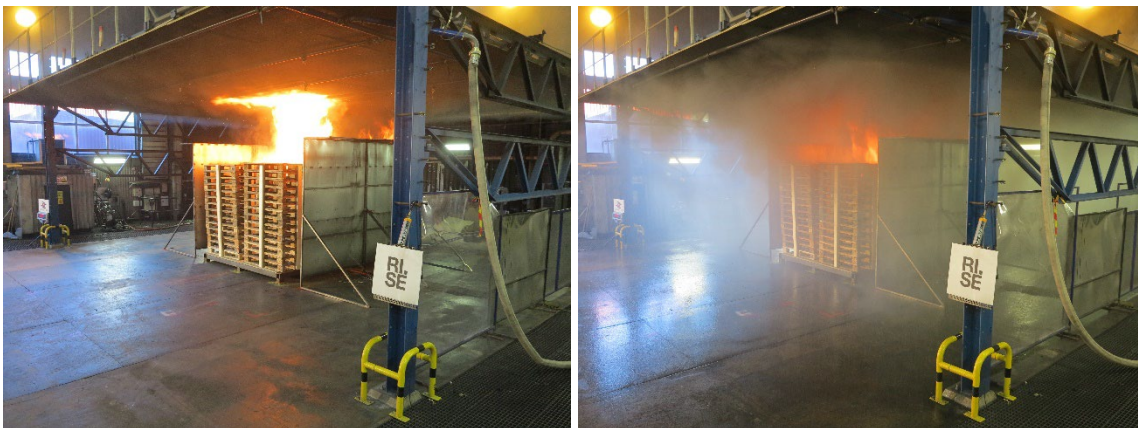
Figure 78. **Test 5:** The fire size at 02:20 [min:s] and 02:30 [min:s], moments before and after the start of the application of water. Photo: RISE.

During the test, a system valve that was supposed to be fully open was partially closed. This reduced the water flow rate from the desired approximate **900 l/min (10 mm/min)**, starting at 06:10 [min:s] and gradually down to below **500 l/min (5 mm/min)**. The reduced water flow rate resulted in a fire re-growth that required the test to be manually terminated using fire hoses. These efforts were started at about 10:00 [min:s]. Figures 77 through 83 shows the test.

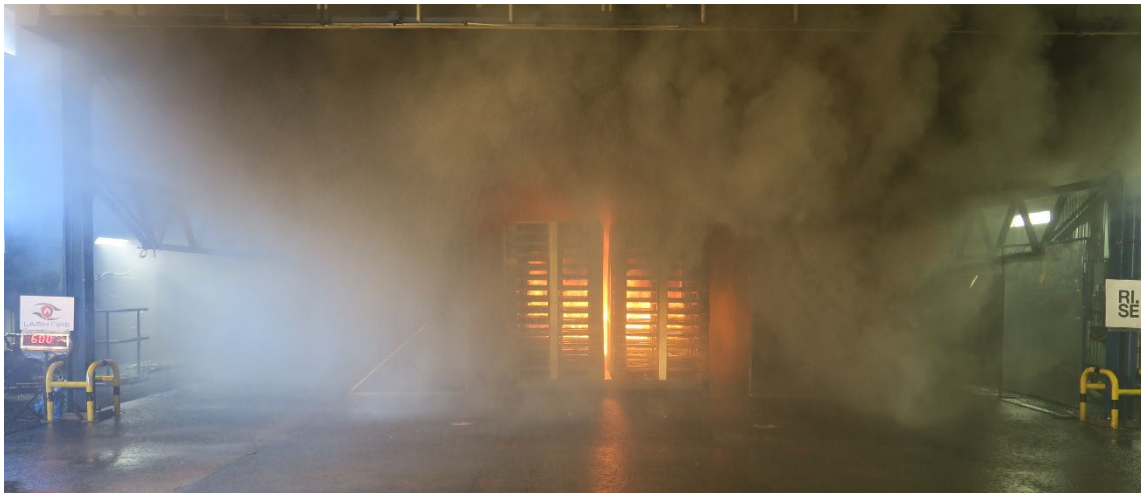
Figure 79. **Test 5:** The fire size at 06:00 [min:s], when the water flow rate started to become reduced. The measured water flow rate is approximately 920 l/min. Photo: RISE.
