Project acronym: **LASH FIRE**  
Project full title: **Legislative Assessment for Safety Hazard of Fire and Innovations in Ro-ro ship Environment**  
Grant Agreement No: **814975**  
Coordinator: **RISE Research Institutes of Sweden**

## **Deliverable D10.4**

# **Large-scale validation of the new fire test standard for alternative fixed fire-fighting systems**

**February 2023**

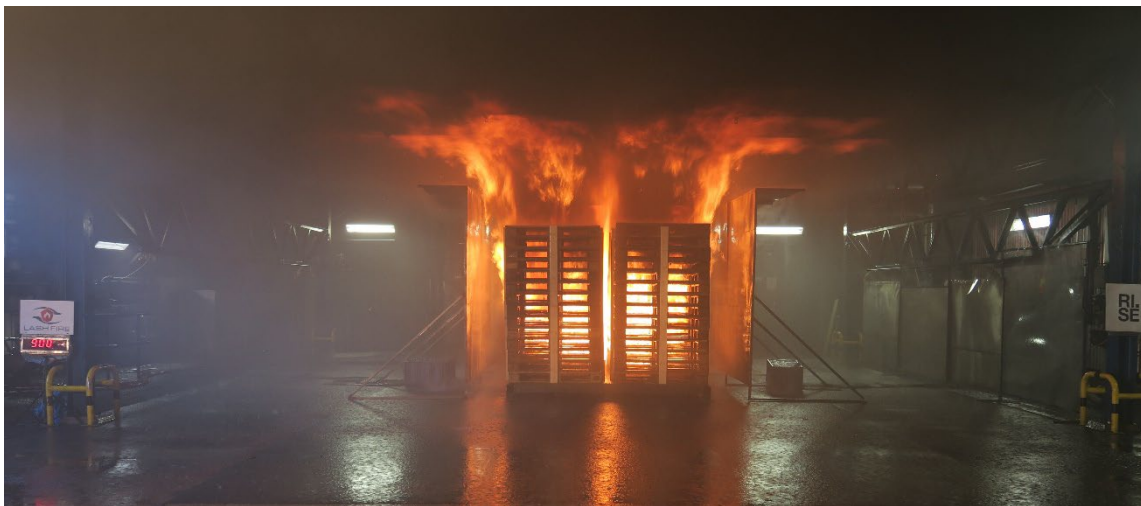
Figure 80. **Test 5:** The fire size at 09:00 [min:s]. The measured water flow rate is approximately 490 l/min. Photo: RISE.

During the test, a system valve that was supposed to be fully open was partially closed. This reduced the water flow rate from the desired approximate **900 l/min (10 mm/min)**, starting at 06:10 [min:s] and gradually down to below **500 l/min (5 mm/min)**. The reduced water flow rate resulted in a fire re-growth that required the test to be manually terminated using fire hoses. These efforts were started at about 10:00 [min:s]. Figures 77 through 83 shows the test.

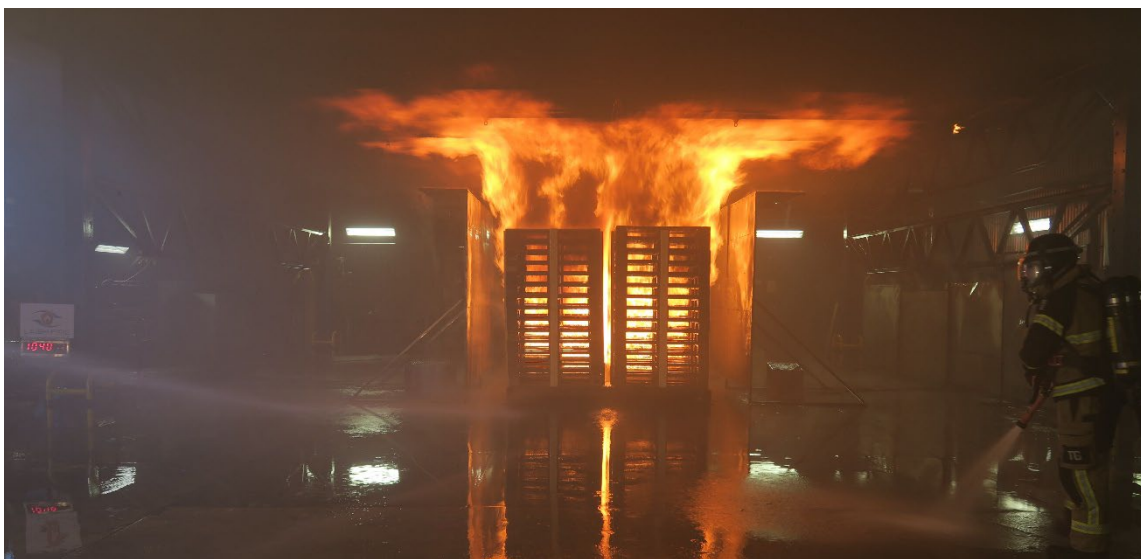
Figure 81. **Test 5:** The fire size at 10:40 [min:s], just prior the termination of the test using fire hoses. The measured water flow rate is approximately 480 l/min. Photo: RISE.

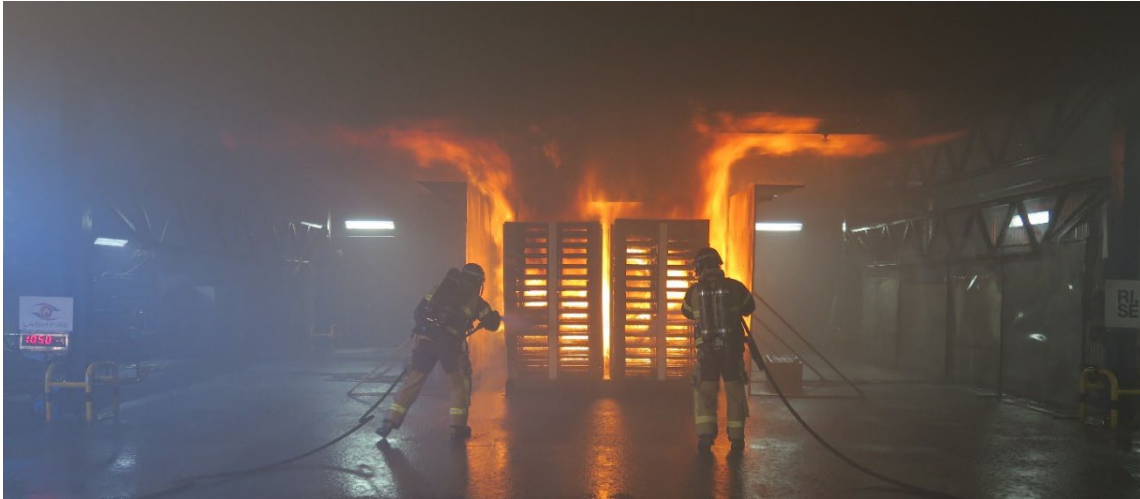
Figure 82. **Test 5:** The fire size at 10:50 [min:s], when the test was terminated by applying water from fire hoses. Photo: RISE.

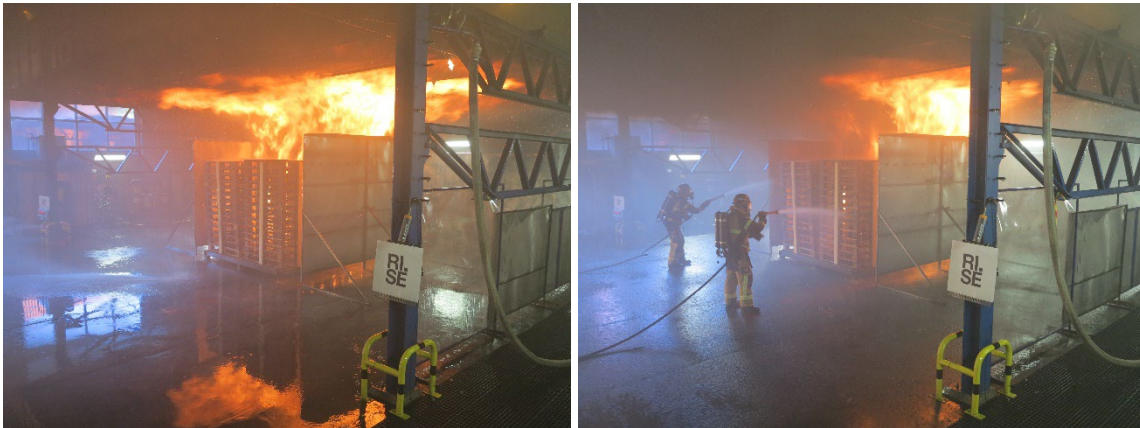
Figure 83. **Test 5:** The fire size documented from a different angle as compared to the photos above but at the same times, 10:40 [min:s] and at 10:40 [min:s], respectively. Photo: RISE.

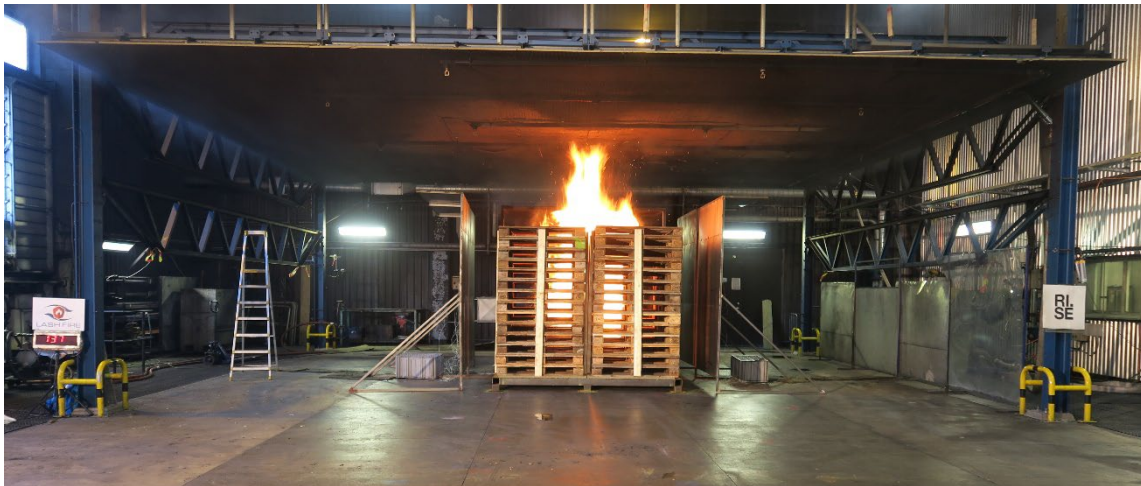
Figure 84. **Test 6:** The fire size at 01:37 [min:s], soon after both thermocouples at a 4,5 m radius from the fire had exceeded the 78 °C temperature threshold. Photo: RISE.

The application of water initially reduced the fire size and the ceiling gas temperatures. But at about 03:10 [min:s] the fire increased in size and the average ceiling gas temperature gradually increased from about 400 °C to about 750 °C at 17:00 [min:s]. Even though it seemed that the ceiling gas temperatures leveled out, the decision was made to terminate the test. At 18:35 [min:s], fire hose streams were applied to the fire to knock it down. Figures 84 through 89 shows the test.

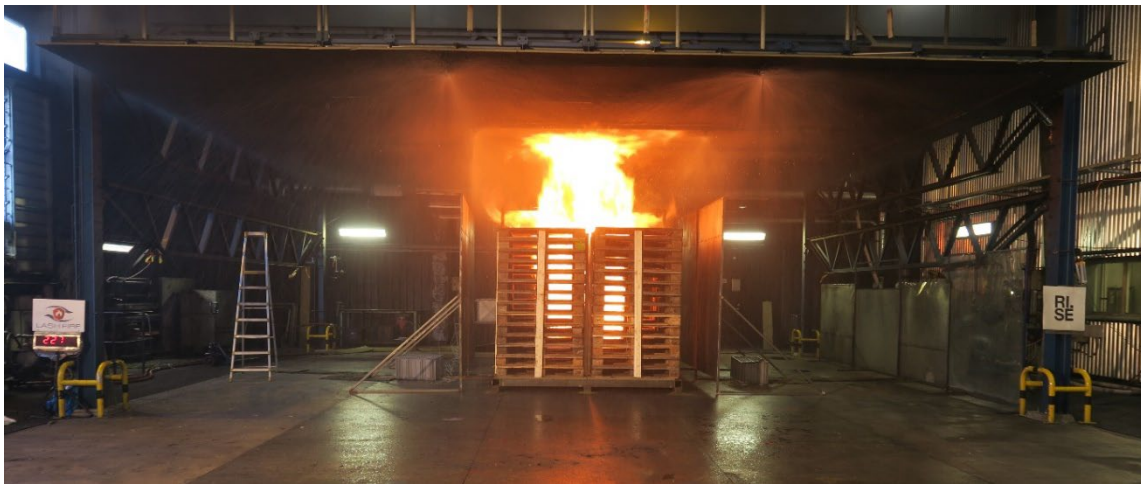
Figure 85. **Test 6:** The fire size at 02:26 [min:s], shortly after the start of the application of water and a few seconds before full system operating pressure was reached. Photo: RISE.

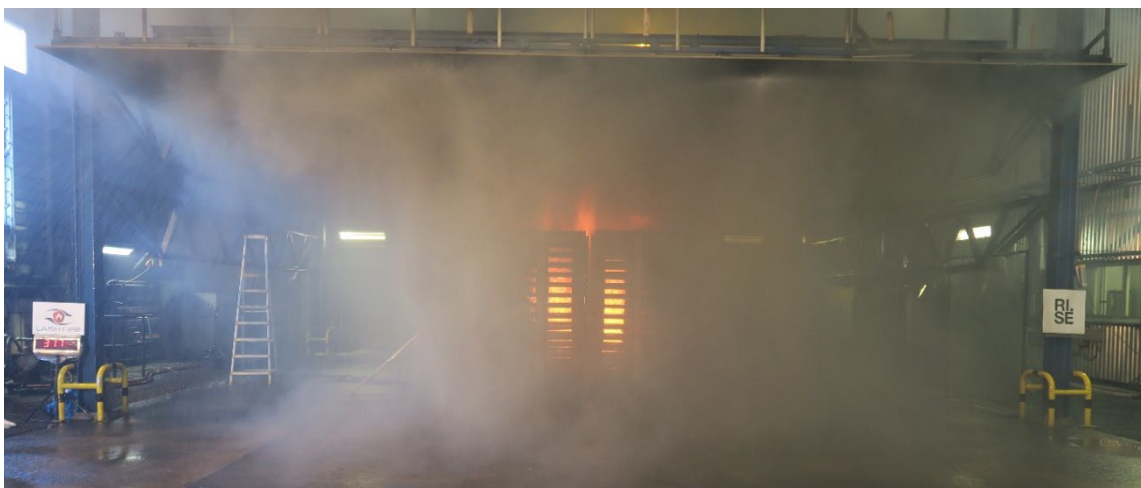
Figure 86. **Test 6:** The fire size at 03:17 [min:s], at about the time when the fire gradually started to increase in size. Photo: RISE.

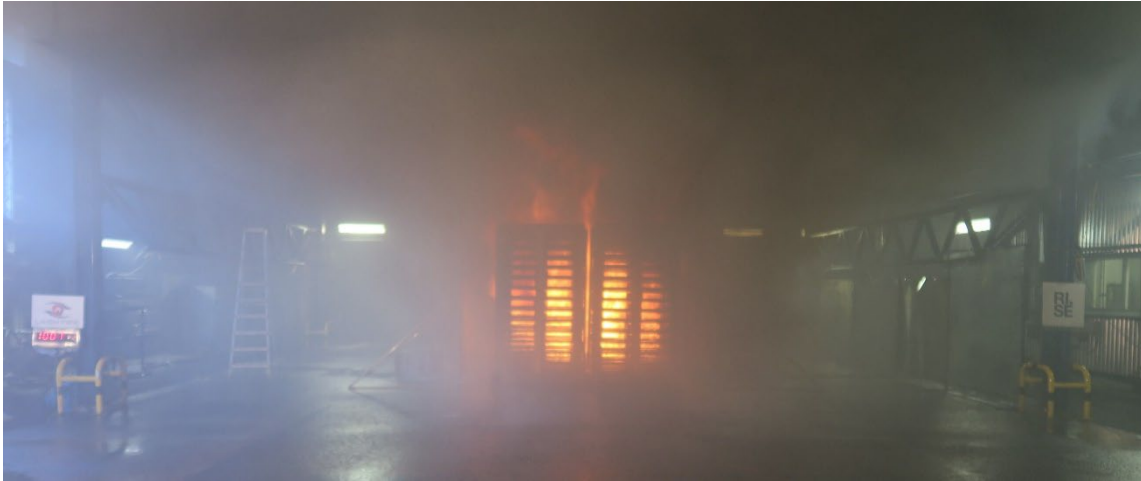
Figure 87. **Test 6:** The fire size at 10:07 [min:s], at about the time when the fire gradually started to increase in size. Photo: RISE.

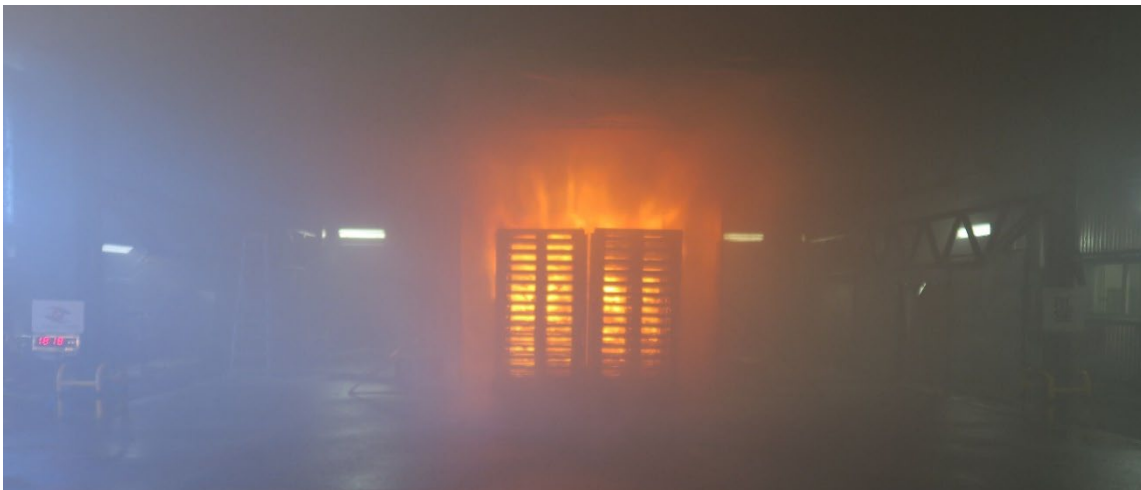
Figure 88. **Test 6:** The fire size at 18:18 [min:s], when the decision was made to terminate the test. Photo: RISE.

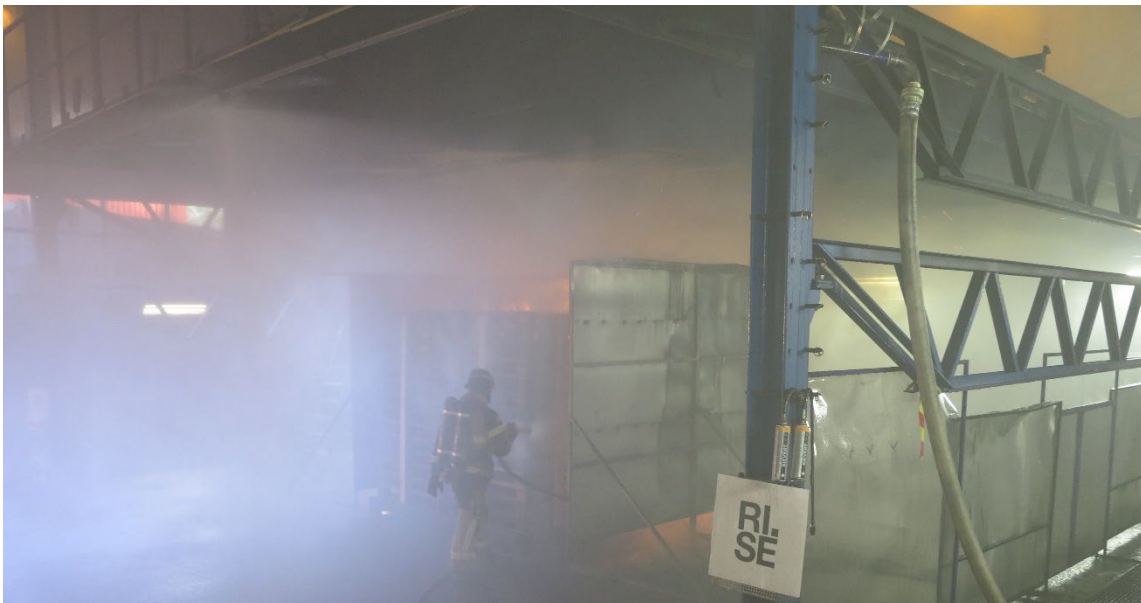
Figure 89. **Test 6:** The termination of the test using fire hoses. Photo: RISE.

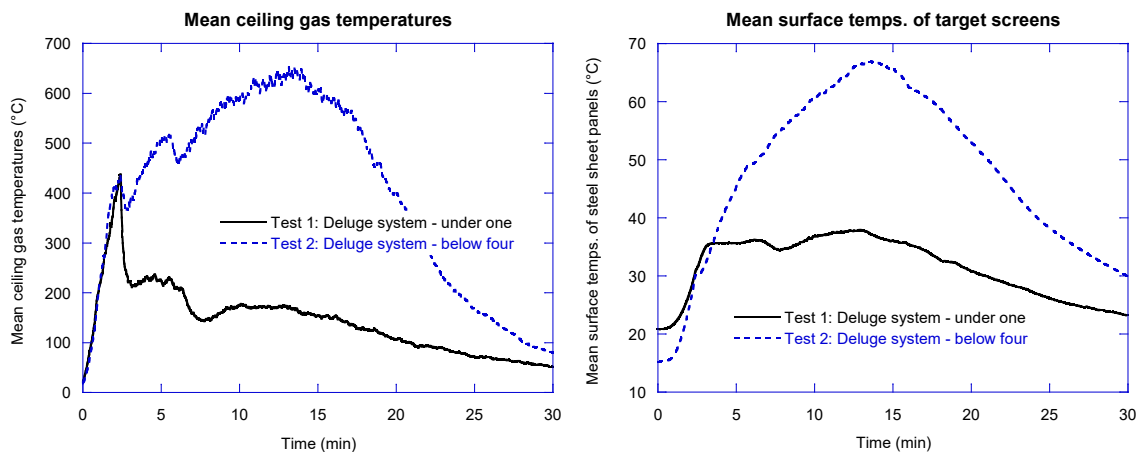
Figure 90. **Tests 1 and 2:** The mean ceiling gas and target steel screen surface temperatures.

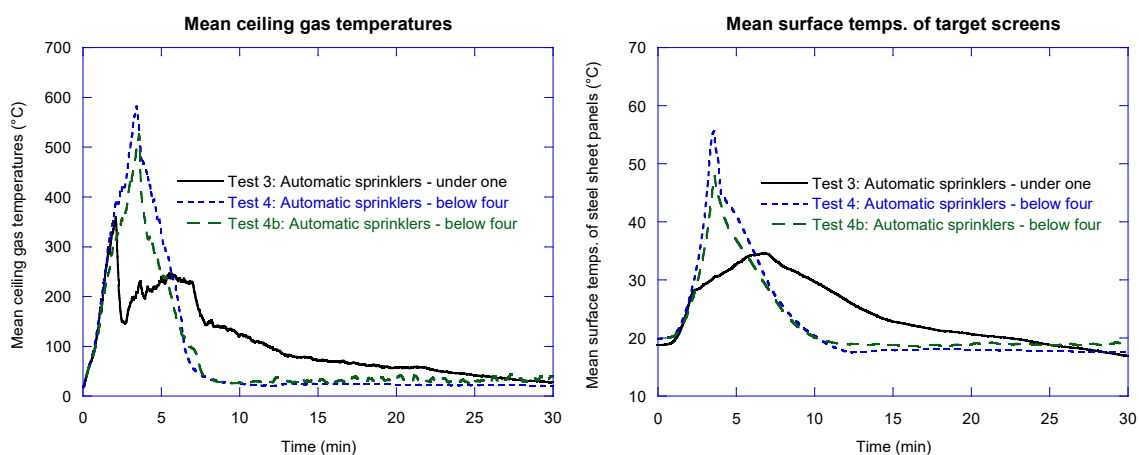
Figure 91. **Tests 3, 4 and 4b:** The mean ceiling gas and target steel screen surface temperatures.

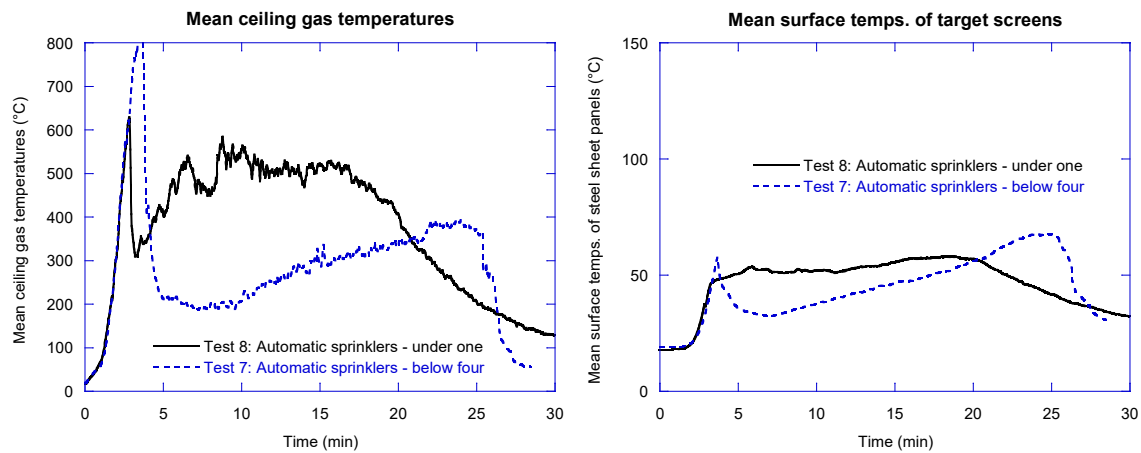
Figure 96. **Tests 7 and 8:** The mean ceiling gas and target steel screen surface temperatures.

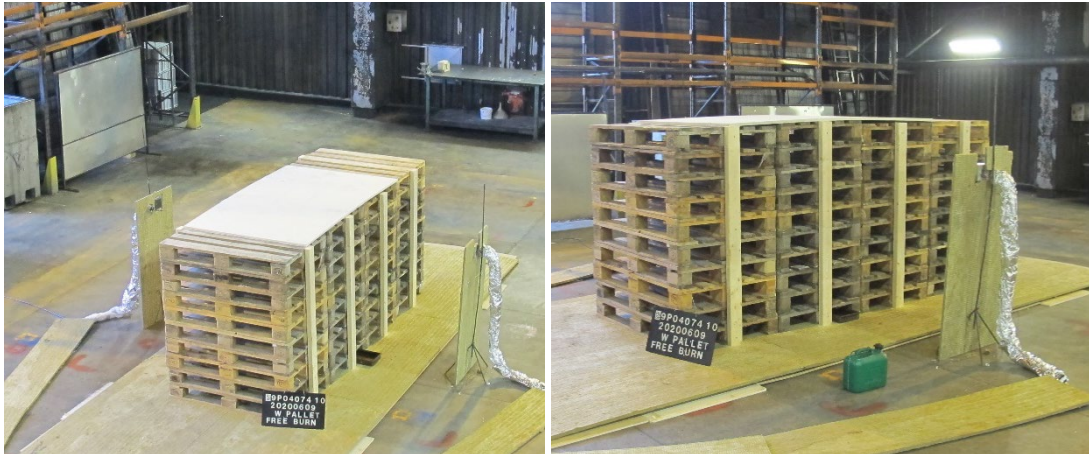
In the first test series, one test was conducted with an array that was 1 pallet (wide) by 10 pallets (high) by 4 pallets (long), i.e., a total of 40 wood pallets. The array is shown in Figure A-1.

Figure A-1 The fire test set-up with 40 idle wood pallets in four stacks with 10 pallets each.

The overall height was about 1,45 m and part of the top surface was covered by two layers of nominally 10 mm thick non-combustible cement fibre boards to simulate the roof of a car. These boards were laid directly on the top of the pallet stacks and secured using wood screws.

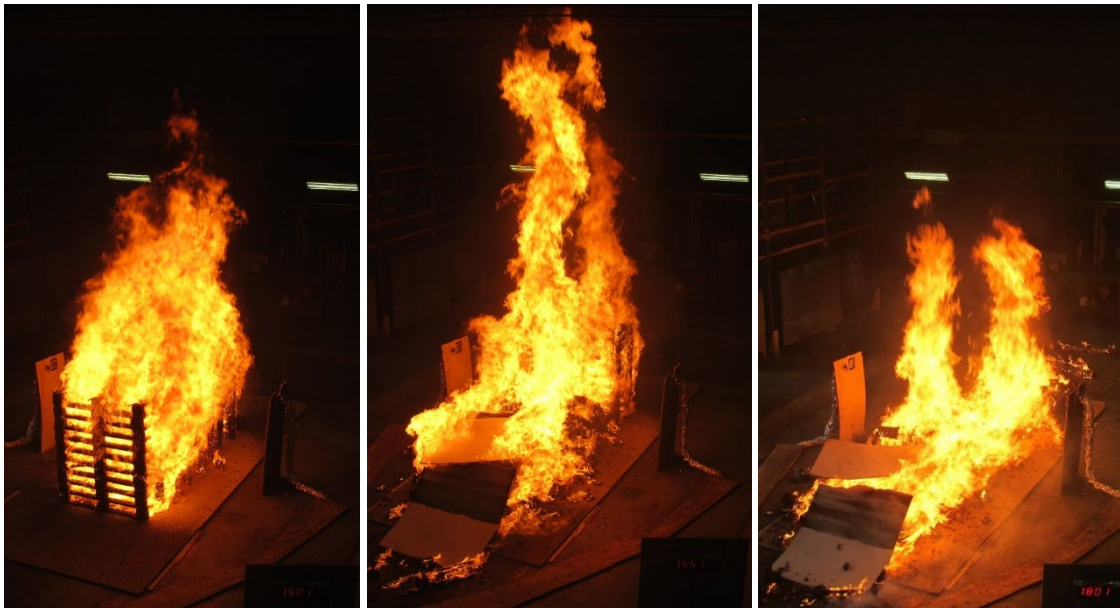
Figure A-4 The fire size at 15:00 [min:s], when the fire intensity had started to decline, at 15:50 [min:s], moments after the partial collapse of the stacks and at about 18:00 [min:s], moments after the collapse of remaining stacks.

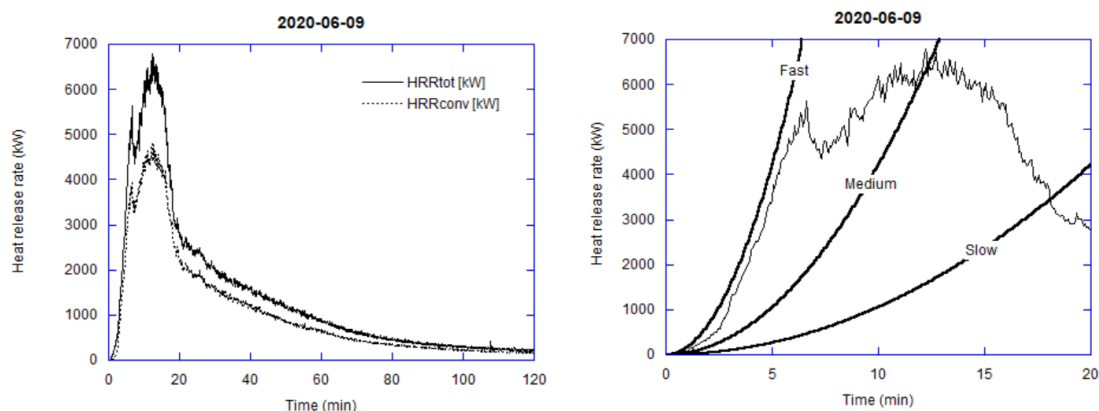
Figure A-5 The total and convective heat release histories (left) and the fire growth rate (right) compared to standard fire growth rate curves.

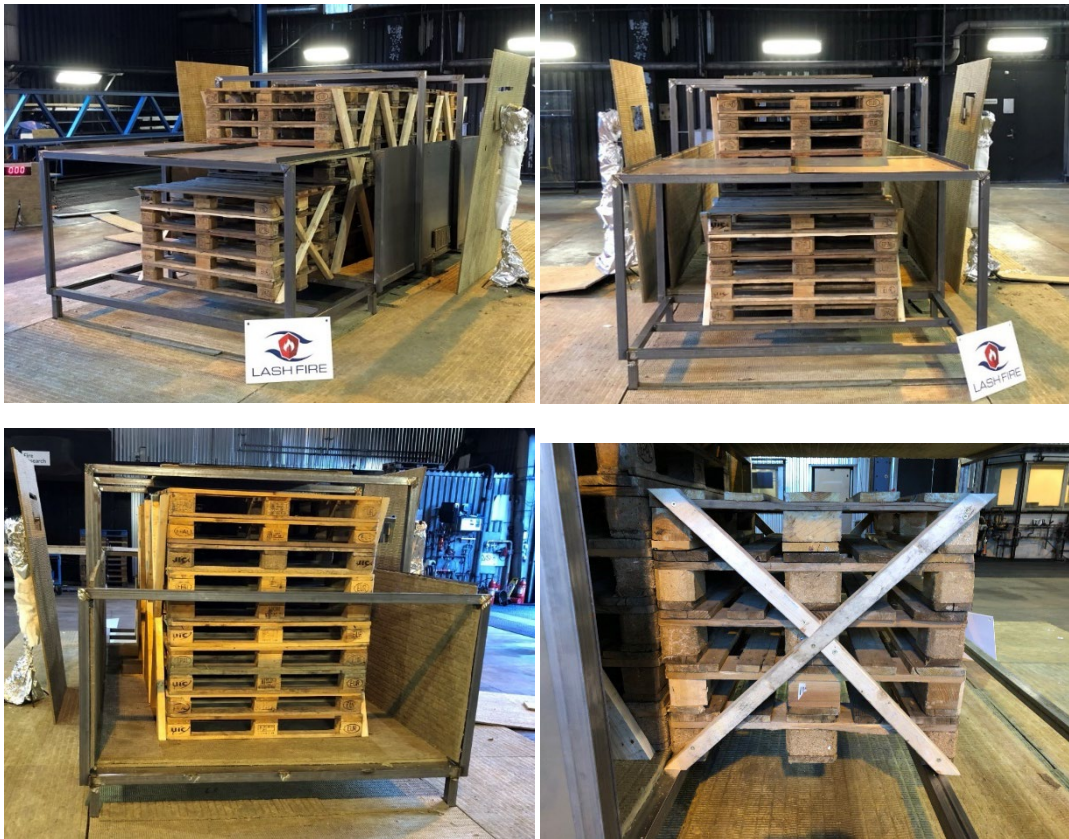
For the second series of tests, a mock-up made from steel sheet had been constructed. Figure A-7 shows the arrangement.

Figure A-7 The passenger car mock-up.

Fire ignition was achieved with an 800 mm (L) by 150 mm (W) fire tray filled with 2 l of heptane on a 2 l layer of water. The fire tray was inserted between the last block of the second stack of the main stacks, i.e., almost at the mid-point of the main stack.

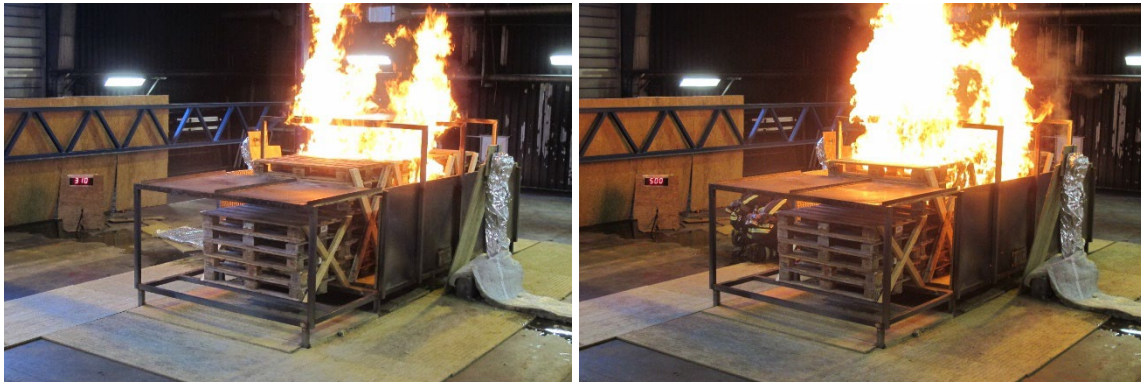
Figure A-12 **Test 2:** The fire size at 03:10 [min:s], reaching 1,0 MW and at 05:00 [min:s], reaching 3,0 MW.

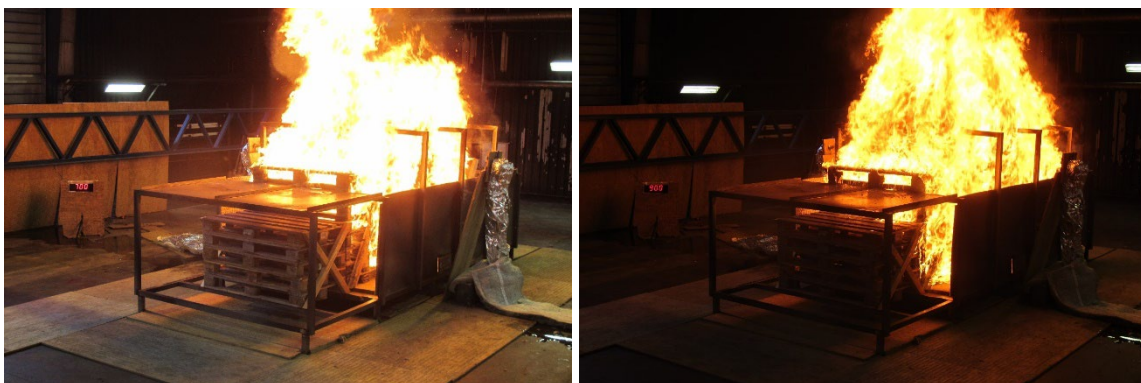
Figure A-13 **Test 2:** The fire size at 07:00 [min:s], being about 5,0 MW and at 09:00 [min:s], reaching 6,3 MW.

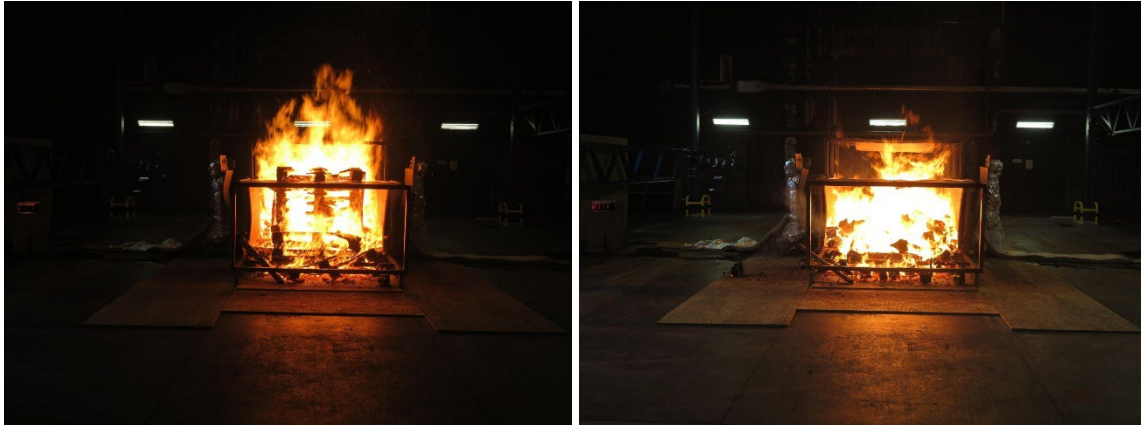
Figure A-15 **Test 2:** The fire size at 21:10 [min:s], being 3,1 MW (left). The photo is taken moments before the collapse of the idle wood pallets and at 23:10 [min:s] being 2,7 MW (right). The photo is taken two minutes after the collapse of the idle wood pallets.

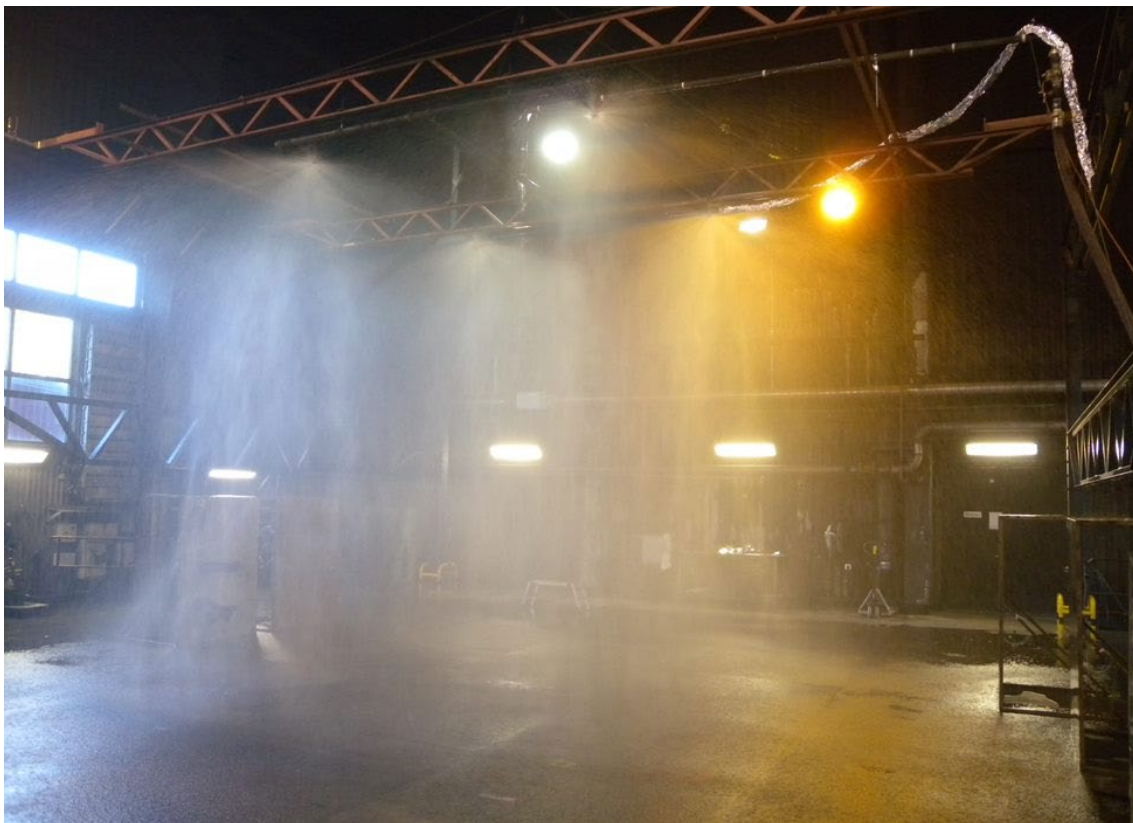
Figure B-2 The spray pattern of the four water spray nozzles used in the tests

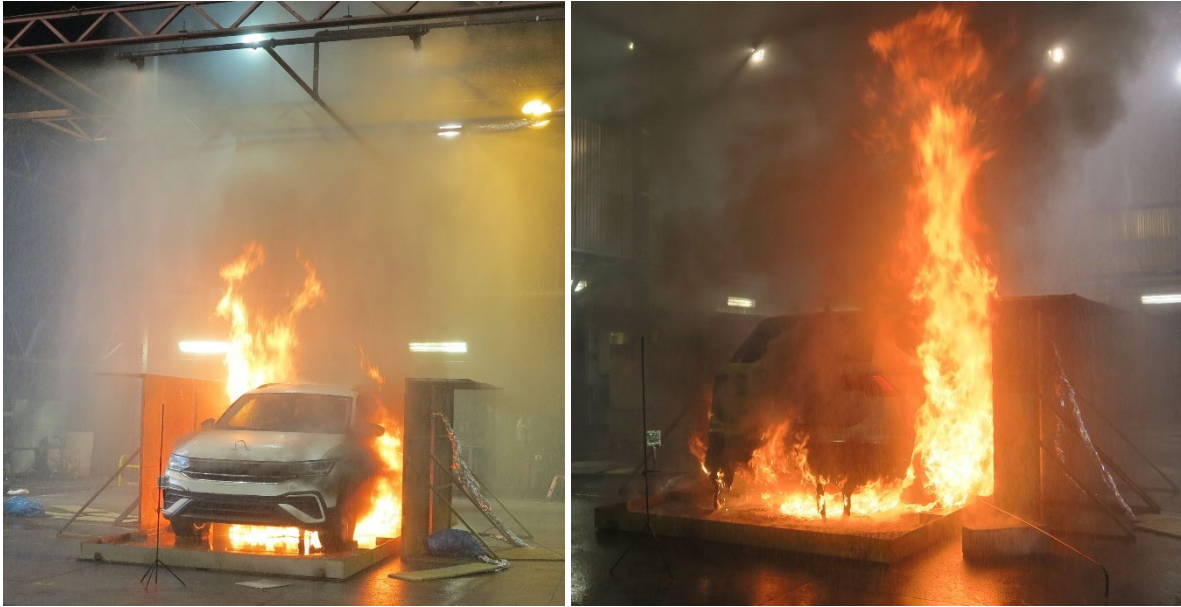
Figure B-3 **ICEV1:** The fire size at 01:12 [min:s], at the start of the application of water from the overhead water spray nozzles, viewed from a position in front of (left) and behind (right) the vehicle.

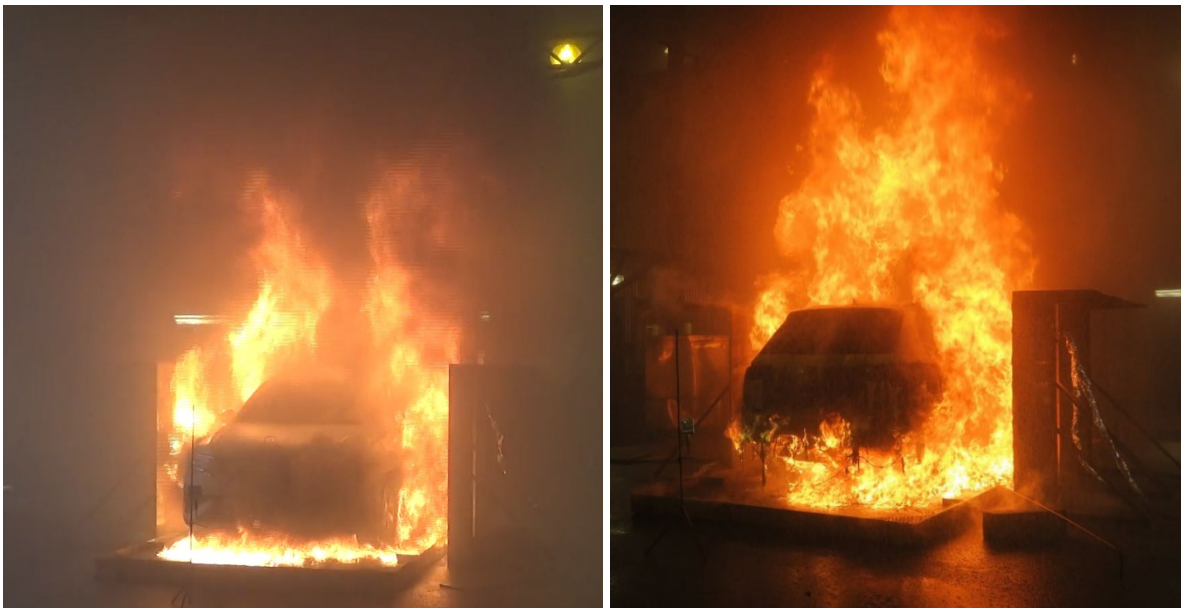
Figure B-4 **ICEV1:** The fire size at the most intense stage at about 03:30 [min:s], viewed from a position in front of (left) and behind (right) the vehicle.

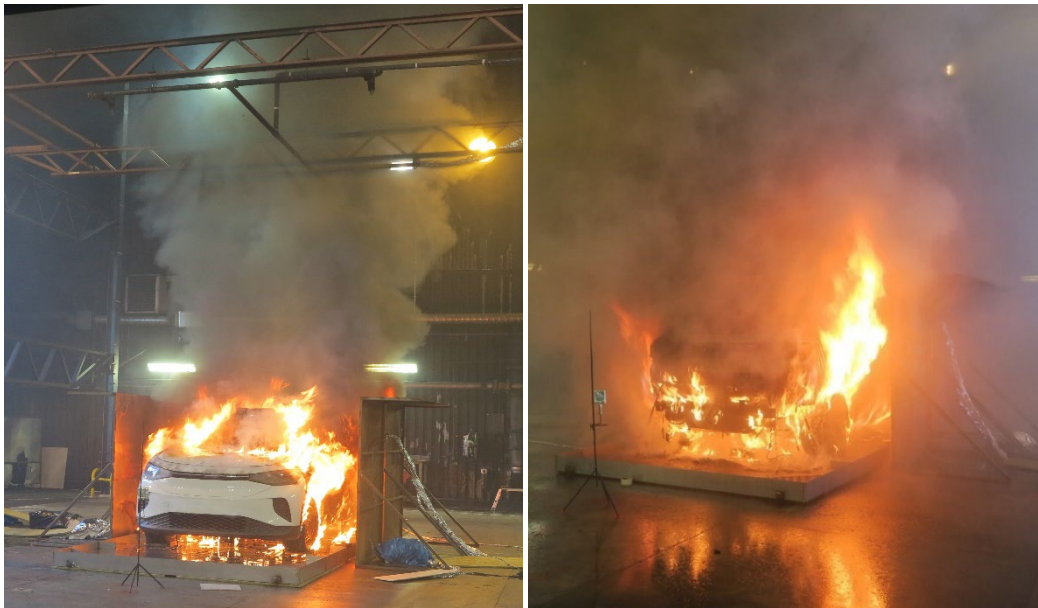
Figure B-5 **BEV1:** The fire size a few seconds prior the start of the application of water from the overhead water spray nozzles at 12:40 [min:s], viewed from a position in front of (left) and behind (right) the vehicle.

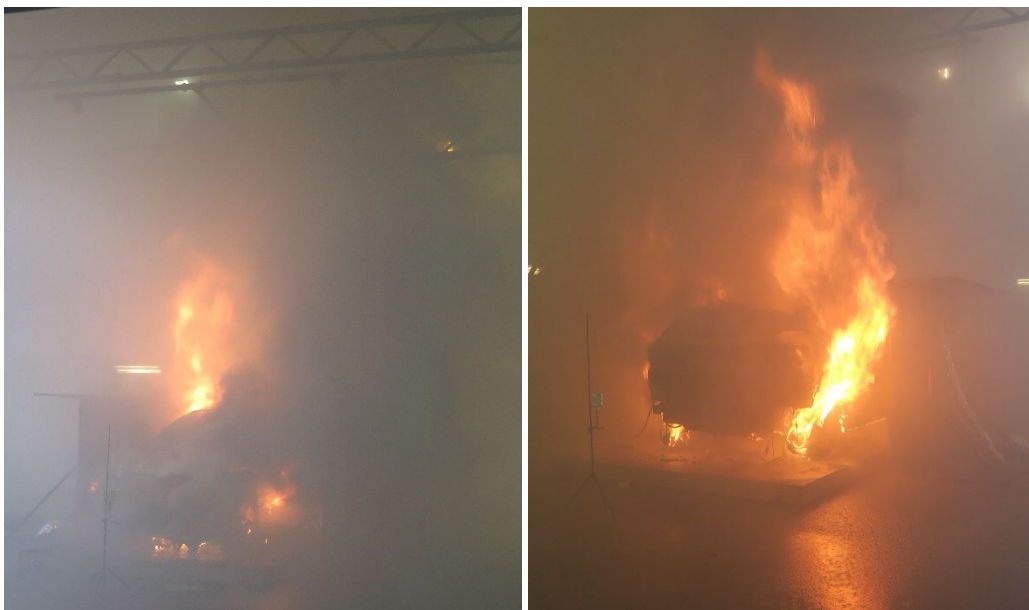
Figure B-6 **BEV1:** The fire size at the most intense stage at about 19:00 [min:s], viewed from a position in front of (left) and behind (right) the vehicle.

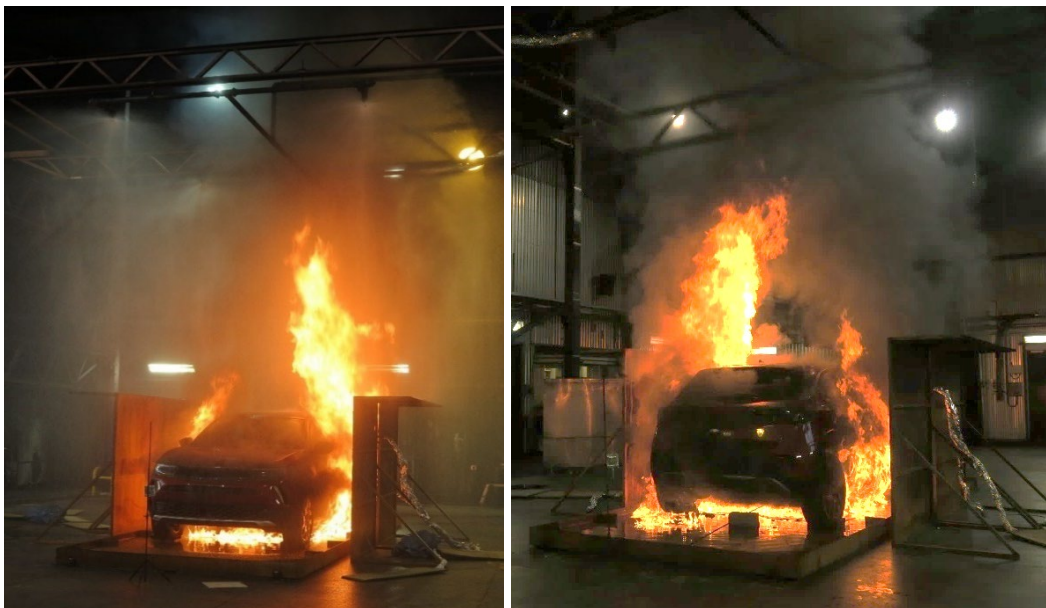
Figure B-7 **ICEV2:** The fire size shortly after the start of the application of water from the overhead water spray nozzles at 00:58 [min:s], viewed from a position in front of (left) and behind (right) the vehicle.

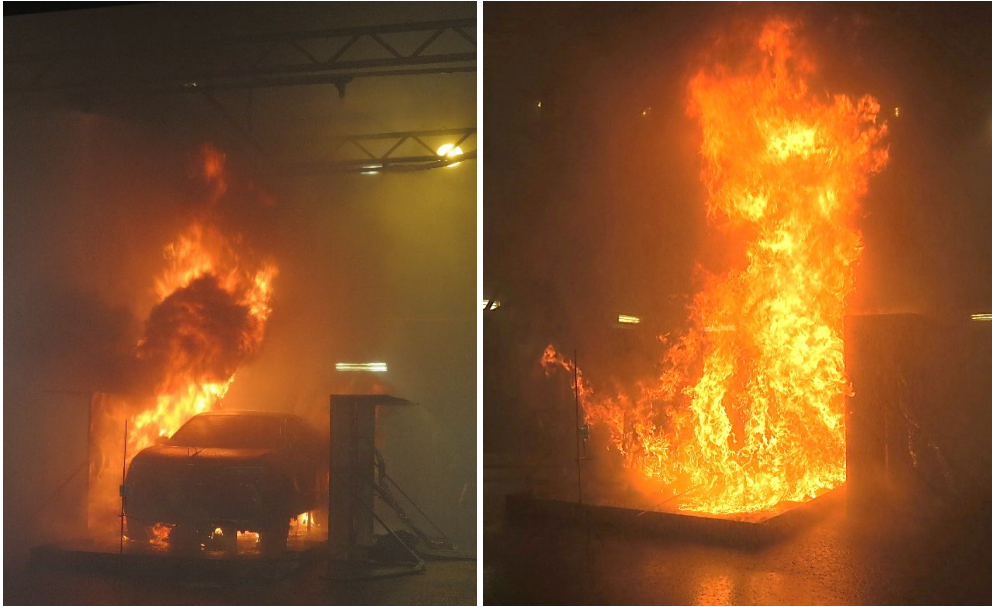
Figure B-8 **ICEV2:** The fire size at the most intense stage at about 04:00 [min:s], viewed from a position in front of (left) and behind (right) the vehicle.

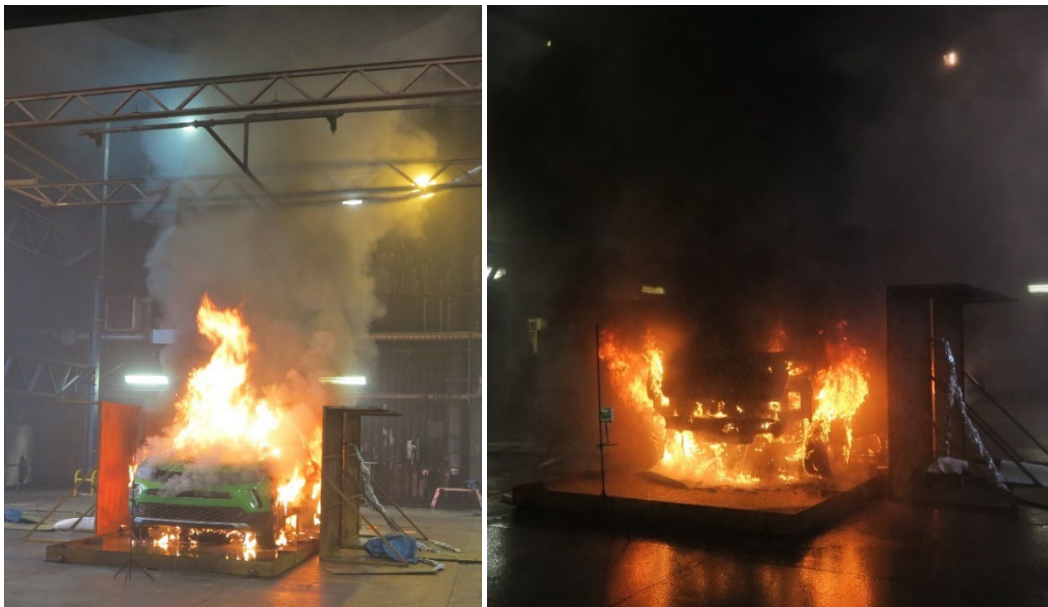
Figure B-9 **BEV2:** The fire size a few seconds prior and after the start of the application of water from the overhead water spray nozzles at 16:45 [min:s], viewed from a position in front of (left) and behind (right) the vehicle.

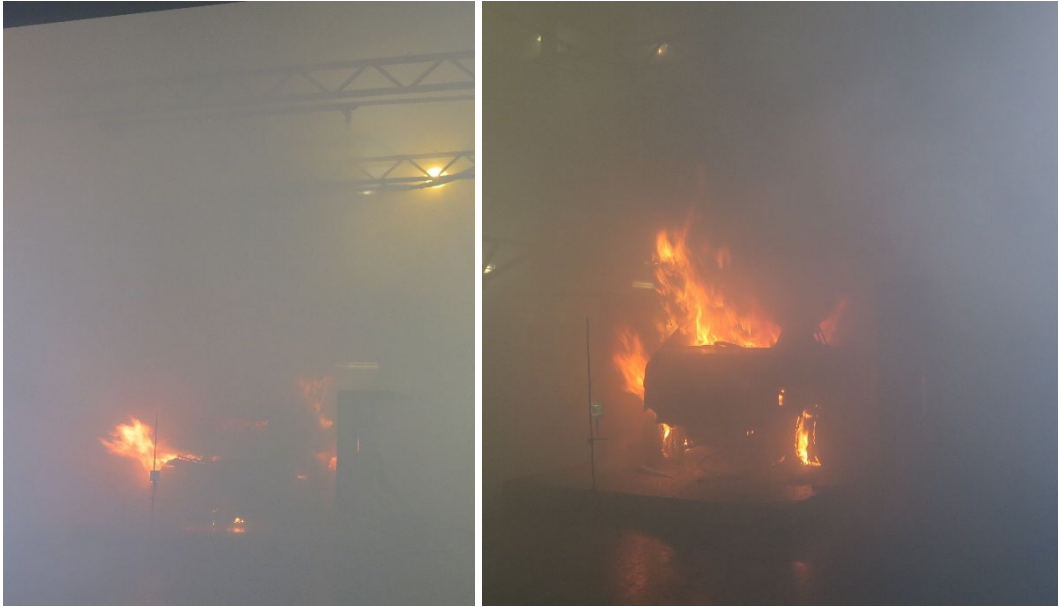
Figure B-10 **BEV2:** The fire size at the most intense stage at about 24:40 [min:s], viewed from a position in front of (left) and behind (right) the vehicle.
