Project acronym: **LASH FIRE**
Project full title: **Legislative Assessment for Safety Hazard of Fire and Innovations in Ro-ro ship Environment**
Grant Agreement No: **814975**
Coordinator: **RISE Research Institutes of Sweden**

Deliverable D08.5

Development and validation of safe electrical systems, equipment and routines

August 2023

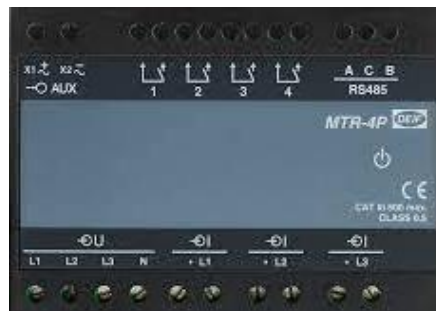
Figure 3 DEIF MTR-4-015 transducer

DEIF's MTR-4-015 transducer, shown in Figure 3, in combination with ASR 21.5 current transformer is chosen as the energy meter to measure instantaneous power, voltages, currents, et cetera. With RS485 as its mode of communication, multiple units can be easily connected in series with a 2-wire system. The energy meter is rigged in a three-phase 4-wire configuration as the output of the distribution transformer to the reefer connections are in a delta configuration. Each phase cable has a current transformer.

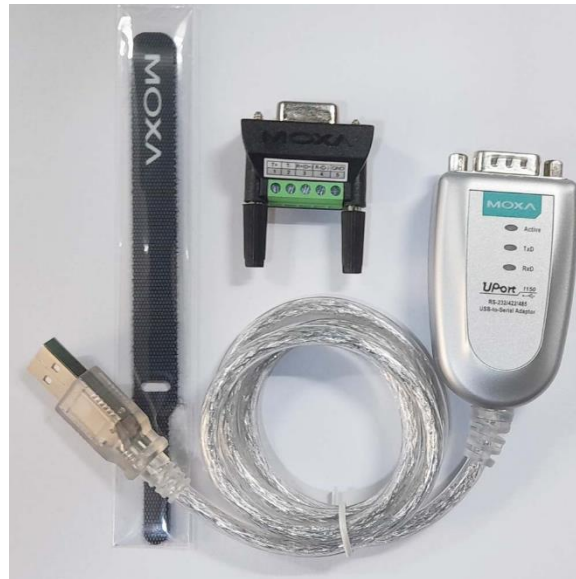
Figure 4 Moxa UPort-1150

The on-board computer has no serial port to support a physical connection for a 2-wire RS485 device and hence a standard serial to USB converter, UPort-1150 by Moxa, Figure 4, is used as an interface between the two.

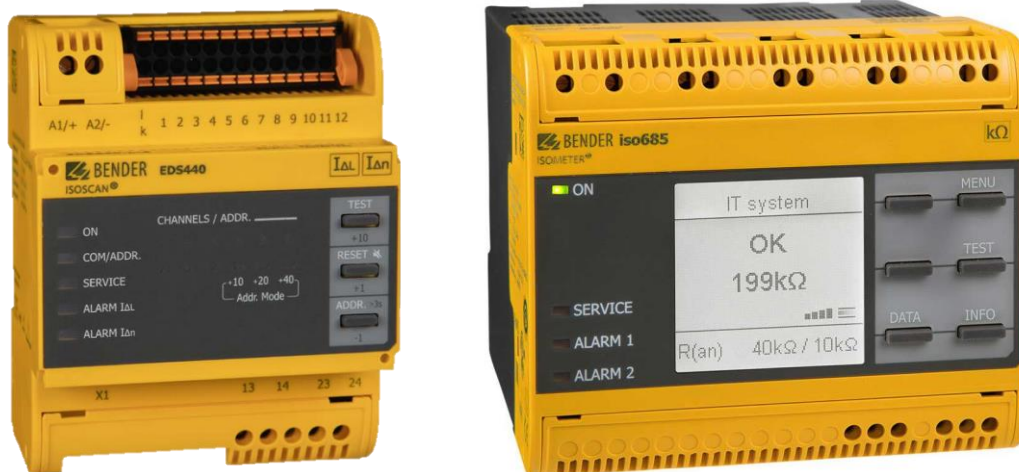
Figure 5 Bender EDS440 and ISO685

Bender's ISO685-D-P is used as the insulation monitoring device. This unit monitors the ground fault by constantly measuring the insulation resistance and relaying it to the computer. It is complemented by the EDS440 which is an insulation fault locator. These are as shown in Figure 5.

When an insulation monitoring device detects an insulation fault, it initiates a fault location process. In IT systems, a residual current flows during the first insulation fault, primarily determined by the system's leakage capacitances. The fault location process involves briefly closing the fault current circuit with a defined resistance to generate a locating current that contains an identifiable signal. The locating current is generated at regular intervals by the locating current injector, the ISO685-D-P unit, limited in amplitude and time, and alternately connects the system conductors to the earth through the defined resistance. The resulting locating current depends on the insulation fault's size and the system voltage, and it is limited based on specific settings. Since reefers are not sensitive or critical loads (unlike say IT systems in hospitals powering life supporting equipment), locating current does not cause harmful reactions in any part of the system. The locating current flows from ISO685-D-P through the live lines to the insulation fault position, passing through the fault and the protective earth (PE) before returning to the locating current injector. The measuring current transformer on the insulation fault path detects this locating current pulse and signals it to the connected insulation fault locator.
