RO-PAX AND RO-RO FIRE SAFETY

THE FLOATING INFERNO

STENA TAKES A LEAD IN FIRE SAFETY

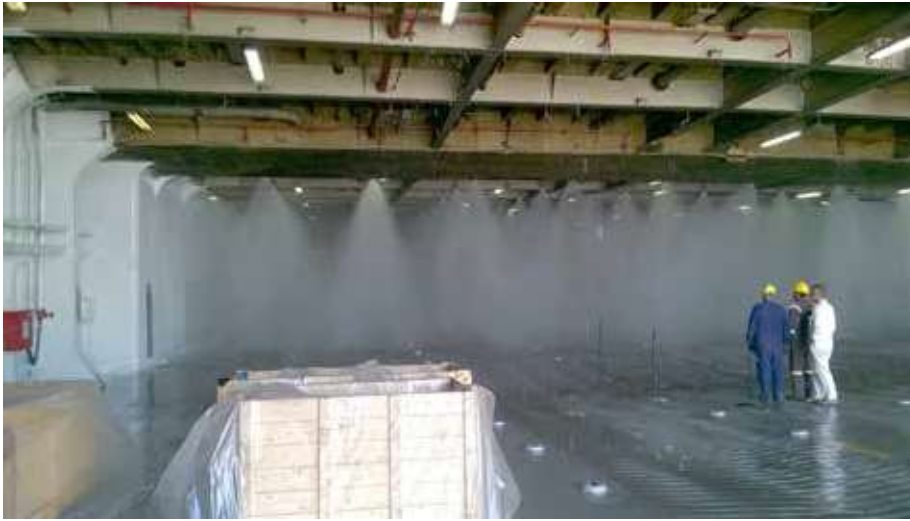
Testing a drencher system.

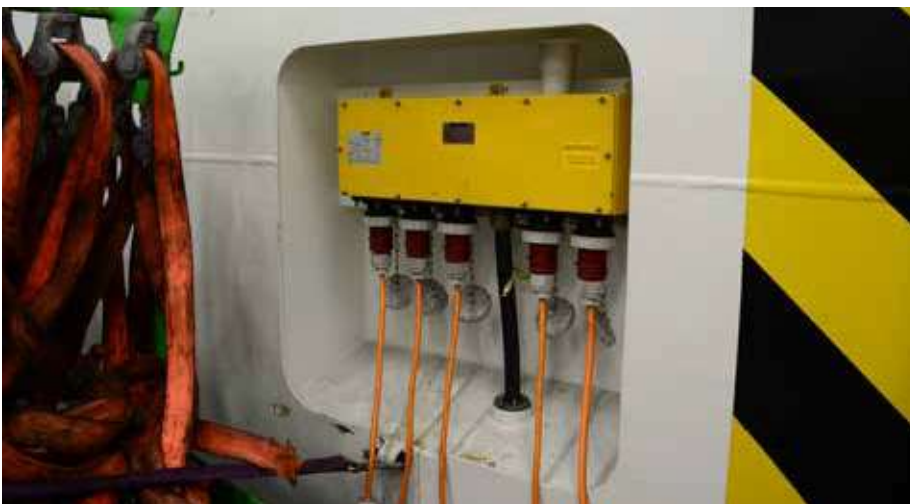
Reefer plugs correctly connected.

to mitigate the risk from the operation of this equipment are to perform a macroscopic inspection and most probably an electrical check on the plugs before they are connected to the vessel’s power.”

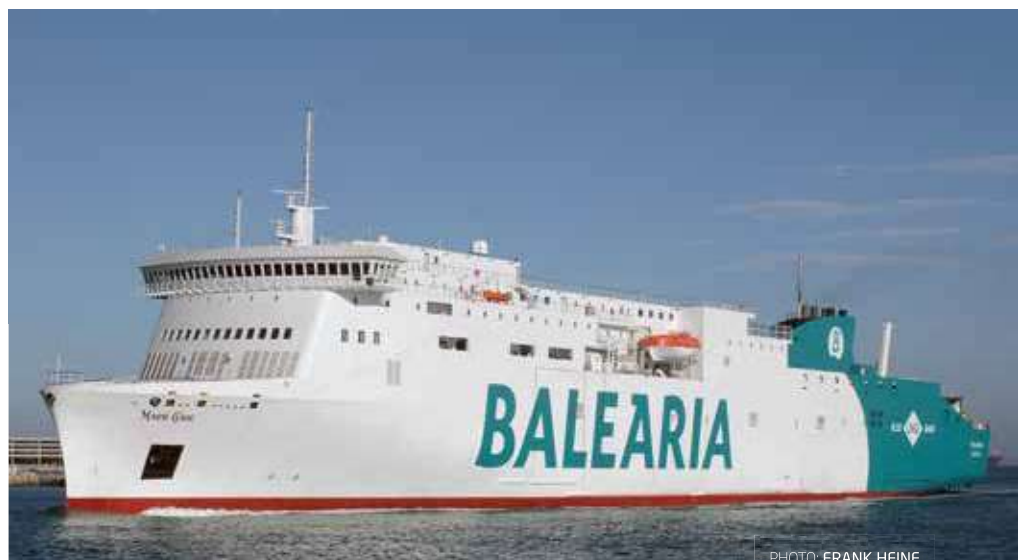
The upper deck on Visentini’s latest newbuilds no longer has side openings and is no longer open aft – it is fully enclosed, using mechanical ventilation.

In the meantime, side openings on the upper ro-ro decks of ro-paxes have become less common on recent newbuildings. In the most recent evolutions of Visentini’s successful series, the upper ro-ro deck on the MARIE CURIE, HYPATIA DE ALEJANDRIA and CIUDAD DE VALENCIA is fully enclosed, requiring additional mechanical ventilation. In contrast, many

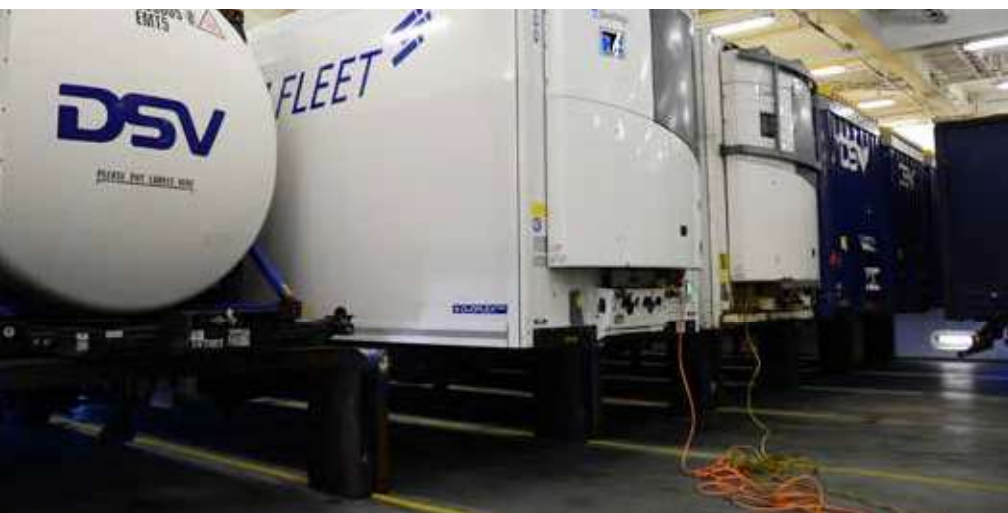
What happens if there are more reefer trailers than available plugs?

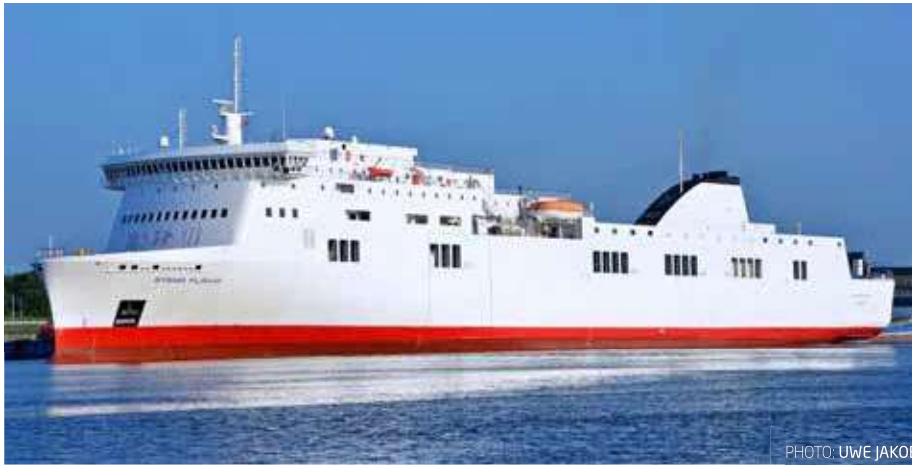
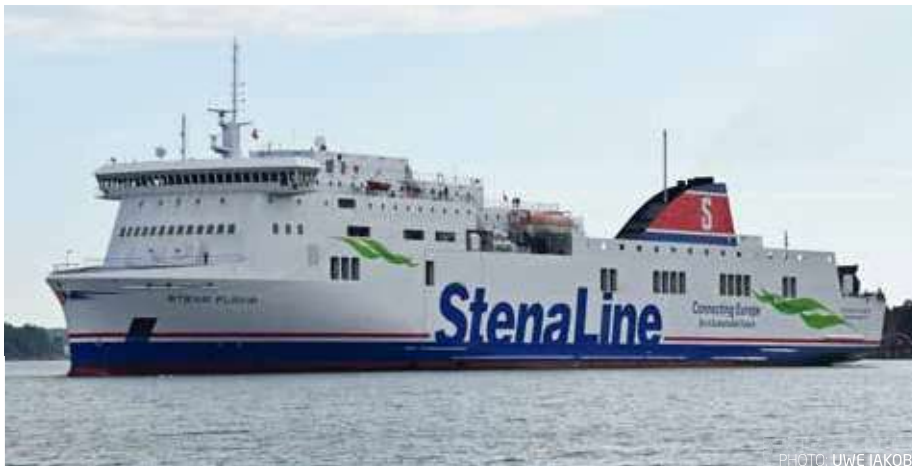
The Visentini Class ships operated by Stena were modified after the NORMAN ATLANTIC accident with a number of side openings closed to better safeguard LSAs as evidenced on STENA FLAVIA.
