# DSM 2023

## Ignition Prevention

## Guidelines and solutions for safe electrical connections

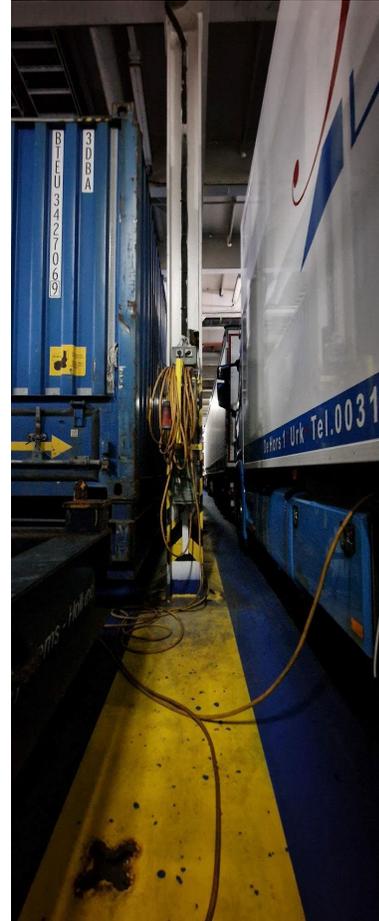
## Operational aspects

- From a pure electrical perspective, connecting a reefer or an EV should involve checking the following.
  - Connection integrity, cable and socket condition, insulation integrity, electrical grounding and overcurrent protection.
- SoPs should be in place that cover connection, disconnection, handling, monitoring and emergency response.
- The connections are to be made by crew only.
